Earthquake Performance of Structures in Bohol: A Post-event Assessment of the M7.2 October 2013 Bohol Philippines Earthquake

M.E. Naguit & P.R. Cummins

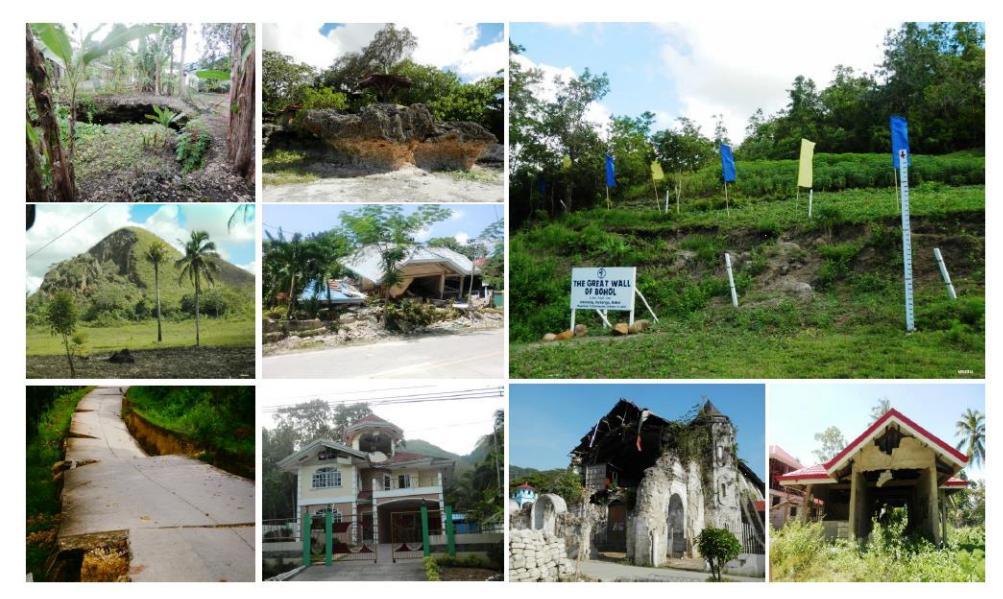
The intense ground shaking during the Bohol earthquake had a tremendous impact not only on buildings but on other infrastructures as well, such as the bridges, roads and highways. This caused major disruptions in transportation and hampered relief efforts. Areas with unstable rock and soil materials succumbed to landslides. Even the Chocolate Hills, a tourist landmark in Bohol, sustained soil failure. Coastal uplift and subsidence were observed in villages along the northwest side of the island. The hundreds of aftershocks that ensued coupled with prolonged shaking caused further damage and casualties. Other hazards posed by the event include liquefaction and sinkholes, probably owing to Bohol being underlain by limestone. Some of the impacts in Bohol's physical environment and structures are featured in Figure 3.

Figure 3.Structural damage & geologic impacts of Bohol Earthquake
