1.0 Introduction

The Scout Hall Slip is on the section of Kwinana Freeway in Perth Western Australia, between Cale Street and Casey Street in Como, just north of Canning Highway. This section of the river shore was originally low lying swampy ground. The natural surface levels at this location required about 1m of additional fill to be placed to raise the site to the freeway design levels. It was estimated at the time that about 100,000 cubic yards (76,000m³) of sand was required (Marsh).

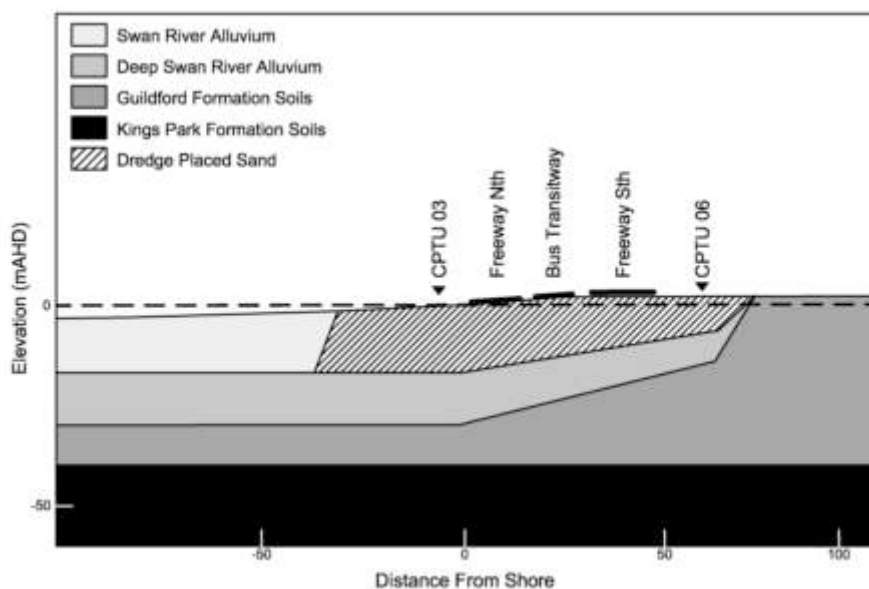
Slip Cross-Section – Figure 2

The Public Works Department (PWD) carried out the fill placement using dredged sand from the riverbed. During the placement of the fill a slip formed and was identified by the Main Roads Department Engineers at the time. The sand was placed using dredging pumps and based on pump throughput rates it is estimated about 600,000 cubic yards (460,000 m³) of sand were placed. This additional 500,000 cubic yards (380,000m³) of sand displaced the soft alluvial mud in the river bank. These displaced soft soils were observed to form a mound in the river and were removed by the PWD. No records of the volume of material removed have been found by the authors. The PWD appears to have continued to add material until the slip stopped moving, i.e. a Factor of Safety (FOS) of 1 was reached. The freeway was then constructed over the “stabilized” slip zone. The volume of material reported above is reproduced from MRWA report on “Narrows Interchange And Section Of Kwinana Freeway On South Perth Foreshore, Implications Of Construction History”, JG (Gilbert) Marsh, June 1993. Figure 2 shows the estimated extents of dredge placed sand fill in a cross-section of the slip zone. This geological model of the slip was developed from CPTU records, observations on site and evidence from G J Marsh (both documentary and anecdotal).

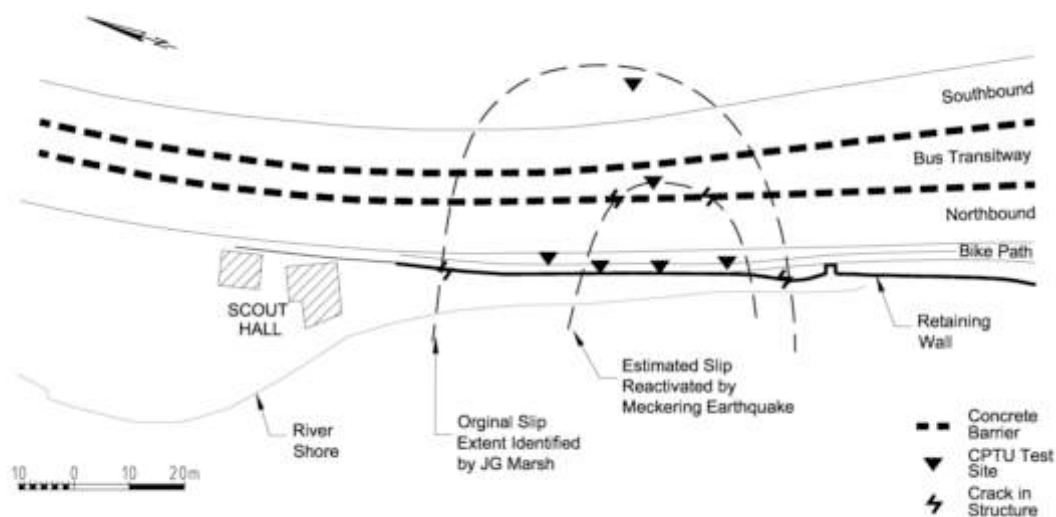
Plan of Slip Areas – Figure 3

The site was visited August 2003 by one of the authors in the company of Mr J G Marsh, who was an Engineer with Main Roads WA at the time of the filling and at the time of the Meckering Earthquake. Discussions with Mr Marsh indicate that the original slip extended about 20m east of the southbound carriageway and affected about 150m of what would become freeway pavement. During the 1968 Meckering Earthquake only part of the original slip was remobilised and only the north bound carriageway was affected. Figure 3 attached shows the estimated extents of the original and the 1968 slip crest lines.

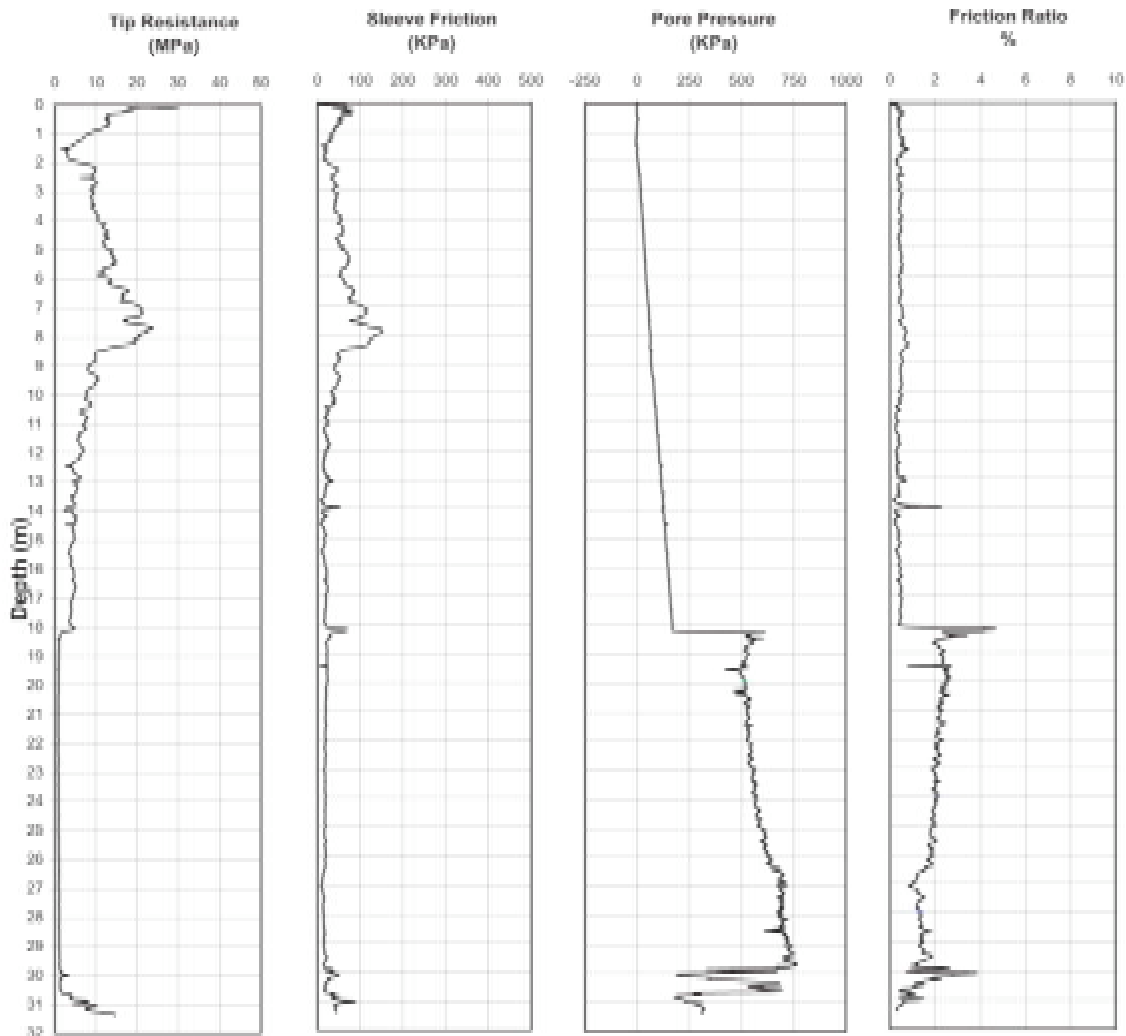
CPTU Probe Record Near Centre of Slip – Figure 4

Six cone penetrometer peizometric tests (CPTU) in the vicinity of the scout hall slip were carried out as part of the 2003 investigations. The CPTU tests generally encountered dredge placed sand fill in a medium dense to dense condition overlying soft to firm clay soils. Coarse-grained materials were encountered underlying the soft clayey soils. Figure 4 shows one of the CPTU records.
