## **Behaviour of Inadequately Detailed Reinforced Concrete Walls**

Adane Gebreyohannes<sup>1</sup>, Charles Clifton<sup>2</sup> and John Butterworth<sup>3</sup>

### **Abstract**

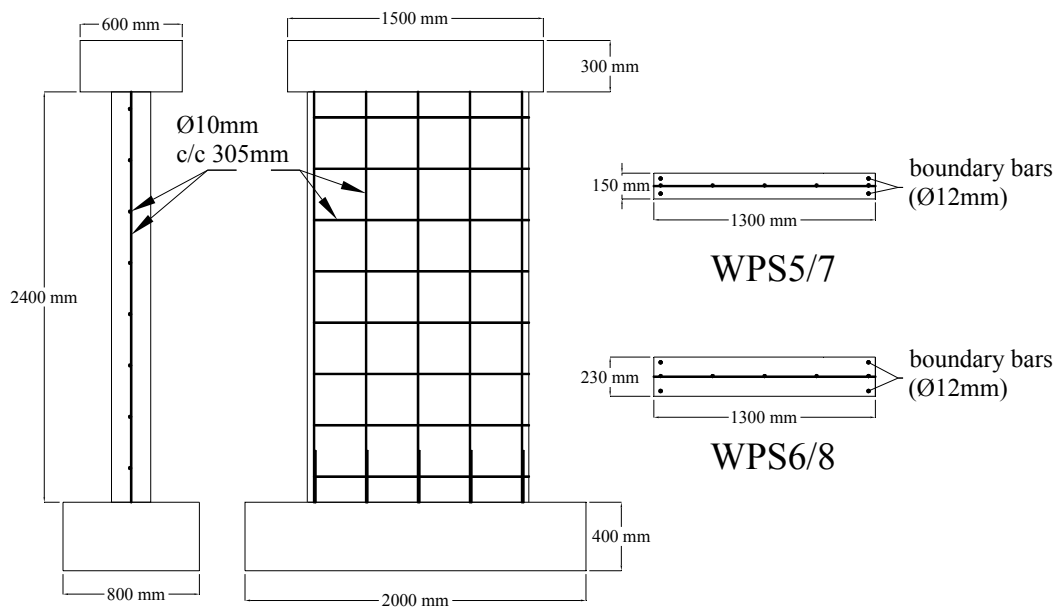
The vertical bars were spliced and boundary reinforcements were provided (See Figure 1). Although the thicknesses of the walls in the building range from 6"(150mm) to 9"(230mm), a single layer of reinforcement is provided to all wall types at 12"(305mm) centres at the mid-thickness plane of the walls in both the horizontal and vertical directions. In addition, two ½"(12.7mm) diameter bars are carried around all openings, and these make up the boundary reinforcements. The bars are spliced just above the floor levels with lap lengths of 12"(305mm) and 18"(457mm) for the 3/8"(9.5mm) and ½"(12.7mm) bars respectively, with no transverse reinforcing bar enclosing the lap.

Figure 1: Experimental specimens

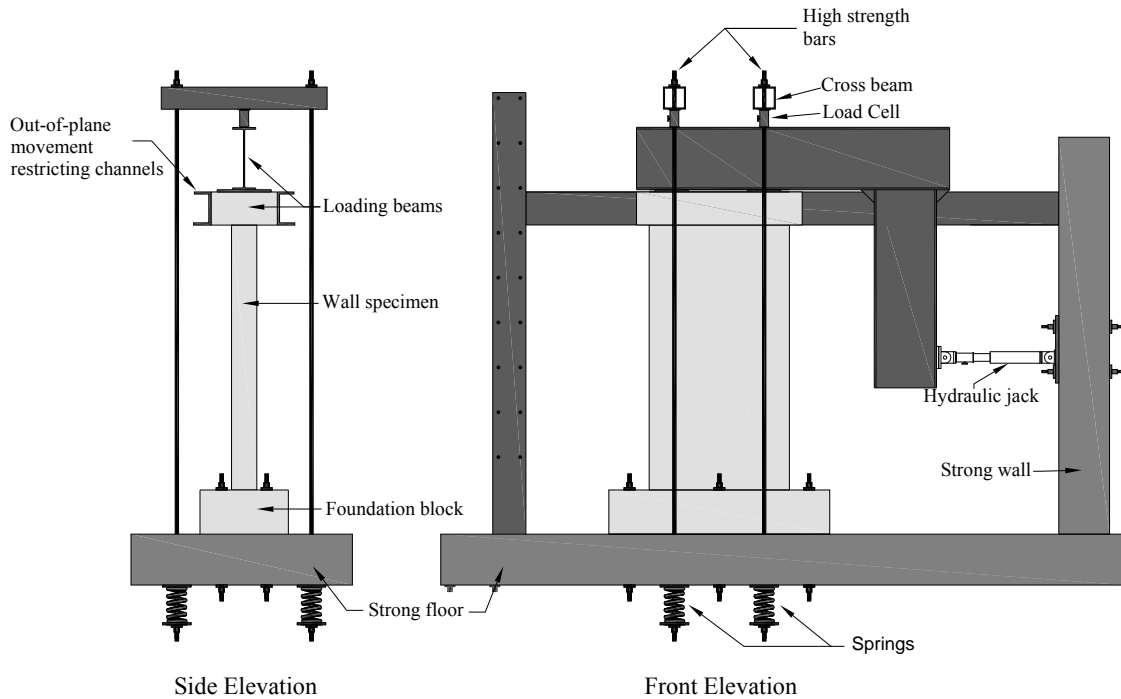
The wall components were built on RC foundation blocks which were then anchored to a strong floor, to provide a fixed condition at the base. The foundation blocks also provided anchorage to the flexural reinforcements. An RC block was constructed on the top of the specimens to maintain continuity of reinforcement and to facilitate a smooth transfer of gravity and lateral loads. Out-of-plane movement of the specimens was prevented using channel sections provided on both sides and parallel to the loading beam.

No axial load was applied on two of the specimens, while the remaining two were subjected to axial loads which are approximately 5% of the section capacity. The axial loads were applied using four high strength bars positioned parallel to the centreline and down the sides of the specimens and anchored to the strong floor. Each pair of bar was connected to cross beams, and they were loaded simultaneously using a jack placed underneath the cross beams

(Refer to Figure 2). The jacks were monitored to keep the axial loads relatively constant throughout the tests. Coil springs were employed at the base of each bar underneath the strong floor to prevent the high strength bars from contributing to the stiffness/strength of the walls.

Figure 2: Test setup

The walls were subjected to quasi-static cyclic loading. Incrementing sets of three complete displacement-controlled reversed cycles shown in Figure 3 were applied using a hydraulic jack mounted on the strong wall (See Figure 2). The load was applied on the steel loading beam at the mid-height of the walls to create a double bending loading condition.

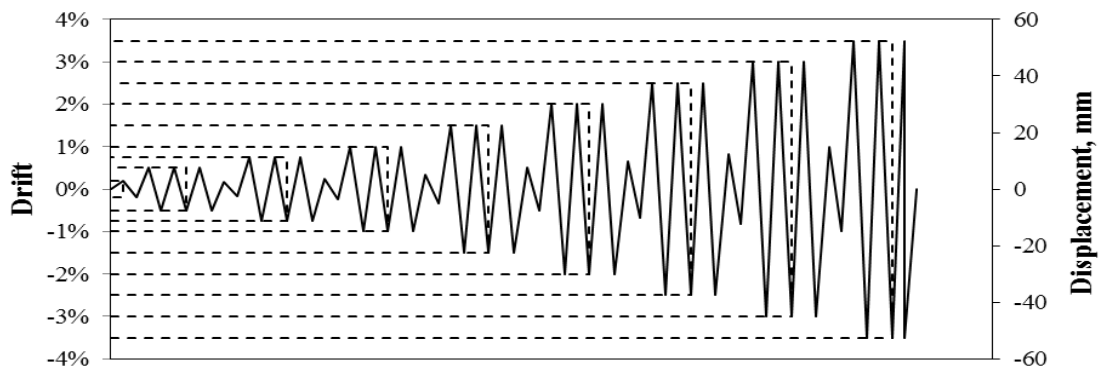
Figure 3: Applied loading regime

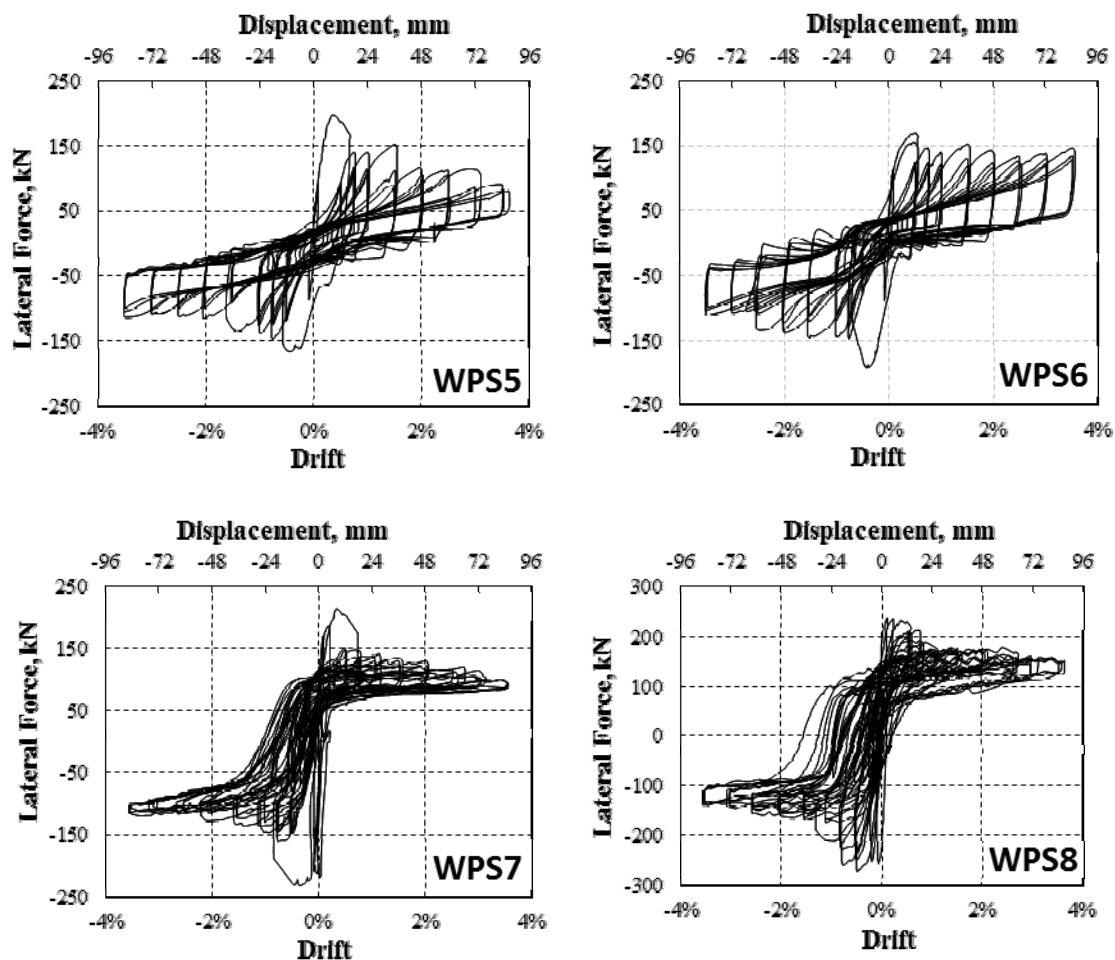
The load-deformation responses of the four specimens are presented in Figure 4. All exhibited a limited amount of energy dissipation capacity. The lateral load capacity of the specimens was dictated by their flexural strength. For these specimens the contribution of shear deformations measured at various locations of the wall appear to have insignificant influence on the responses. No significant flexural deformations were recorded within the body of the panels as well. This is mainly due to the splice location and provision of fewer amounts of flexural reinforcing bars than required by current standards.

Figure 4: Lateral force vs top displacement of the specimens

The walls were able to develop 97-102% of the computed yield strengths (Refer to Table 3), although strain gauge readings show that slip between starter and vertical bars was observed even during the initial elastic cycles. The readings also indicate that the peak strengths were reached just after or prior to yielding of the starter bars at the edges. These peak strengths dropped significantly after very low drift cycles; however, the walls were able to maintain the reduced strength to relatively higher drift levels of up to 5%.

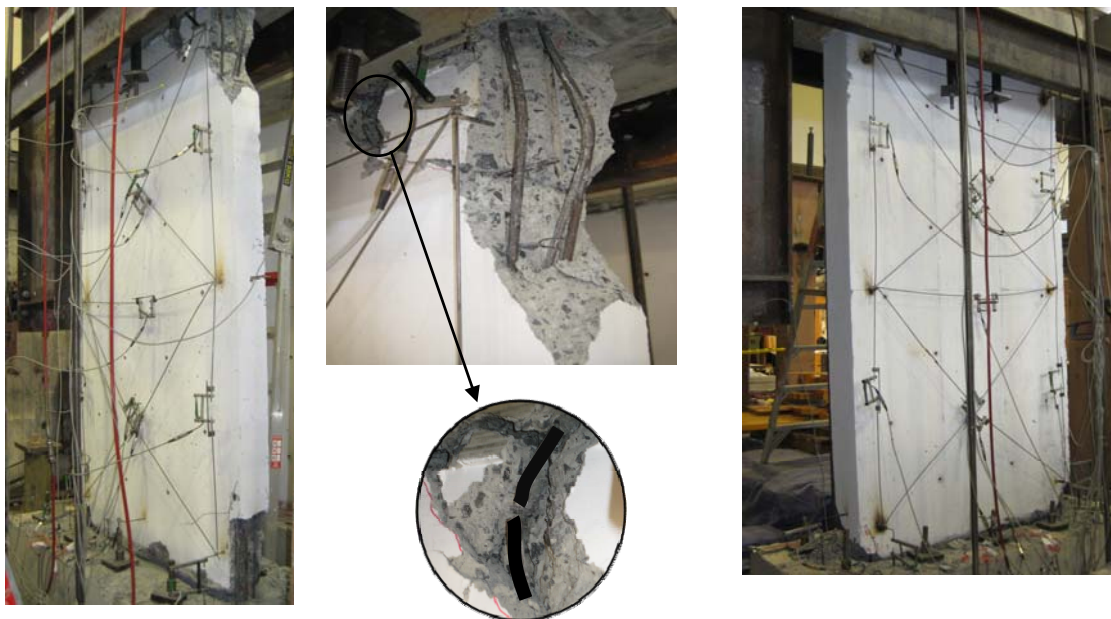
Figure 5: Left: WPS7, significant crushing and spalling of concrete and buckled bars at the corners; middle: buckled and ruptured bars at the top right corner of WPS 7; and right: WPS8, limited crushing and spalling at the base edges only

During testing of WPS7 the concrete at the top right corner cracked under tension at low drift levels (<0.5%), and when subjected to compression in the next cycles, it just gave way and

spalled when pushed out by the buckling reinforcing bars at that location. After the concrete has crushed/spalled at that corner, the compression block moved further into the wall and caused buckling and then rupturing of an interior reinforcing bar during successive cycles causing compression at that location (See Figure 5).

At higher drift levels (>1%) the cracks at the top nearly closed back (during testing of WPS5 and WPS6 became almost invisible) and they exhibited a predominantly rocking response about a single crack located at the wall/ foundation interfaces followed by limited sliding at these interfaces and significant slip along the splice lengths. No sliding took place at the loading beam/wall interfaces in all of the tests and a maximum sliding of 0.5mm of a foundation block was recorded. The 150mm thick walls (WPS5 and WPS 7) experienced significant crushing and spalling of concrete at their corners, while the 230mm thick wall with no axial load (WPS6) experienced none and the one with axial load (WPS8) experienced relatively limited crushing and spalling at the base edges only (Refer to Figure 5). Apart from crushing and spalling at the corners, which were unsymmetrical, and the single crack which extended across the full length of the wall, there were no other significant cracks within the main body of the panels.
