Performance of Masonry Buildings in the 2010/2011 Canterbury Earthquake Swarm and Implications for Australian Cities

Jason M. Ingham¹, Lisa Moon² and Michael C. Griffith³

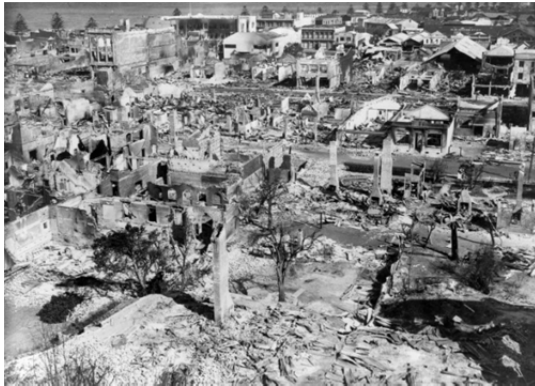
(a) Overlooking Napier at the buildings destroyed by the 1931 earthquake and fires [Alexander Turnbull Library]

- The M7.8 1931 Hawke's Bay (New Zealand) earthquake caused widespread devastation to URM buildings in the city of Napier (see Figure 1(a)), with 256 fatalities. This earthquake remains the worst disaster of any type to occur on New Zealand soil (Dowrick, 1998).

Although these earthquakes early in the development of Christchurch did result in some damage to buildings, and in particular to stone and clay brick masonry buildings, none of these earthquakes had an effect on the construction and design of buildings as did the 1931 Hawke's Bay earthquake (see Figure 1(a)).

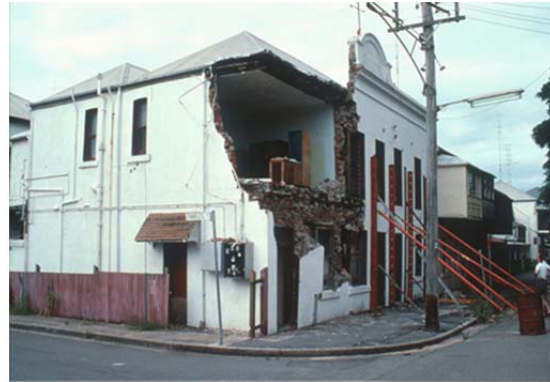
(b) Out-of-plane wall failure in the 1989 Newcastle earthquake

- The M5.6 1989 Newcastle (Australia) earthquake resulted in 13 fatalities and over 160 casualties. The earthquake damaged approximately 50,000 buildings (80% of these were homes) with unreinforced masonry buildings most widely affected (Page, 1991) (see Figure 1(b)).

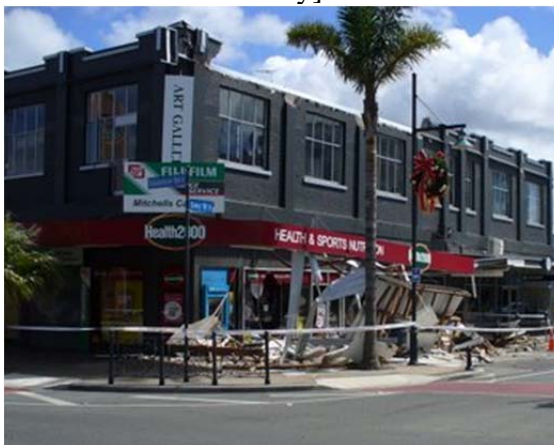
(c) Topped parapet in the 2007 Gisborne earthquake

- The M6.8 2007 Gisborne (New Zealand) earthquake caused damage to numerous unreinforced masonry buildings, including the collapse of 22 parapets (Davey and Blakie, 2010). An example of damage to URM buildings is shown in Figure 1(c).

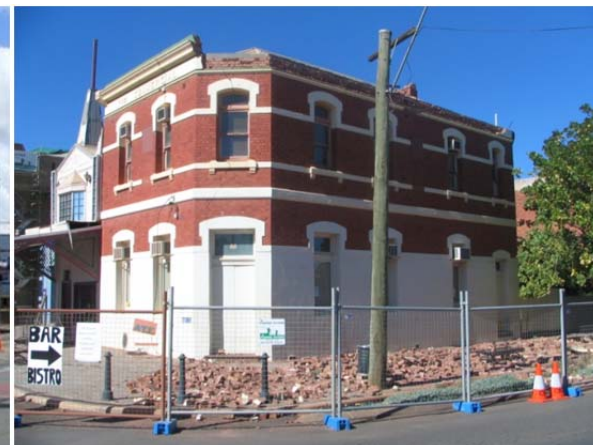
(d) Topped parapet in Boulder after the 2010 Kalgoorlie-Boulder earthquake

- The M5.0 2010 Kalgoorlie-Boulder (Australia) earthquake occurred near the city of Kalgoorlie-Boulder, causing damage to historic buildings in Kalgoorlie-Boulder (see Figure 1(d)). There were no fatalities but two people were treated at Kalgoorlie Hospital for minor injuries resulting from the earthquake (Edwards et al., 2010).
