***Comparison of the 1989 Newcastle and  
2010 Kalgoorlie and Christchurch earthquakes***

**Kevin McCue ASC**

**Abstract**

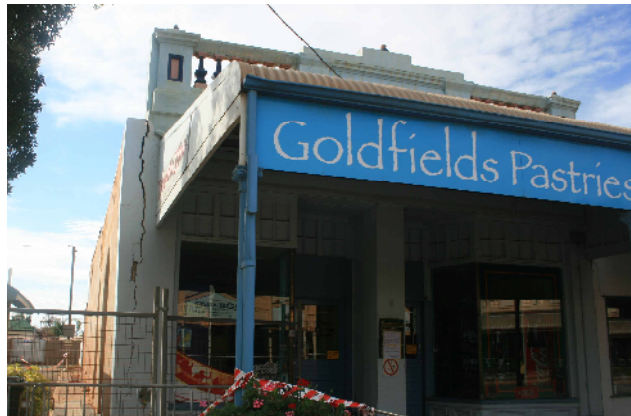
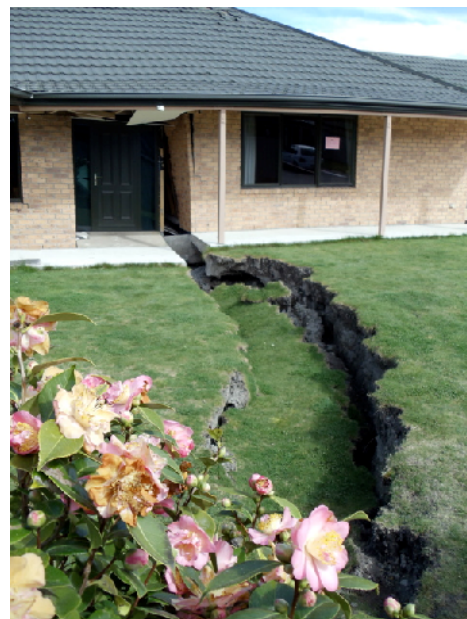
Thousands of aftershocks were (and are occurring at time of writing) recorded by GNS Science on Geonet stations, seismographs, accelerographs and GPS stations. Those in the first few days delineated a 60km long complex fault zone about 25km west of Christchurch, a city of 300,000 people. The mainshock focal mechanism shows a right-lateral

strike-slip fault but aftershock mechanisms varied, some of the earlier larger events had thrust mechanisms and seemed to be en-echelon to the main eastwest zone.

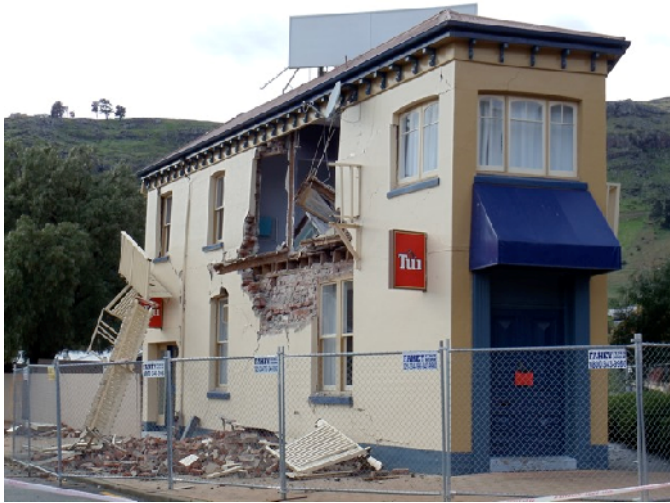
Old un-reinforced masonry buildings (photo above) showed similar damage to those in Newcastle and Kalgoorlie. Housing damage was particularly severe where there was substantial foundation failure, liquefaction and lateral spreading. In those areas sewerage and water pipes and underground electricity cables were broken. Many apparently undamaged

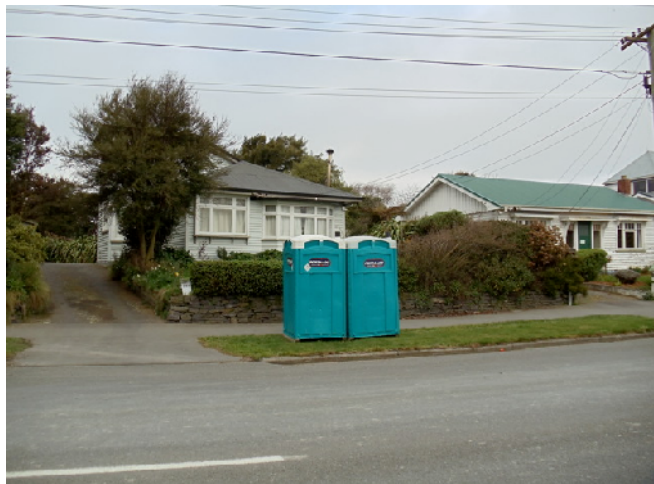
wooden houses lost chimneys though not all, as seen in the accompanying photograph. The damage was only apparent because of the *porter loos* lining the streets (see photo). Reinforced old heritage masonry buildings seemed to be undamaged. Some URM buildings were damaged by pounding against adjacent structures of different height. Modern tall buildings suffered no structural damage.
