1. INTRODUCTION

2. DESCRIPTION OF SPECIMENS

In order to assess the behaviour and capacity of different reinforcement systems a series of shake table tests of 1:2 scale u-shaped adobe mudbrick wall units have been undertaken at UTS (Figure 1). This paper focuses on the preparation and testing of specimens 3J and 3K, whose specifications are summarised in Table 1 and discussed below.

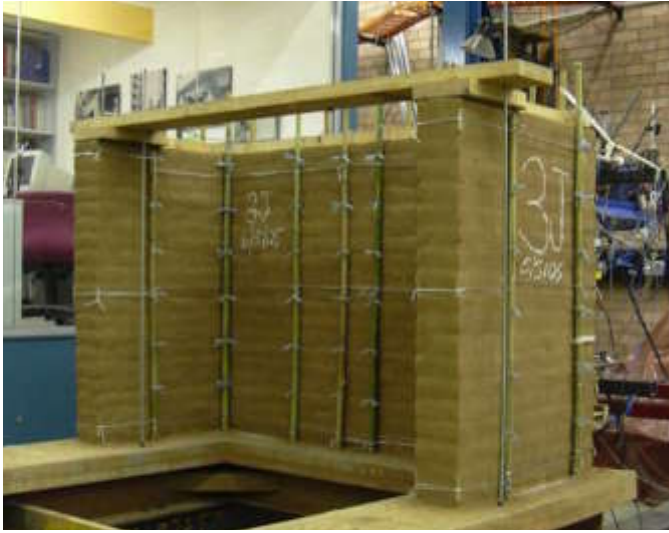
Figure 2a. Specimen 3J prior to testing.

Specimen 3J was reinforced with external vertical bamboo reinforcement, internal horizontal chicken wire mesh, external horizontal wire and a timber ring beam (Figure 2a). The horizontal chicken wire mesh reinforcement was laid horizontally in the mortar joints every three courses during construction. Prior to laying the mesh polypropylene strings were woven through the mesh (perpendicular to the wall). After construction and curing of the wall the vertical bamboo was tied to the wall (via the polypropylene string). 2 mm-gauge wire was tied horizontally between the bamboo poles at the base, middle and top of the wall, and tensioned using pliers. The timber ring beam was connected to the wall via dowels (resisting shear forces), plus staples and 2 mm-gauge wire securely attached to the external bamboo (Figure 2b).

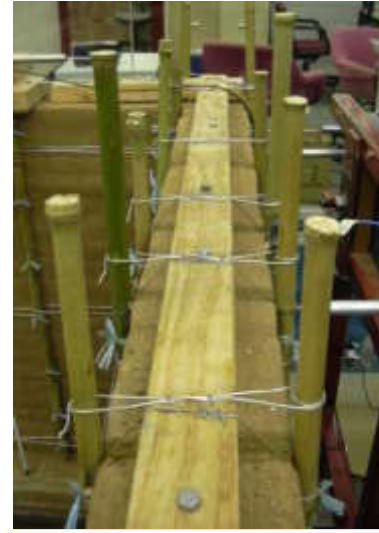
Figure 2b. 3J: Connection between bamboo + ring beam.

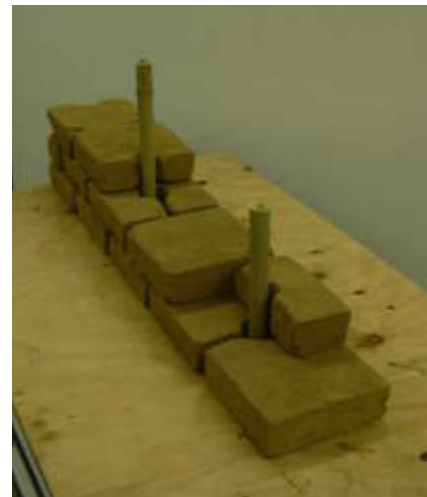
Figure 3b. Layout of bricks and poles (3K)

Specimen 3K was reinforced with internal vertical poles (timber ‘broom sticks’), internal horizontal chicken wire mesh (every three courses), and a timber ring beam. (Timber ‘broom stick’ poles were used in this specimen for ease of construction and to create an ‘idealised’ system.) The poles were securely attached to the foundation prior to construction, and half bricks and full bricks with notches were configured to encase the poles at alternate courses (Figure 3). Holes were drilled in the timber ring beam to snugly fit the vertical poles and provide a connection between the wall and the ring beam.

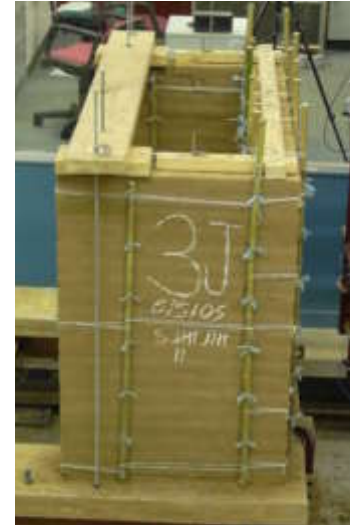
Figure 5a & b. Specimen 3J after simulation S12 (100%)

Both specimens 3J and 3K performed extremely well, withstanding the forces of a series of simulations of varying intensity: S4 (20%), S5 (50%), S6 (75%), S7 (100%), S8 (125%), S9 (75%), S10 (75%), S11 (100%), S12 (100%). [By contrast, an unreinforced specimen (3A) was severely damaged (collapse imminent) after S6 (75%) (Dowling *et al.*, 2004).] Initial hairline cracking appeared in specimens 3J and 3K during simulation S7 (100%) with progressive additional damage during subsequent simulations. Figures 5 and 6 show the state of each specimen after the full testing sequence.

For both specimens collapse of the structure was prevented by the combined contributions of the vertical poles, wire mesh, wire and ring beam. This integrated matrix acted to restrain movement, and absorb, dissipate and redistribute energy within the structure. The main factors contributing to damage were:

- Flexure in the out-of-plane 'long' wall generating vertical and diagonal cracking.
- Tearing failure at the corners due to the relative movement between the 'flexible' out-of-plane 'long' wall and the stiff in-plane shear 'wing' wall causing vertical cracking in the shear wall at or near the corner.

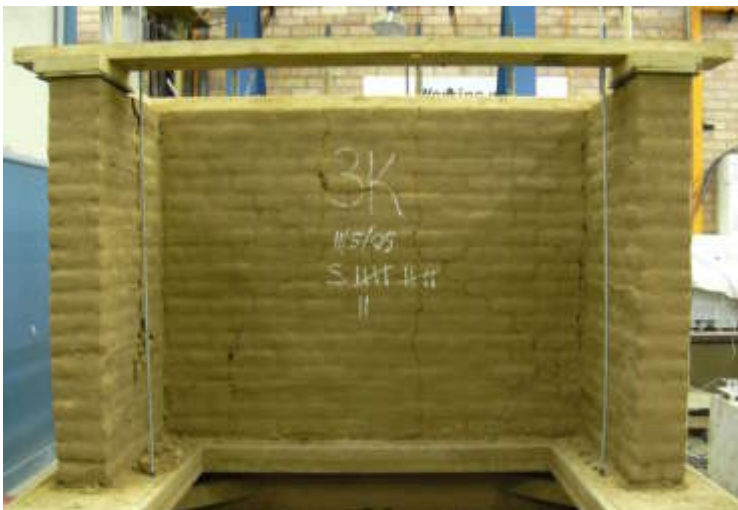
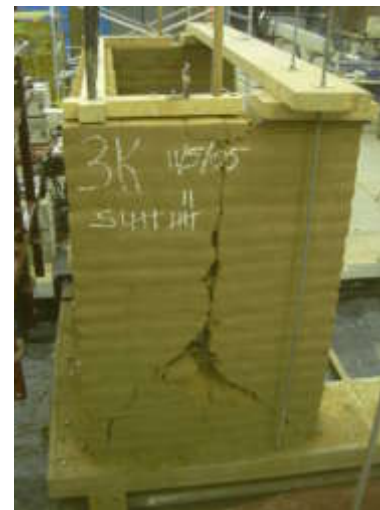
Figure 6a & b. Specimen 3K after simulation S12 (100%)

Of special interest was the failure pattern in specimen 3K, with vertical cracking concentrated around the location of the vertical poles. This phenomenon may be attributed to a difference in dynamic response between the stiff mudbrick wall and the flexible timber poles which caused a pounding effect in the out-of-plane 'long' wall. In

the shear ‘wing’ wall, the vertical poles introduced a discontinuity in the wall, which also reduced the effective cross-sectional area, making tearing failure more likely (Figure 6b). Weaknesses in the bricks may have also been introduced during the process of ‘notching’ the bricks (moulded during brick fabrication, or notched with a trowel, machete or masonry drill after curing).

The shake table testing proved both systems (3J and 3K) to be an extremely effective means of improving the seismic capacity of adobe-mudbrick u-panels. Although significantly damaged after the rigorous testing program, both wall units resisted collapse. Overall, specimen 3J performed marginally better, exhibiting less relative wall movement and more even distribution of cracking, with no single crack of major concern. By contrast, the large failure in the shear wall in specimen 3K (Figure 6b) presents a major problem in terms of structural stability.
