## Identification of Neotectonic Features in the Gladstone Region, Central Queensland

Neotectonic features in the Gladstone region of Central Queensland were identified and assessed for activity within the context of the Australian Neotectonics Database at Geoscience Australia (Clark 2006). Following Clark (2006), within the Australian Neotectonics Database, “neotectonic deformation” is one which has hosted deformation under the current Australian crustal stress regime (estimated as having established in the last 10-5 Ma). This study identified structures with evidence of neotectonic deformation by interpreting geomorphologic expression (scarps, elevated terraces, offset drainages, shutter ridges) through interpretation of high-resolution LiDAR based DEMs, aerial photograph, published geologic mapping, and field reconnaissance mapping. The geomorphic interpretation was supplemented with assessment of temporal clustering of seismic events and, where available, from published studies, subsurface investigation and geophysics. In the Gladstone Region, the Australian Neotectonics Database identifies the West Basement fault as a Neotectonic Feature. A review of published geologic surfac

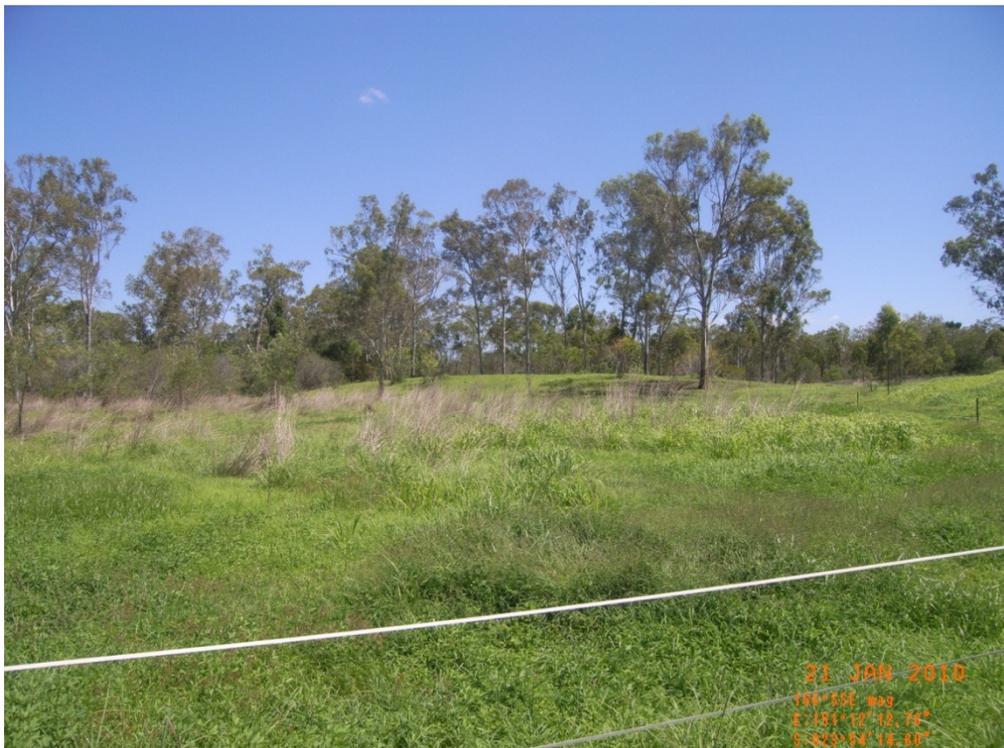
A total of 7 sites were mapped along the fault trace spanning over 50km along its trace (Figure 2). The sites were in either Quaternary deposits or Tertiary gravels and showed little to no expression of the fault trace (Figure 3). The field mapping was unable to demonstrably locate the fault trace in the Tertiary and Quaternary sediments along its mapped trace. In a few instances there were local breaks in slope that were subparallel to the fault trace. These features were short, relative to the fault trace and could be explained by normal alluvial processes of deposition and erosion. The published geologic mapping shows the fault defining a major contact between distinct rock units, this contact was not observed at any of the field sites.

Figure 3 Photograph showing the typical subdued geomorphic expression along the “mapped” WBF trace.

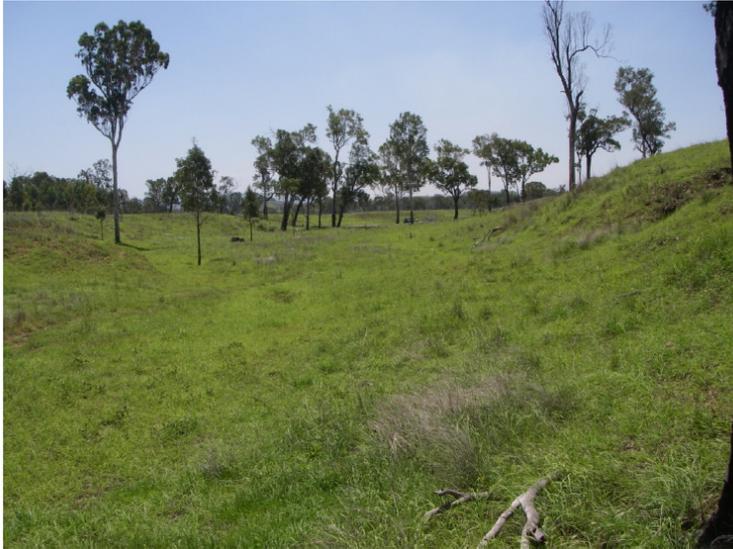
The northern edge of the channel follows the mapped fault trace. The northeast bank is rock, where the southwest bank is alluvium (Figure 7). The creek was observed to have gentle banks with a flat wide bottom. This morphology is not observed in other creeks in the region. Following the trace south across a terrace to the south of the channel is a slight change in gradient of across the alluvial terrace.

Figure 6 View along the Queensland Fault trace looking north. The slope on the right is Devonian aged rock. The slope on the left is Quaternary Alluvium.

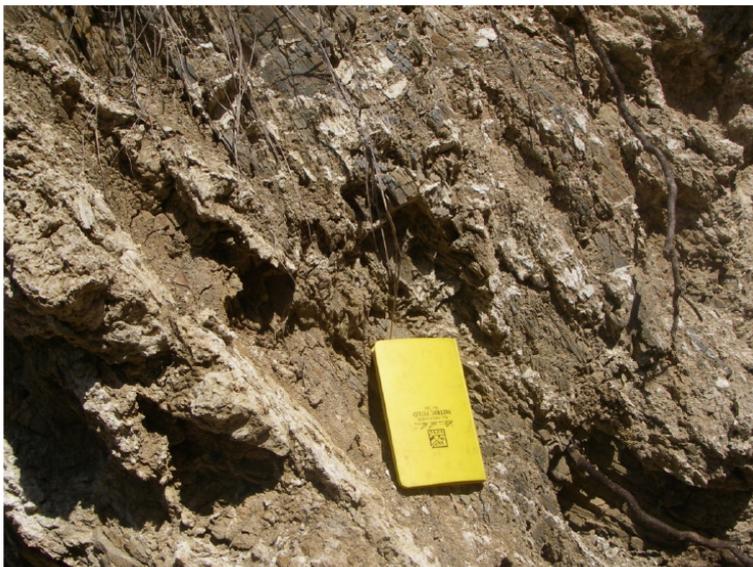
Further to the south is a tributary, entering the main drainage from the north. There is a prominent shear zone within the incised creek (Figure 7). The shear zone is not evident on the surface of the terrace. The presence of this deformation zone confirms the existence of the fault at this location. At a junction where the fault meets the Calliope River, there is a 3m over steepened scarp parallel to the projected fault trace.

Figure 7 Fault shear and gouge zone of the Queensland Fault.

1. Shear zone with gouge.
2. Up thrown ridge on NE of fault.
3. Structural control on river sections
4. Offset or dissected terraces.
5. Over steepened creek banks.
6. Defined contact between Quaternary Alluvium and Devonian Rocks.
