Review of In-service Assessment of Timber Poles

Baraneedaran S¹, Gad EF^{1,2}, Flatley I³, Kamiran A¹, Wilson JL¹

1. Swinburne University of Technology, Australia
2. University of Melbourne, Australia
3. Groundline Pty Ltd, Australia

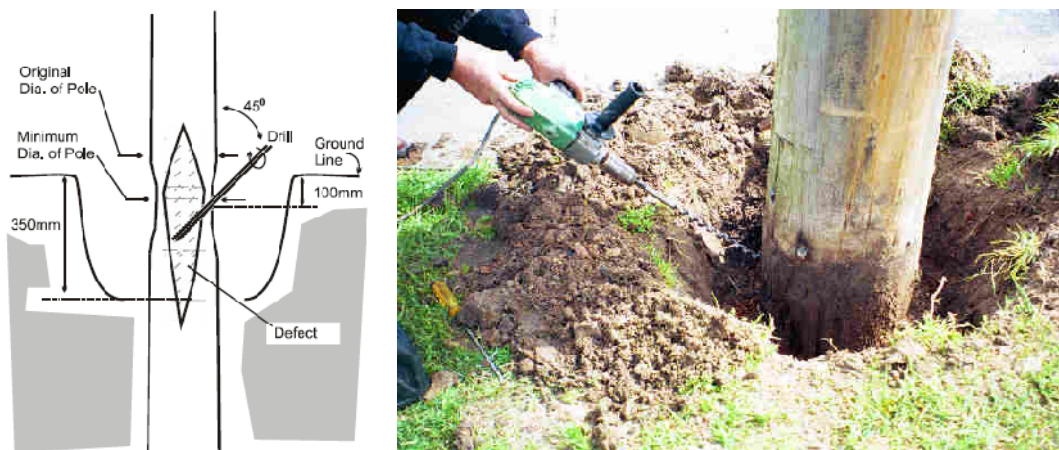
Figure 3: Details of inspection below ground line

Drilling is normally used to assess the pole between the groundline and 350mm below ground as shown in Figure 3. This section of the pole is commonly referred to as the critical zone because it is subjected to the highest bending moment and generally suffers the greatest degradation due to the moisture and oxygen availability in this layer of soil. The drilling may be accompanied by excavation around the pole.

All below ground inspection holes are drilled at 45° to the pole and all above ground inspection holes are drilled at 90° to the pole face except the inspection holes for reinforced poles (Figure 3). All inspection holes drilled are generally sealed with blue plugs (Energy Australia 2006).

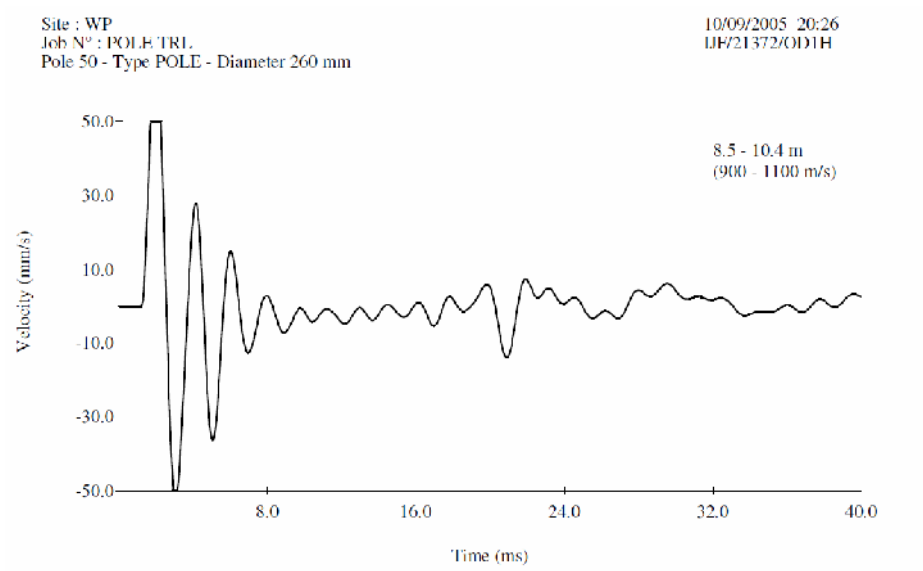
Figure 4: Typical time domain trace.

A typical plot of velocity versus time for a good timber pole is shown in Figure 4. A good pole clearly shows signal reflections from the top and the bottom of the pole. The majority of the poles tested during the investigation showed reflections which enabled length measurements to be made. However, the time domain was limited with respect to the separation of multiple reflections on aged poles. Additional analysis is therefore necessary.
