Twenty years of improvement in the seismic performance of masonry veneer construction

Graeme Beattie¹ and Stuart Thurston²

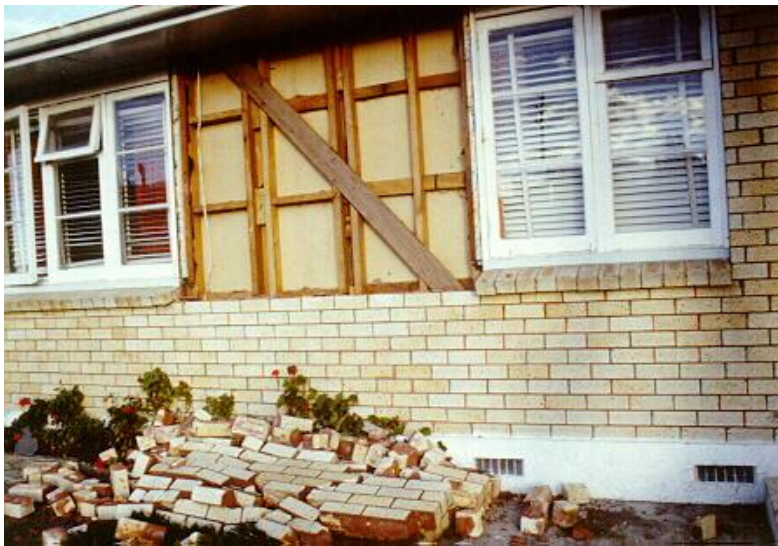
Figure 1 Example of brick veneer failure in the 1987 Edgecumbe earthquake

The 1987 Edgecumbe earthquake was the last major earthquake to strike a populated area in New Zealand. This was a magnitude 6.3 earthquake (c.f. Newcastle 5.6). Probably a more relevant measure of the earthquake is its Modified Mercalli intensity. Both earthquakes were judged to be MM 9 at their worst and in such events it is stated that brick veneers are expected to collapse. And indeed they did partially collapse (Figure 1). However, while not so obvious in the photograph, there are significant differences between the veneer in vogue at that time and that being constructed these days in New Zealand. Several points worth noting are that the individual bricks are solid (or may have small holes) in this typical example of the time, the veneer thickness is 100 mm and there are no signs of any brick ties still attached to the wall framing, probably because the nails/staples have pulled out.

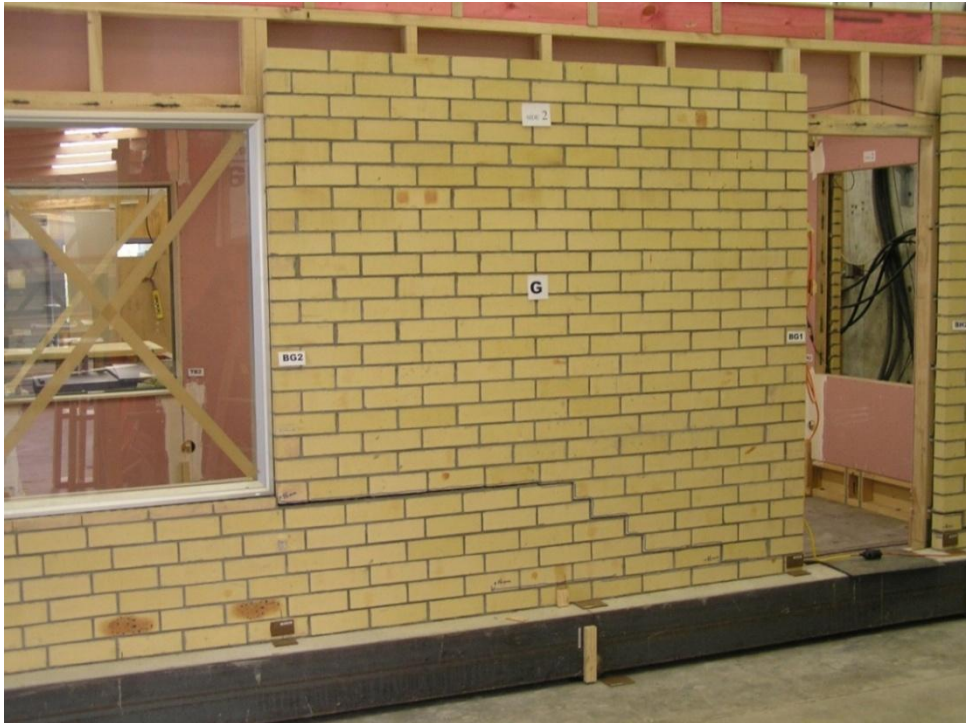
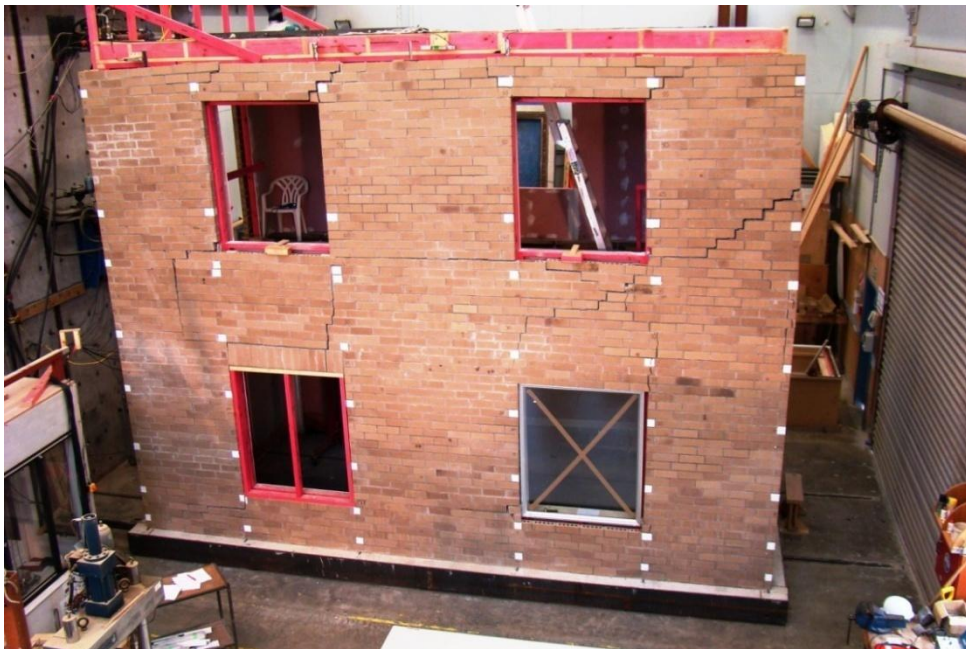
Figure 2 Views of rocking panels – single and two storey specimens

In its investigation, BRANZ has also recognized the mechanical connection being provided by the mortar as it penetrates the holes in the individual bricks. Full scale one and two storey buildings have been constructed in the BRANZ Structures laboratory and subjected to static and dynamic load testing [1][14]. The buildings were lined with plasterboard to provide the normally expected bracing function. The static testing was designed in such a way that the lateral force transfer from the timber framing to the brick veneer could be measured. It was found that about 60-70% of the lateral load that was applied to the timber frame was transferred by the ties to the veneer. It was clear from the tests that the veneer does not behave as a collection of individual brick elements but as cohesive rocking panels (Figure 2) and that the

rocking panels between openings provide a restoring force, resulting in very little permanent lateral deflection once unloaded. The behavior of the two storey specimen was particularly encouraging.
