50 YEARS SINCE THE SKOPJE 1963 EARTHQUAKE – IMPLICATIONS FOR AUSTRALIAN BUILDING STANDARDS

C.Sinadinovski¹ & K.F.McCue²

Abstract

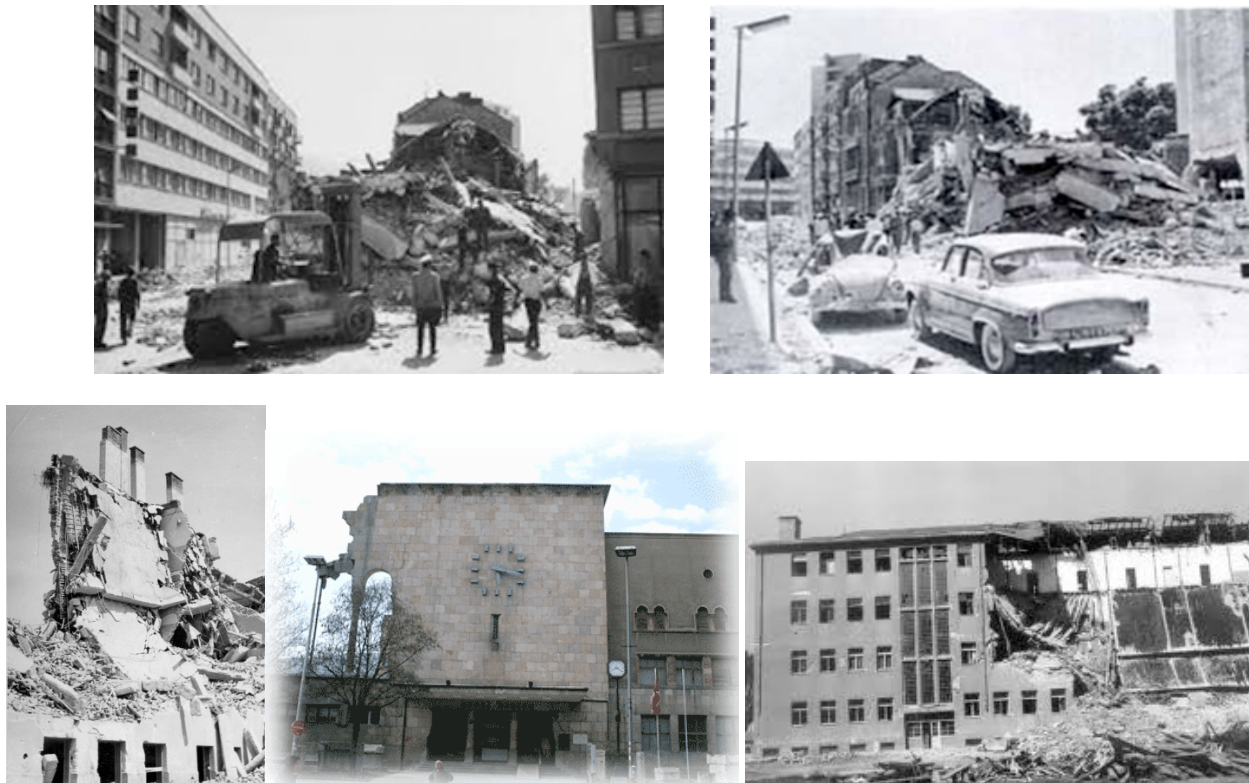
Figure 1: Images of damaged buildings from the 1963 Skopje earthquake

Generally speaking, buildings with brick masonry wall suffered more than any other type and accounted for the highest number of deaths. Mixed construction also suffered considerably. Although many of those buildings did not collapse they were left completely shattered, beyond repair. Old adobe structures, particularly those with timber bracing, resisted the shock with some damage but behaved far better than the brick masonry or the mixed structures. Reinforced concrete skeleton structures suffered comparatively little damage and only two small structures of that type collapsed. As mentioned above tall structures up to 15-storeys high, performed far better due to the frequency content of the earthquake. They were constructed with more care and, in some cases, wind forces were considered in the design. Finally, pre-stressed structures were totally destroyed after the collapse of their supporting columns.

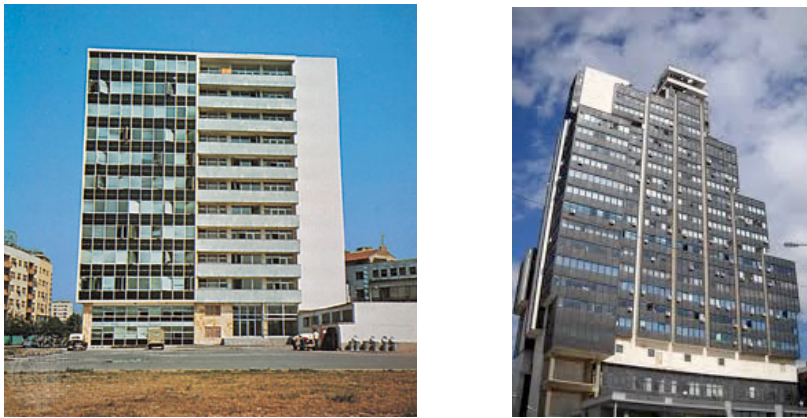
Figure 4: Examples of structures built within the reconstruction period

The second direction of reconstruction was intensive construction of new buildings. After the earthquake, an international architectural-urban competition was opened for reconstruction of the city centre of Skopje. The first prize was awarded to the Japanese architect, Kenzo Tange. Although the original idea of that work was not fully implemented its basic concepts were preserved and incorporated in the Master Plan of the City of Skopje that followed. According to the Master Plan, the construction of the "City Wall" started in the very centre of the city in 1969, consisting of multi-story residential buildings of two types: residential blocks up to 6-storeys in height and residential towers of ground plus 12 floors. Another construction of a large building complex east of the city centre for accommodation of 80,000 inhabitants started in 1975. In each of the new settlements, there were other types of structures, many of them with reinforced concrete walls and other types representing a combination of reinforced concrete walls and reinforced concrete frames for high-rise commercial and business buildings (Fig. 4).

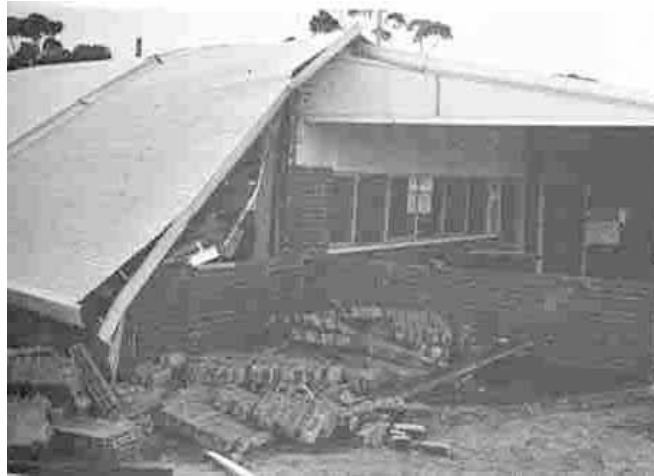
Figure 6: Damage in Cadoux Western Australia due to the M6.2 June 2, 1979 earthquake

minor damage many buildings causing losses well in excess of \$100 million at today's dollar value. In 1979 the small wheatbelt town of Cadoux WA, was shaken by a magnitude 6.2 earthquake similar in size to the Skopje 1963 earthquake (Sinadinovski and McCue, 2003). There were no injuries, but 25 buildings in Cadoux were extensively damaged (Fig. 6). The damage cost was \$3.8 million. Tall buildings in Perth at a distance of 180 km swayed during the earthquake, but suffered no damage.
