Earthquake Impacts on Mountain Communities - Observations and Lessons from the Mw 7.8 Gorkha Earthquake of 25 April, 2015

S. Wilkinson¹, M. Whitworth², M. DeJong³, B. Ghosh⁴, P. Burton⁵, S. Tallet-Williams⁶, V. Novelli⁷, G. Franco⁸, T. White⁹, A. Trieu³, S. Datla¹⁰, T. Lloyd¹⁰, K. Goda¹¹

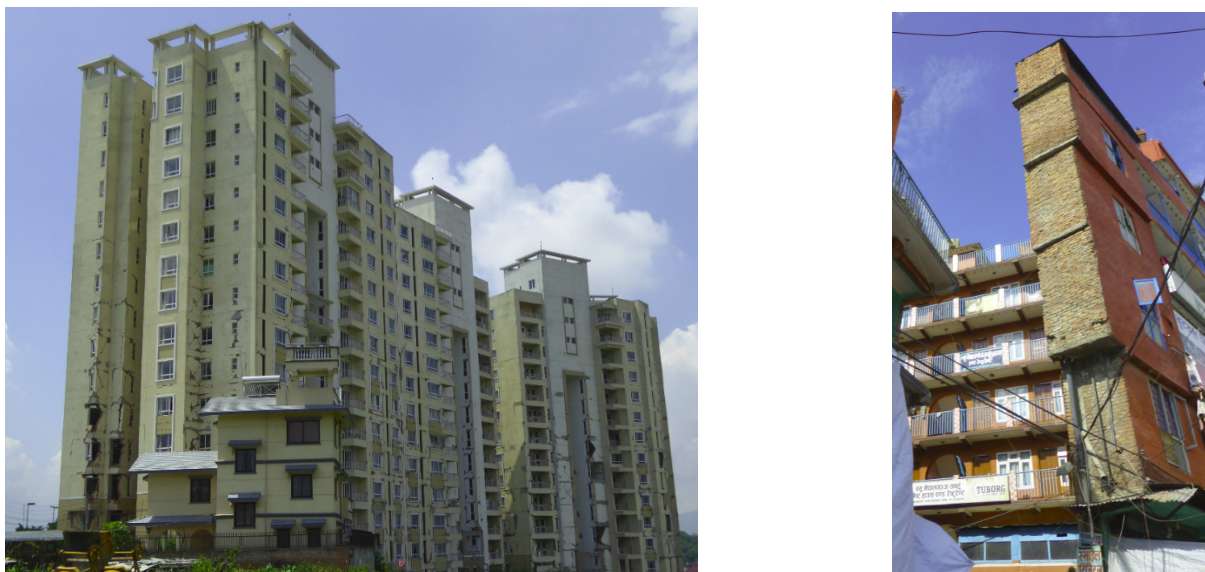
Figure 2. Reinforced concrete framed buildings with masonry infill.

To help relate the damage resulting from this earthquake to other seismic events, it is necessary to understand the building typologies of the given region so that the damage can be described relative to other buildings of this type. The better constructed buildings located in Kathmandu were mainly reinforced concrete framed structures with masonry infill. The buildings were typically up to approximately 4 storeys high, but there were examples of structures up to 7 stories, with the tallest building encountered being 14 stories. These buildings were often very slender and it was surprising that many of these structures survived an earthquake of this magnitude. Pictures of surviving slender concrete buildings as well as a 14 storey structure are shown in Figure 2.

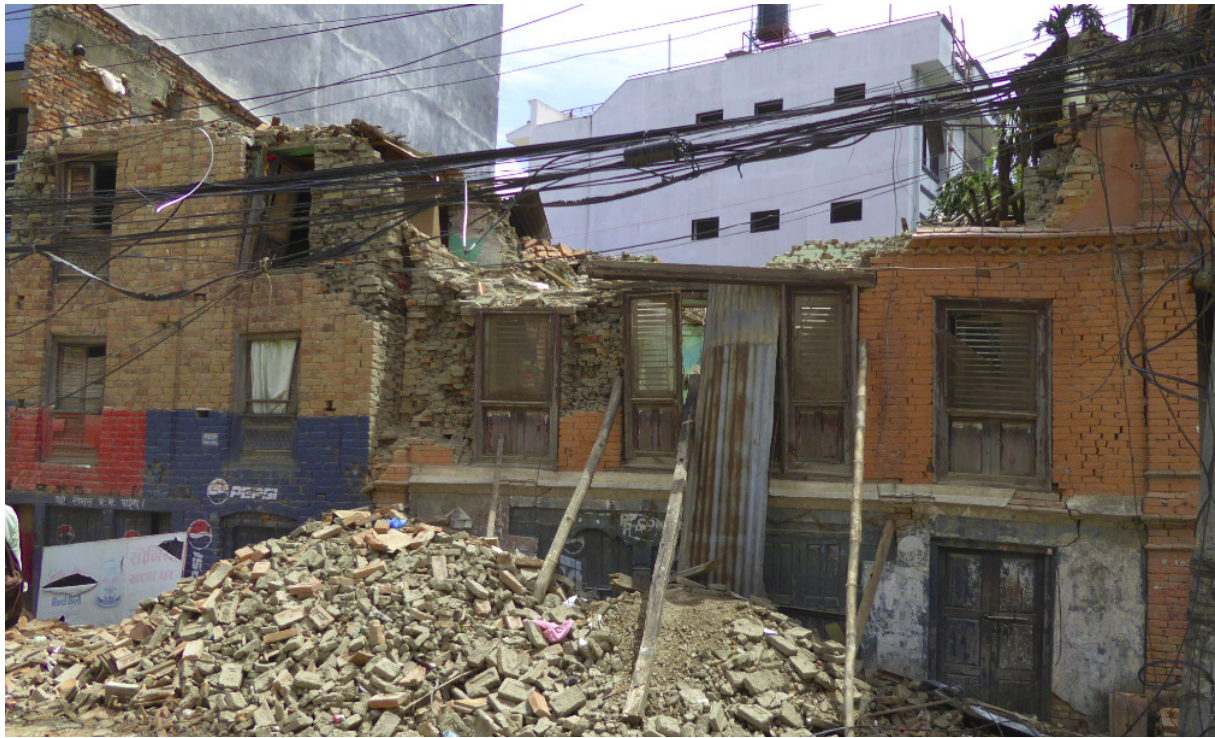
Figure 3. Example of partial collapse of a masonry structure near Kathmandu.

There was also many two-storey masonry buildings as well as rubble masonry buildings. The masonry buildings consisted of low-fired clay bricks typical of regions such as this and were therefore weaker than well-fired bricks typically used in more developed regions. The rubble masonry was typically of poor construction and was common in poorer regions of Kathmandu as well as in outlying areas. Mortar in these buildings was often either very weak or sometimes without any form of binder. These buildings typically showed either complete or partial collapse and aftershocks were causing further collapse to already weakened structures or damage due to secondary collapses. Typical masonry structures are shown in Figure 3.

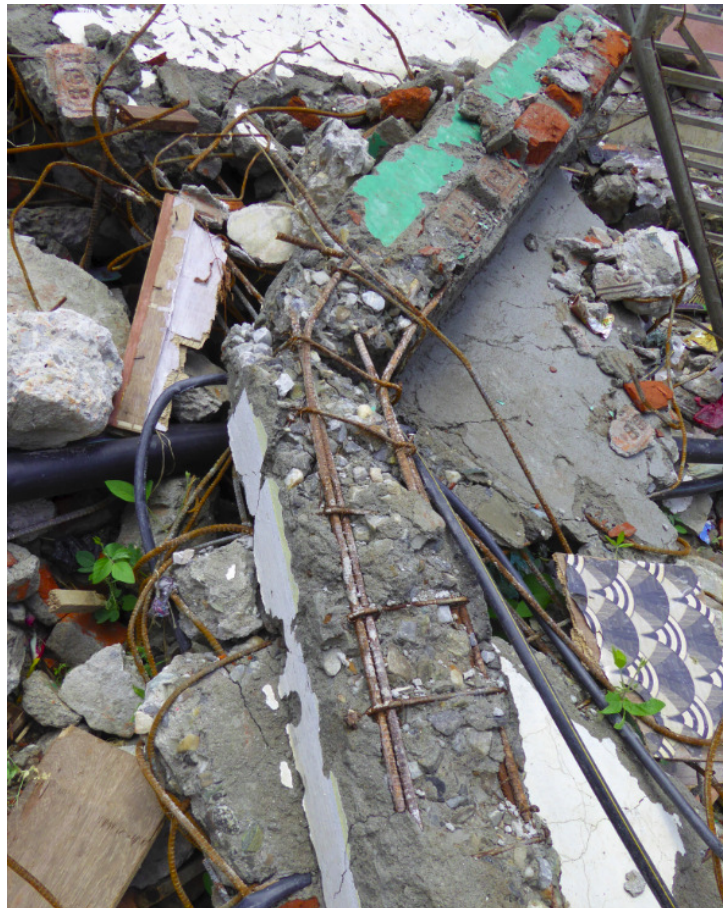
Figure 4. Detail of column reinforcement.

There is awareness within the NSET that there may be a mismatch between these specifications and the ability of local labour to interpret them. They are currently producing simplified pamphlets and training to help remedy this situation. These standard designs may help explain some instances of good performance of buildings in Nepal. For example, Figure 4 depicts the column of a structure in the village of Sangachok that, although collapsed, shows good lap lengths for lapped bars (as did many buildings

that were under construction) and reasonably closely spaced confinement reinforcement. It should be noted however that the concrete had very large aggregate in it and was not of good quality and the column dimensions were quite small (approx. 225mm square). The reason for the collapse of this structure is not clear, and could be either related to poor structural layout (causing a soft-storey collapse) or not all of the connections being well detailed. There was evidence of this latter point, but it is difficult to say for certain if either of these mechanisms were responsible.

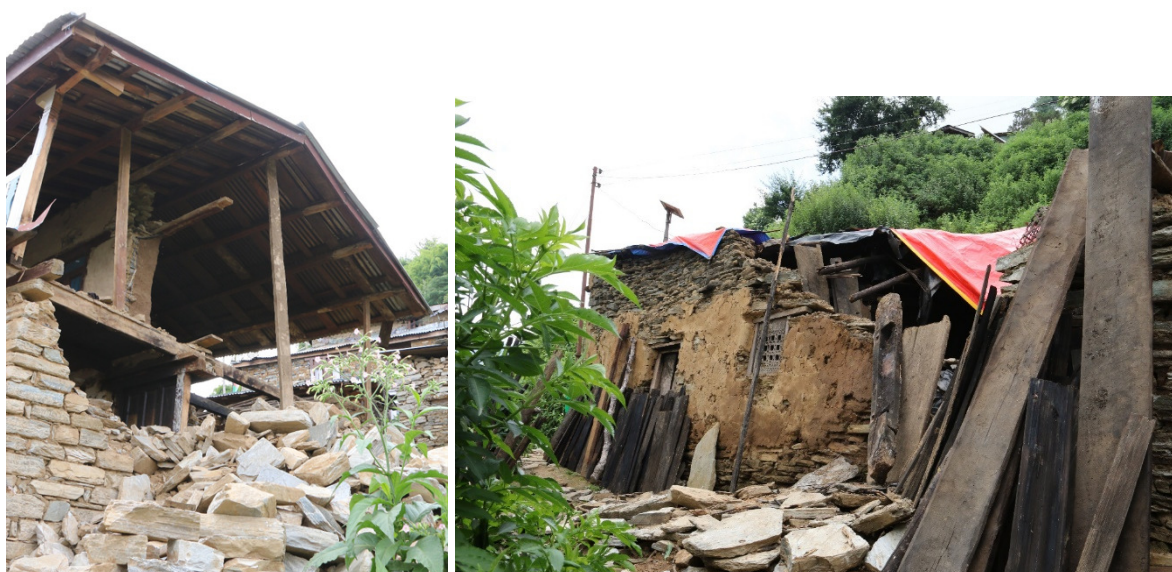
Figure 5. Examples of building and typical damage in Yamagaum.

A rapid tour (approx. 30 mins) of the village and immediately surrounding slopes was made. This village is located on a steep sided hillslope in Gumda district. The village consists of 47 households, mainly rubble masonry construction with timber and corrugated steel sheet roofs. The construction quality of these dwellings is very poor. The mortar was very weak although it did have some form of binding material (most likely either cement or lime). Most of the buildings suffered either partial or complete collapse (examples are shown in Figure 5).

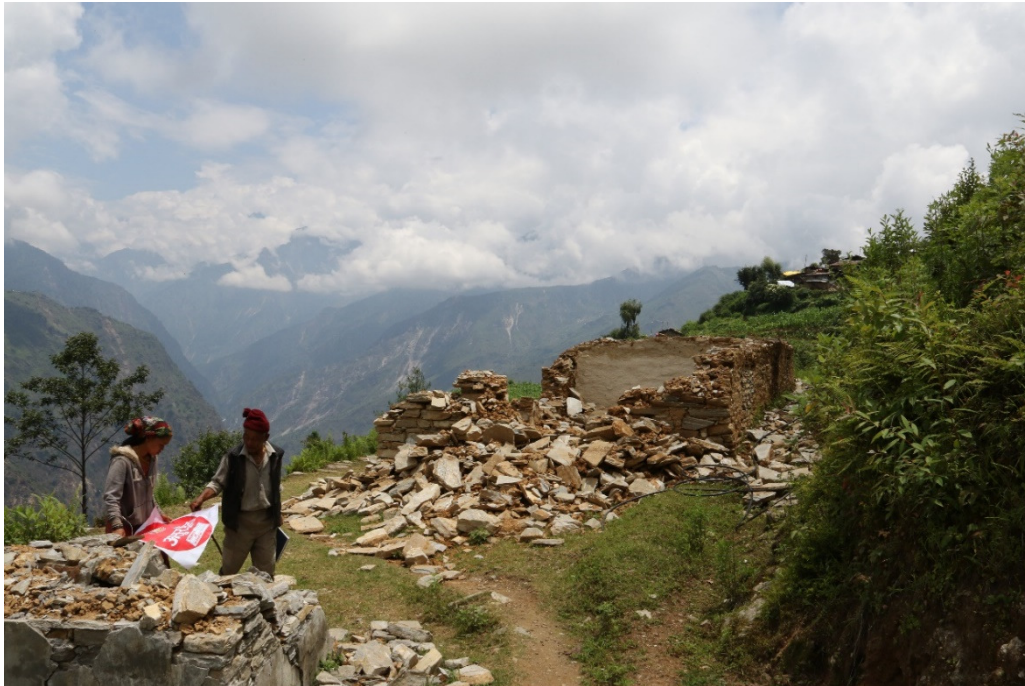
Figure 6. School building in Yamagaum.

The local school was also visited. This was of an even poorer construction. It is likely that no binder was used in the mortar and the school suffered complete collapse (see Figure 6). A temporary school had been constructed towards the bottom of the village and lessons were taking place during the visit.

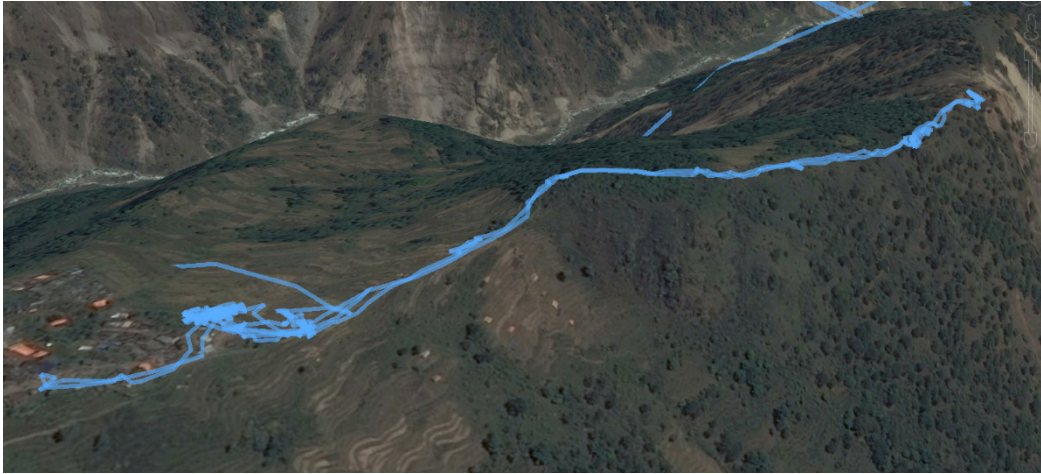
Figure 7. Route of landslide survey.

To the North-East of the village is a trail that follows a ridge that eventually descends into the village of Machikhola. During a walk along the ridge (the route of which can be seen in Figure 7) a small landslide was observed. Further along this trail a series of tension cracks were also observed running along the ridgeline. Example of these cracks can be seen in Figure 8. Due to time constraints the exact nature of this system of cracks and landslide could not be established. The observations terminated at a large landslide shown in Figure 9.

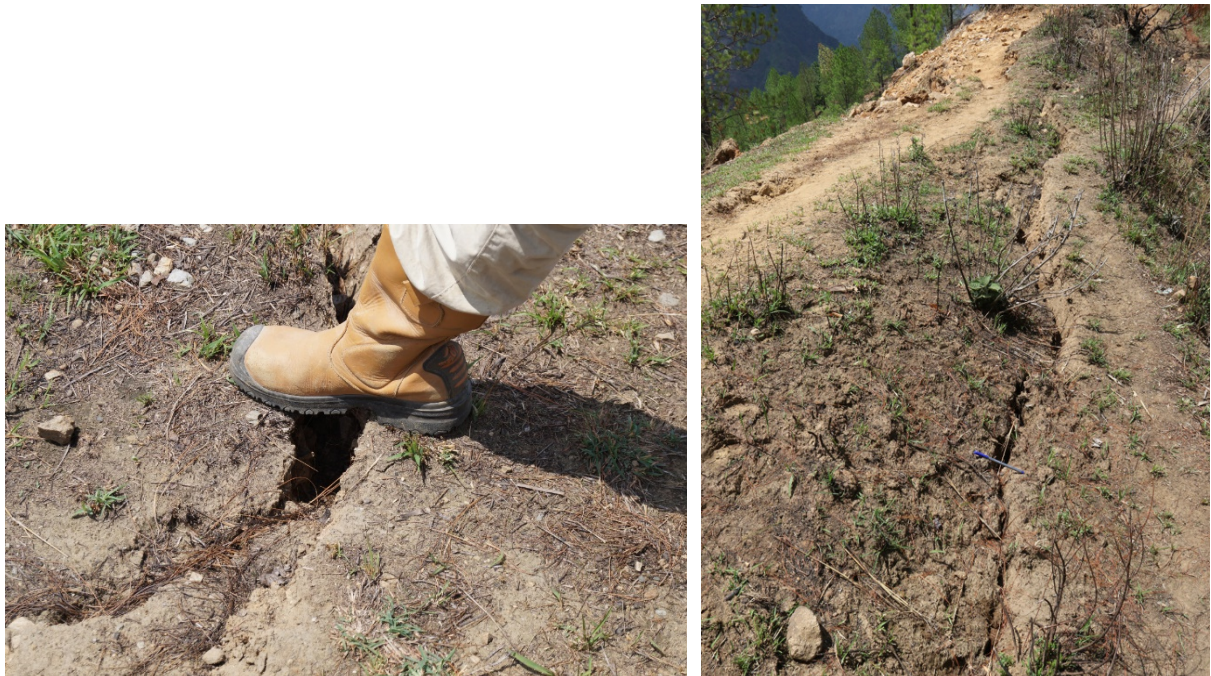
Figure 8. Tension Crack.

These general observations of landslide extent, building damage (grades 4 and 5 to highly vulnerable building stock A or B) and cracks in soil (extending to 40 mm width) observed through rapid observation with sparse coverage) all suggest intensity extending to IX or possibly X on EMS98.
