## A resilient shallow foundation system in coastal zone with liquefaction and lateral spreading potential

R. Kamuhangire, & I.D. McPherson

*Aurecon New Zealand Limited, Christchurch, New Zealand.*

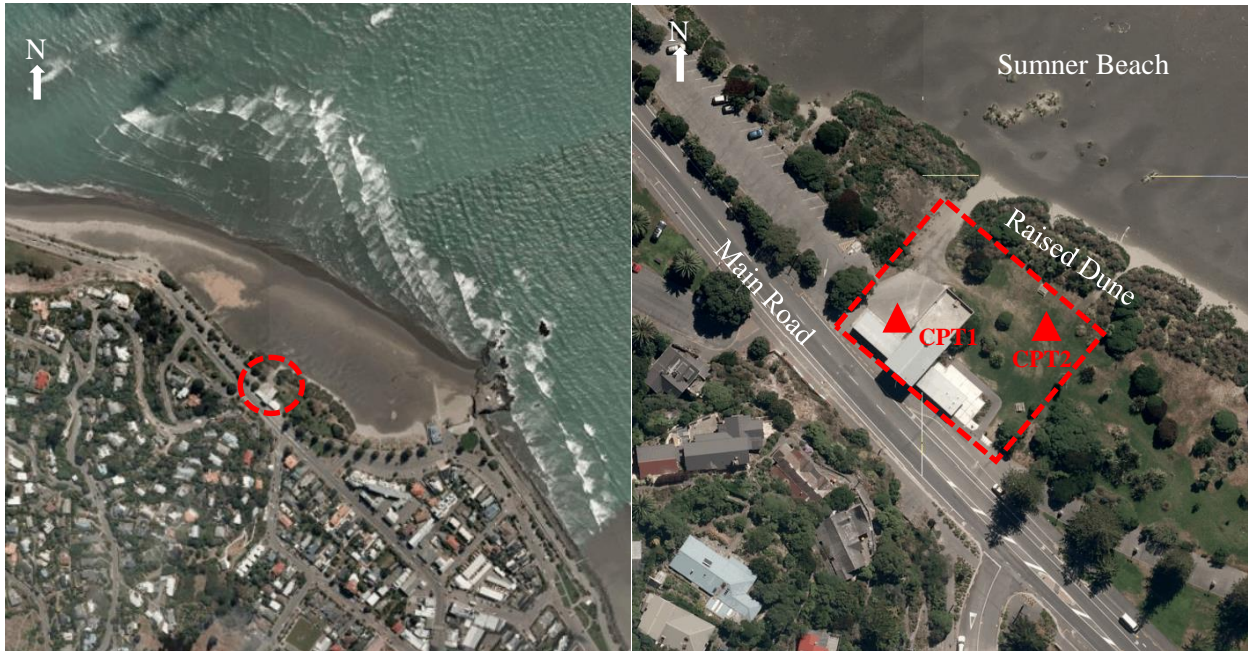
The site is located at 301 Main Road, Sumner Christchurch and slopes from about 12.7mRL at the road level to 11.2mRL to the landward side of the dune sands (see Figure 1 below). An approximate 0.6m high dune separates the site from Sumner beach, and there is a near vertical 15m to 20m high rock cliff to the south of the site across the road.

Figure 1 – Aerial Photographs showing site location (on the left) and site detail (on the right) including location of CPT investigations. Image background sourced from LINZ Crown Copyright Reserved.

A review of the regional geology (Brown and Weeber, 1992) and ground investigations including the two Cone Penetration Tests CPT1 and CPT2 in Figure 1 around the site indicate the following:

- The logs of CPT1 and CPT2, and accompanying Dynamic Penetrometer Super Heavy adjacent to the CPT positions indicate that the underlying rock slopes from about 5.5m depth at CPT1 location to 12.5m depth at CPT2 location over a distance of less than 50m.

A liquefaction hazard assessment was undertaken based on Idriss and Boulanger (2008) to better understand the liquefaction and lateral spreading potential at the site. The assessment was based on the CPT1 and CPT2 on Figure 1, and showed the following:

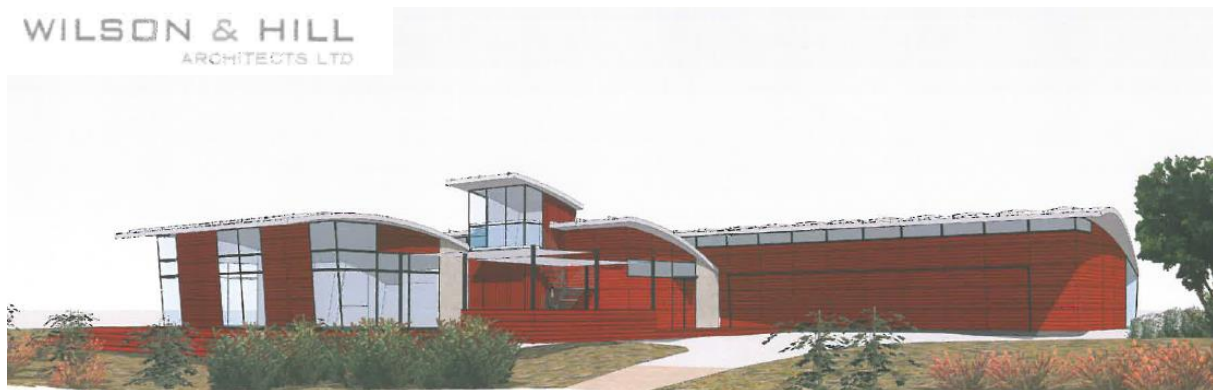
The new building complex comprises an architecturally designed single storey (except two storey life guard observation tower) building across an approximate 550m<sup>2</sup> footprint and additional 200m<sup>2</sup> timber deck with associated canopy structures (see Figure 2 below). The structural form comprises timber and steel frame with precast concrete panels in places.

Figure 2 – Architectural Visualisation of proposed building complex from the beach end

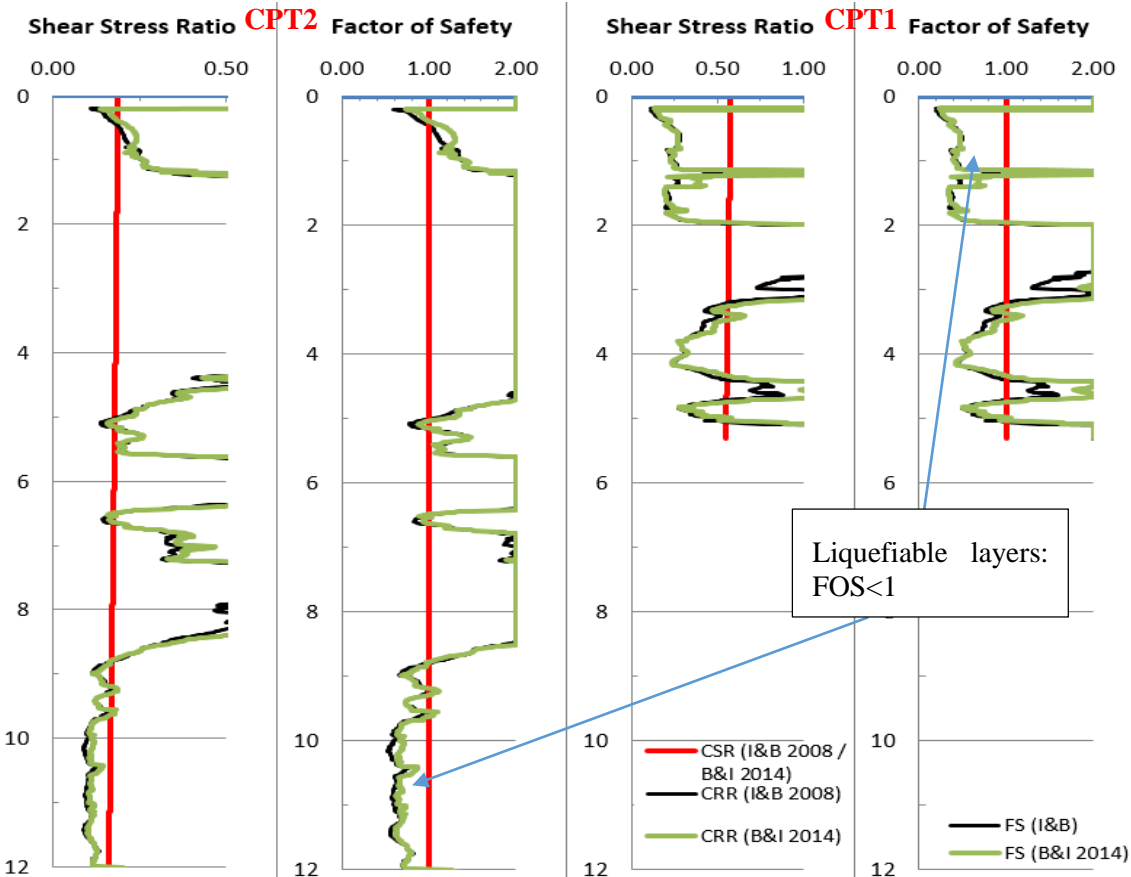
- The site is prone to liquefaction in both an SLS and ULS design earthquake event due to the presence of potentially liquefiable sand layers at the site. The liquefiable layers are generally below 9m depth under SLS level event but are spread throughout the depth profile under a ULS event (see Figure 3). Minor liquefiable layers were assessed in the top 1m depth under SLS.

Figure 3: Results of Liquefaction Analysis under ILS earthquake event (Mw7.5, PGA 0.35g) for CPT 1 and CPT2

- The calculated liquefaction induced settlements could be up to 100mm and 200mm in an SLS and ULS earthquake event respectively.
- The differential free field liquefaction induced settlement could be up to 100mm in either SLS or ULS event because of the variable depth to rock across the site (i.e. 5m inferred from CPT1 and 12m inferred from CPT2).

A review of the analysis has been completed for this paper based on Boulanger and Idriss (2014) and similar conclusions were reached.

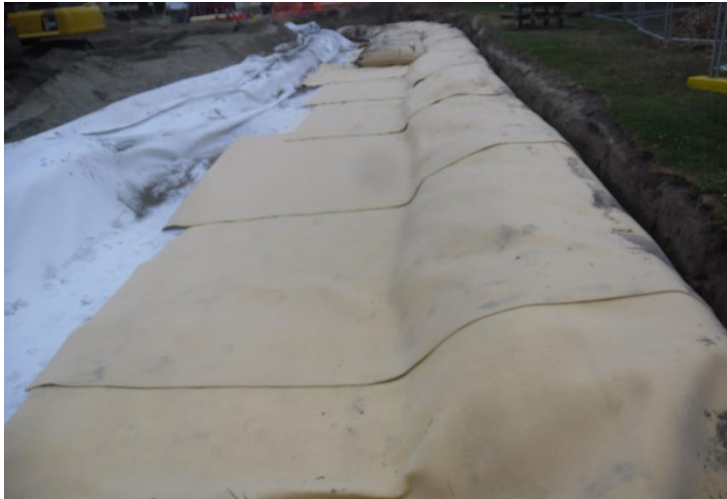
Due to Contractor’s resourcing constraints during construction, the 0.75m<sup>3</sup> containers with a special ‘self-healing toe’ could not be used and the smaller bags wrapped in Elcomax® 600R high strength geotextile was used as per Figure 5 below.

Figure 5 – Alternative system to 0.75m<sup>3</sup> self-healing toe
