Cyclic in-plane shear testing of unreinforced masonry walls with openings

C. Allen, M.J. Masia & A.W. Page

The University of Newcastle, Australia.

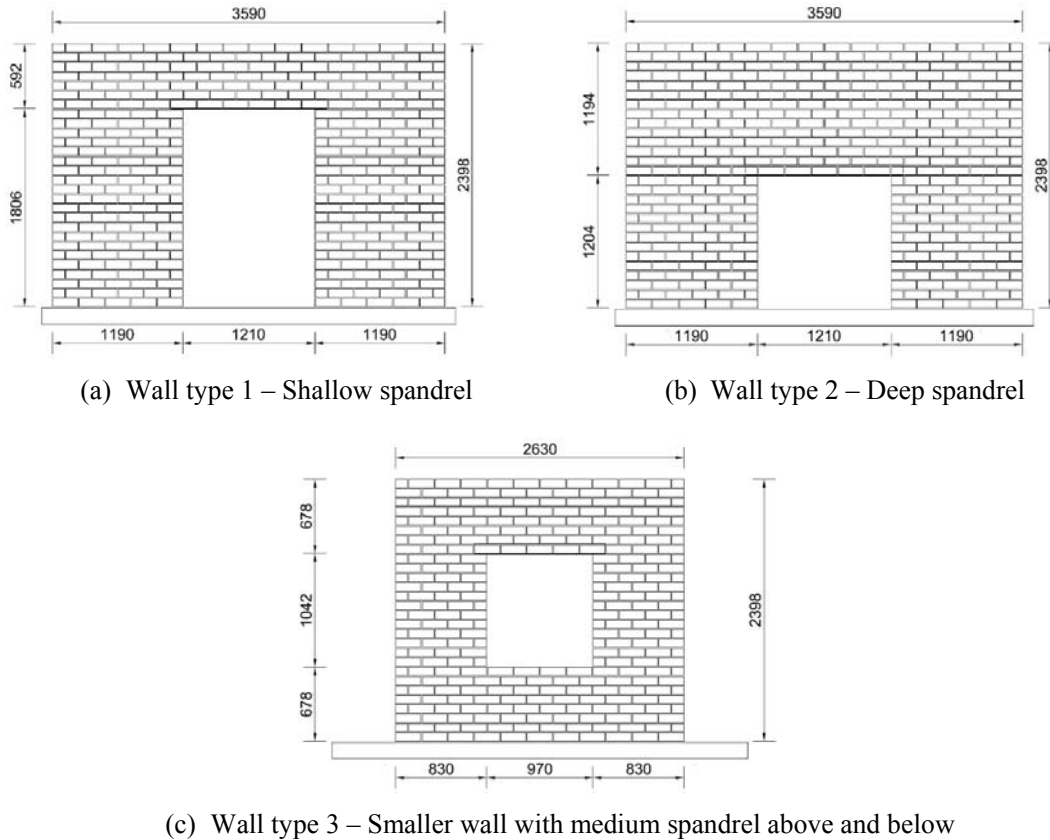
Figure 1 – Wall geometries for experimental testing programme. Note that all walls are 110mm thick.

The geometrical properties of the walls included in this study have been determined based on observed examples typical of Australian URM construction. The wall geometrical properties and vertical pre-compression levels for the experimental testing programme were selected so that both pier and spandrel failure modes would occur in the walls.

The walls presented in this paper consist of a single skin of clay masonry 110mm thick. Steel equal angle sections are provided as lintels for each of the walls to be tested.

A summary of the tested wall geometries is presented in Figure 1.

The wall specimen labelling convention adopted for the experimental testing programme is as follows: *<Wall geometry type>_<precompression level>_<test repeat>*. For example, W01_02a refers to the first repeat of the test for wall geometry type 1 (see Figure 1) with 0.2MPa precompression per pier. A listing of the 10 wall tests performed to date can be found in Table 2.

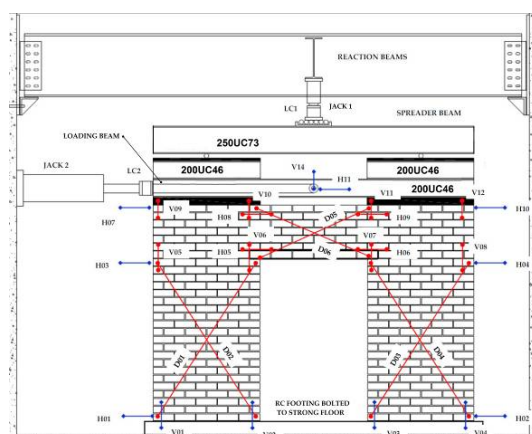
a) Elevation of testing setup. Note that displacements to the left are taken as positive.

Figure 2 – Experimental testing setup

An elevation of the experimental testing setup and instrumentation is presented in Figure 2 a). The vertical precompression loads of either 0.2MPa or 1.0MPa per pier were applied at the centreline of each pier via jack 1 which reacts against steel beams spanning between laboratory strong walls. The jack imparts a vertical load to a spreader beam (250UC73), which in turn distributes half of this vertical load to each pier. Due to the shallow depth of the loading beam (200UC46) an extra section of beam (200UC46) was bolted to the top of the loading beam over the piers. This extra section of beam allows the vertical load applied by the spreader beam and roller above to be essentially uniformly distributed along the plan length of the pier, thereby reducing the chance of localised failure due to vertical loads.

A key feature of the adopted loading beam arrangement is the connection between the loading beam and URM piers which is achieved by a 100mm \times 100mm square hollow section which is bolted to the loading beam and epoxied to the piers, allowing a gap over the spandrel which allows the spandrel to deform vertically as the wall is subject to lateral displacements. Dimensions of the loading beam steelwork were determined from linear finite element analyses which were used to simulate realistic wall boundary conditions found in multi-storey walls (Allen, Masia, & Page, 2014)

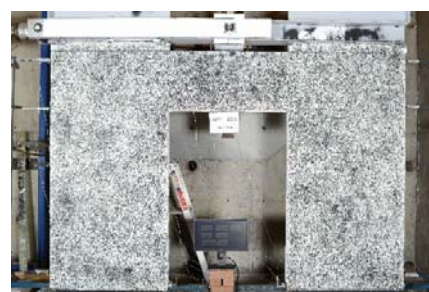
b) Photograph of wall in situ showing speckle pattern used for digital image correlation (DIC)

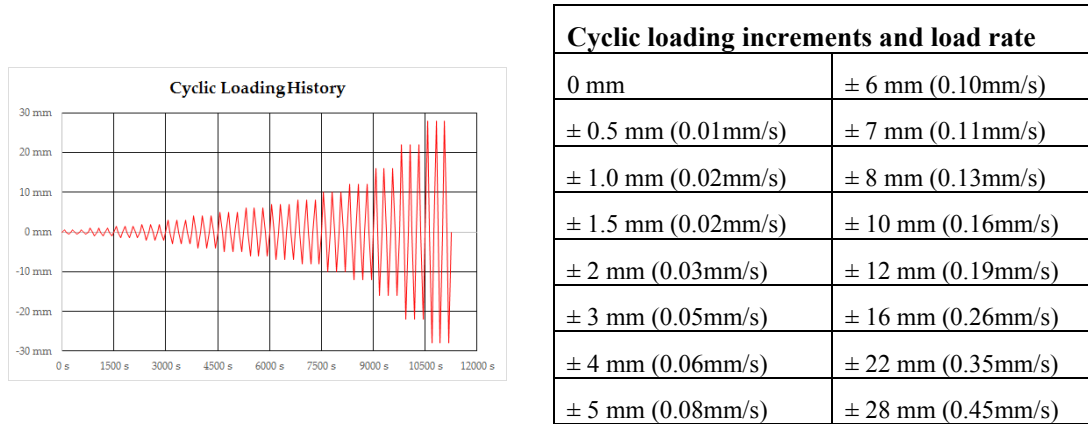
Figure 3 – Adopted quasi-static cyclic loading regime for wall tests

Cyclic lateral displacements were applied at the centreline of the 200UC46 loading beam. The cyclic lateral displacements consisted of a push cycle (negative) and a pull cycle (positive) which were increased in magnitude until the post-peak lateral load of the wall dropped by 20%, or excessive damage or instability of the wall specimen was observed. The adopted lateral displacement regime is presented in Figure 3.

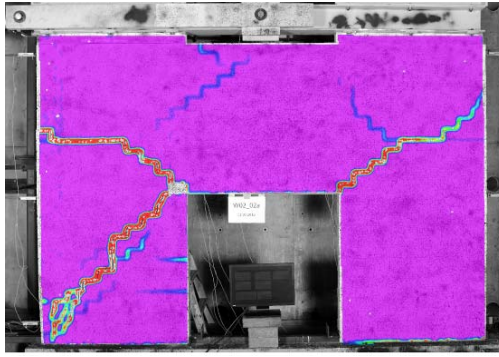
a) Positive (left) direction
(d = +10mm)

b) Negative (right) direction
(d = -10mm)

Figure 6 – Damage mapped by major principal strain contours for wall **W02_02a**

(W02_02a, W02_02b) damage primarily consisted of cracks propagating upward and outward from the corners of the opening to the edge of piers with rocking observed in a similar fashion to wall geometry type 1. For wall W02_02a, diagonal shear cracking was observed in the left hand pier after this rocking failure had occurred, resulting in a sharp decrease in load. The test for wall W02_02b was ended prematurely after debonding of epoxy at the loading beam to wall connection occurred after the onset of rocking.

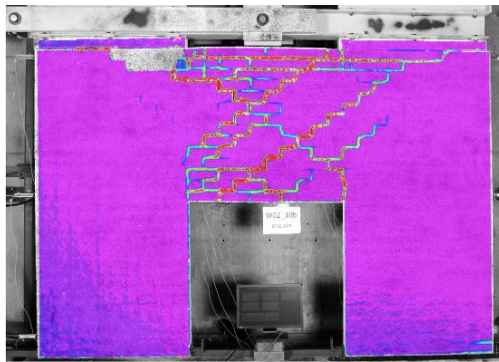
a) Positive (left) direction
(d = +16mm)

b) Negative (right) direction
(d = -16mm)

Figure 7 – Damage mapped by major principal strain contours for wall **W02_10b**

For wall geometry type 2, full height rocking of piers was observed combined with spandrel flexural or shear failure when the axial loads were high (W02_10a, W02_10b). When axial loads were low

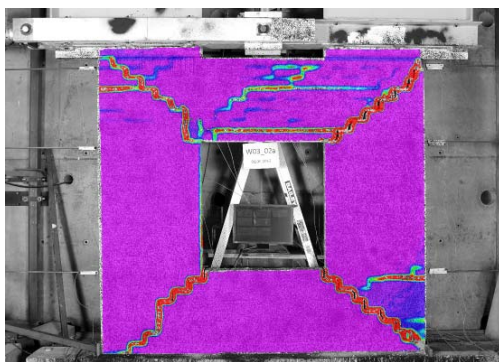
a) Positive (left) direction
(d = +22mm)

b) Negative (right) direction
(d = -22mm)

Figure 8 – Damage mapped by major principal strain contours for wall **W03_02a**

Wall geometry type 3 experienced rocking failures for both of the walls tested so far (W03_02a, W03_10a). The influence of axial load in this wall affected the amount of damage to the spandrel. For the low axial load case (W03_02a) damage to the spandrel was limited with rocking and subsequent out-of-plane twisting (as evidenced by the blue colour at the base of the right hand pier and the edges of spandrel in Figure 8 b)) as the limiting failure modes. For the case of the high axial force level (W03_10a), shear and flexural sliding of bed joints was observed in the spandrel coupled with pier rocking.

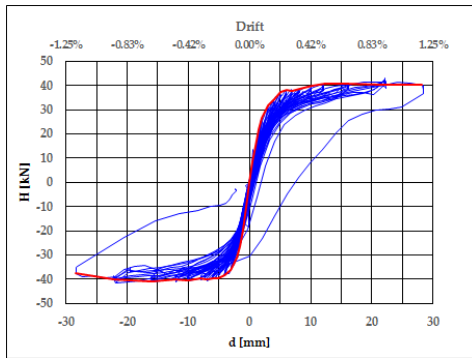
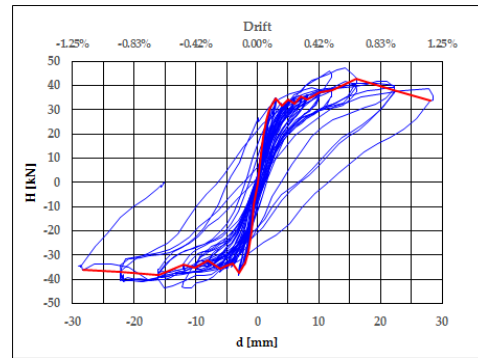
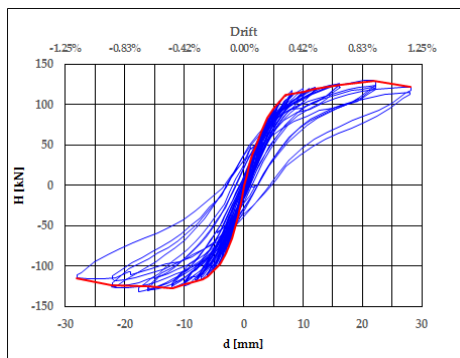
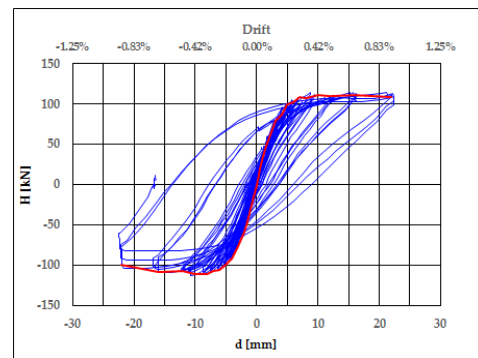
a) W01 – 0.2MPa - Repeat a (W01_02a)

b) W01 – 0.2MPa - Repeat b (W01_02b)

c) W01 – 1.0MPa - Repeat a (W01_10a)

d) W01 – 1.0MPa - Repeat b (W01_10b)

Figure 10 – Hysteresis loops and backbone curves for wall geometry type 1 (W01)

The force-displacement response for each of the 10 walls tested to date as well as the backbone curves corresponding to these are presented in Figure 10, Figure 11, and Figure 12.

From the force-displacement response for walls W01 and W03 the ultimate displacement does not appear to be significantly affected by an increase in vertical load. W02 however shows a marked increased ultimate displacement with increasing vertical precompression.

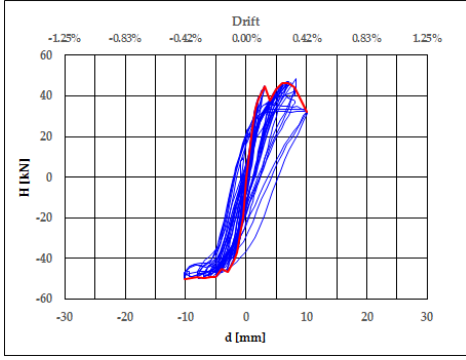
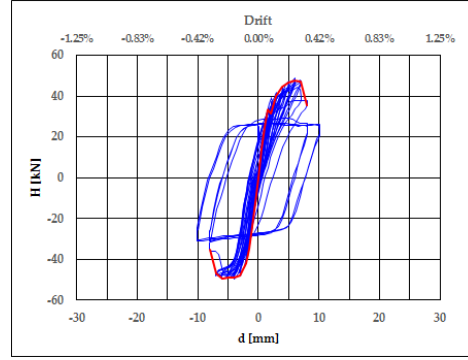
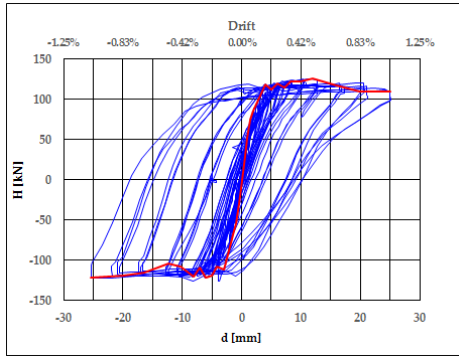
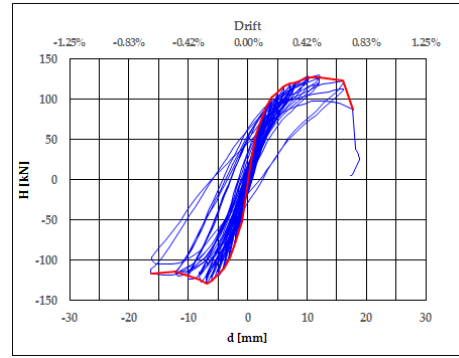
a) W02 – 0.2MPa - Repeat a (W02_02a)

b) W02 – 0.2MPa - Repeat b (W02_02b)

c) W02 – 1.0MPa - Repeat a (W02_10a)

d) W02 – 1.0MPa - Repeat b (W02_10b)

Figure 11 – Hysteresis loops and backbone curves for wall geometry type 2 (W02)

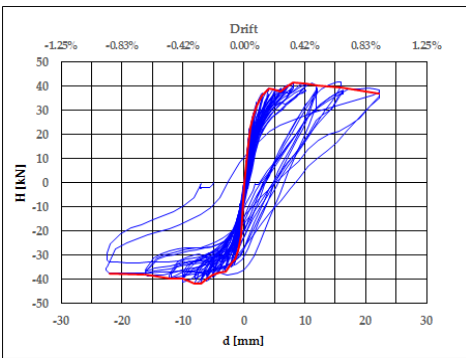
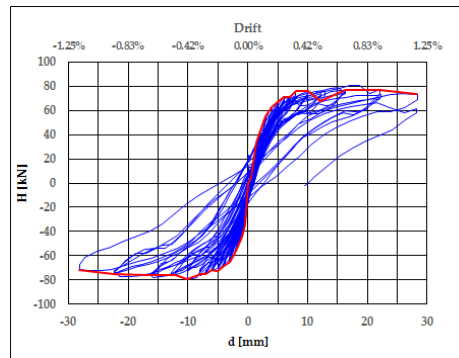
a) W03 – 0.2MPa - Repeat a (W03_02a)

b) W03 – 1.0MPa - Repeat a (W03_10a)

Figure 12 – Hysteresis loops and backbone curves for wall geometry type 3 (W03)

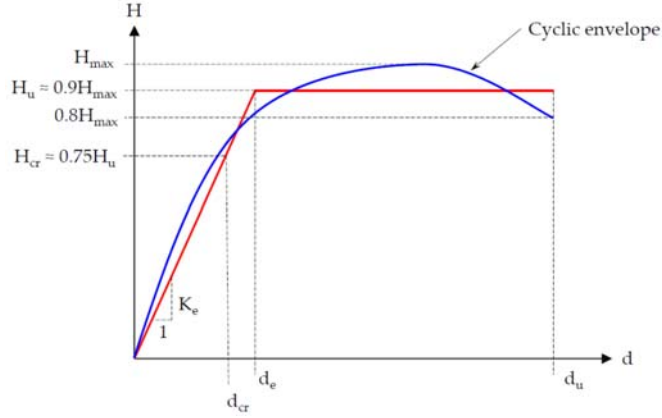
Figure 13 – Equivalent bilinear in-plane wall response parameters.
Adapted from (Magenes & Calvi, 1997).

From the force-displacement hysteresis graphs presented in Figure 10, Figure 11, and Figure 12, in-plane wall response parameters were calculated. A summary of the parameters calculated is shown in Figure 13 and key values are presented in Table 2.
