Experimental research on reduced beam section to concrete-filled steel tubular column joints with RC slab

R. Li, B. Samali & Z. Tao

Institute for Infrastructure Engineering, University of Western Sydney, Penrith, Australia

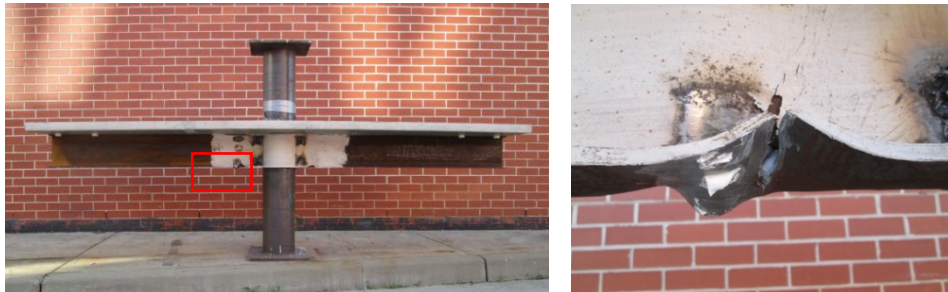
At a story drift of 0.03 rad, only a slight inelastic deformation occurred on the specimen CS-5, which located at the lower portion of the web of the north RBS region. Later, initiation of web local buckling was observed in the next loading step (0.04 rad story drift), indicated by the flaked whitewash paint. The strength degradation was observed at the 0.07 rad story drift resulted from a serious local buckling in the RBS region. Ultimately, the slab concrete near the column surface crushed and spalled, and then the joint failed because of the torn flange in the south RBS region, as shown in **Figure 9**.

Figure 9. Steel fracture observed in specimen CS-5.
