Experimental research on reduced beam section to concrete-filled steel tubular column joints with RC slab

R. Li, B. Samali & Z. Tao

Institute for Infrastructure Engineering, University of Western Sydney, Penrith, Australia

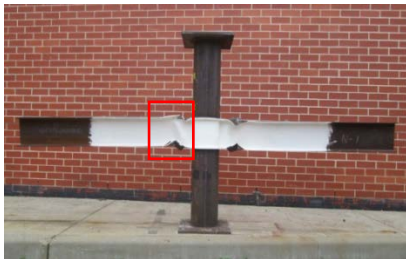
Specimen CN-1 failed by fracture of the steel beam at the end of the test. Initial yielding occurred during the first cycle of 2% rad story drift, which was observed at the south beam. Later, initiation of the flange buckling appeared close to the yielded top flange of the north beam at a drift of 4% and the whitewash of the beam web peeled off. When the displacement of the beam tip reached 75 mm (5% rad), the ultimate bending moment of the joint was observed, which was 1.18 times its yielding bending moment, as shown in **Figure 7**. At this point, load started dropping and the buckling of beams became more obvious with the increasing of the displacement of the beam tip. Finally, the test was terminated on the cycles of 8% rad story drift due to the bending moment of the joint had decreased to 85% of its ultimate bending moment. **Figure 5** shows the final appearance of specimen CN-1. Fracture was visible at the top weld seam edge, as shown in **Figure 6**.

Figure 5. Final appearance of specimen CN-1.

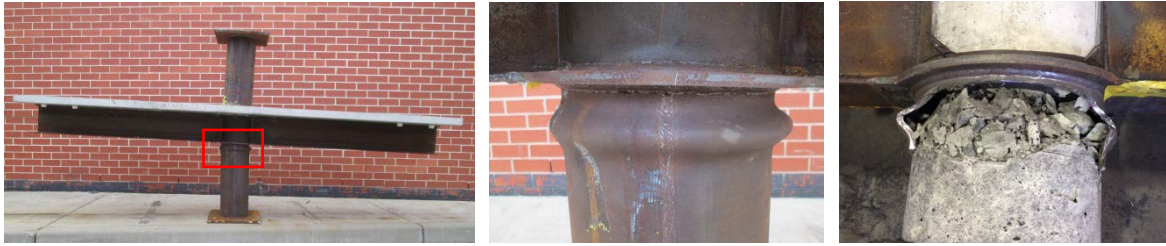
Column failure and beam failure were observed for specimens CS-1 and CS-5, respectively. The first flexural crack developed on the slab surface of these two specimens close to column at a rotational angle of 0.0075 rad, and then propagated outward. The length and width of cracks expanded in the direction of slab edges with the increasing of the beam tips load. In successive loading cycles, a visual buckling occurred in the column of specimen CS-1 (on the side of the beam under hogging moment) about 30 mm below the bottom through diaphragm when the rotational angle reached 0.015 rad. As the column-to-beam bending moment ratio for specimen CS-1 was less than 1, local buckling occurred in the column before the bottom steel beam flange yielded. At a rotational angle of 0.03 rad, the local buckling became more obvious, and significant deformation of the column was observed at a later stage, as shown in **Figure 8**, accompanying with clear sounds of the infilled concrete being crushed. The test terminated due to the strength of the joint decreasing to 85% ultimate strength on the second cycle at the stage of 0.03 rad.

Figure 8. Failure modes of specimen CS-1.

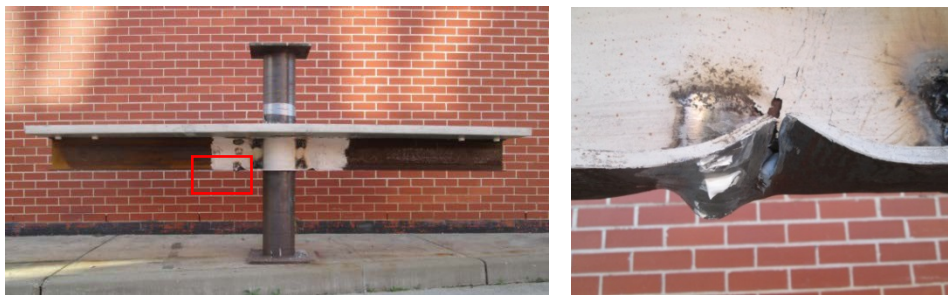
At a story drift of 0.03 rad, only a slight inelastic deformation occurred on the specimen CS-5, which located at the lower portion of the web of the north RBS region. Later, initiation of web local buckling was observed in the next loading step (0.04 rad story drift), indicated by the flaked whitewash paint. The strength degradation was observed at the 0.07 rad story drift resulted from a serious local buckling in the RBS region. Ultimately, the slab concrete near the column surface crushed and spalled, and then the joint failed because of the torn flange in the south RBS region, as shown in **Figure 9**.

Figure 9. Steel fracture observed in specimen CS-5.

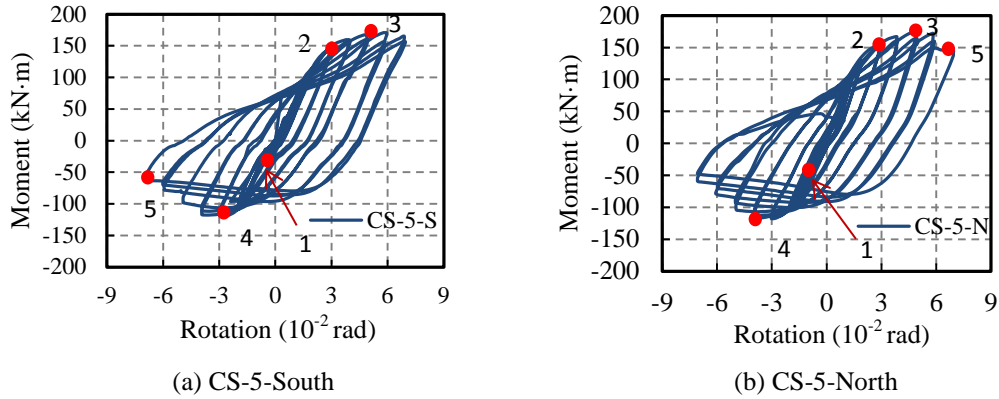
(1. Crack initiation; 2. Yielding point; 3. Maximum strength; 4. Local buckling of the web; 5. Beam flange fracture.)

Figure 11. $M-\phi$ hysteretic curves of specimen CS-5.

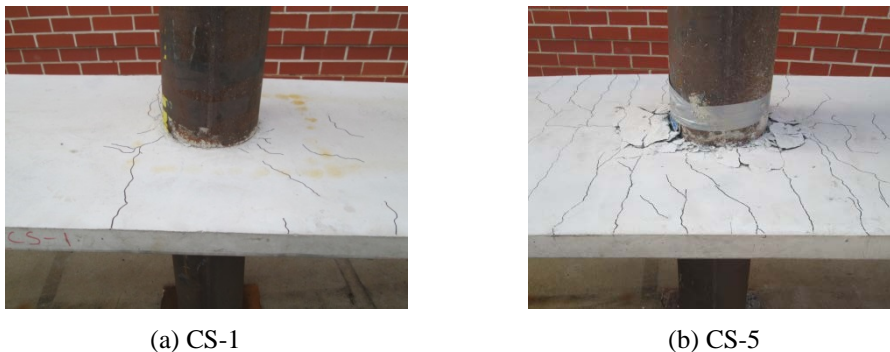
Although the concrete defects in specimen CS-1 were mainly responsible for the column failure, the increased bending moment capacity because of the slab might also be a reason. In contrast, due to the use of RBS, CS-5 showed a beam failure. The ductility coefficients for each specimen are presented in **Table 3**. The average ductility coefficient in two directions increased from 1.34 (CS-1) to 2.73 (CS-5) due to the effect of RBS. Developments of concrete cracks in the concrete slabs were also different for the two specimens. Only a few cracks were observed on the slab of specimen CS-1 due to the column failure mode, as shown in **Figure 14**. But the slab concrete in specimen CS-5 was crushed around the column and cracks were observed in almost a quarter of the beam span, as shown in **Figure 14**.

Figure 14. Concrete cracks and crushed concrete in slabs.
