Application of a Proposed Methodology on Performance-Based Assessment to a Reinforced Concrete Heritage Buildings in the Philippines

M.R. Del Prado & A.W.C. Oreta

De La Salle University, Manila City, Philippines

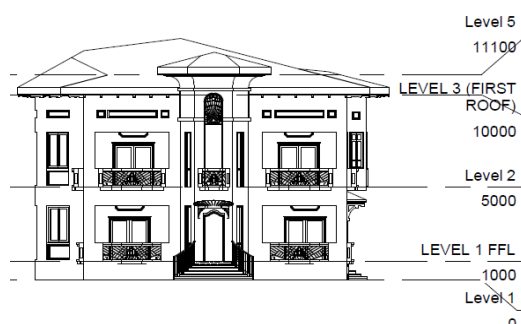
Figure 4. Front Elevation

Actual measurements were done to develop detailed structural plans of the heritage building. The front elevation of the heritage building is shown in Fig. 4. The yield strength of steel reinforcement that was used is the default value provided by ASCE 41(2013) for those building constructed during 1911-1959, which is 228 MPa. The summary of the modelling parameters are presented in Tab. 5. The over strength factor (R) was set to 3.5 to account for the Low Code Design taken from the study of Hernandez & Pascua (2012). The Low Code Design refers to the design method that assumes the elastic response of materials which is common for older buildings. The loads were taken from the National Structural Code of the Philippines of ASEP (2010).
