Building Post-Earthquake Business Resilience Through Geotechnical Design: A Christchurch Case Study

D.P. Mahoney

Aurecon NZ Ltd, Christchurch, New Zealand.

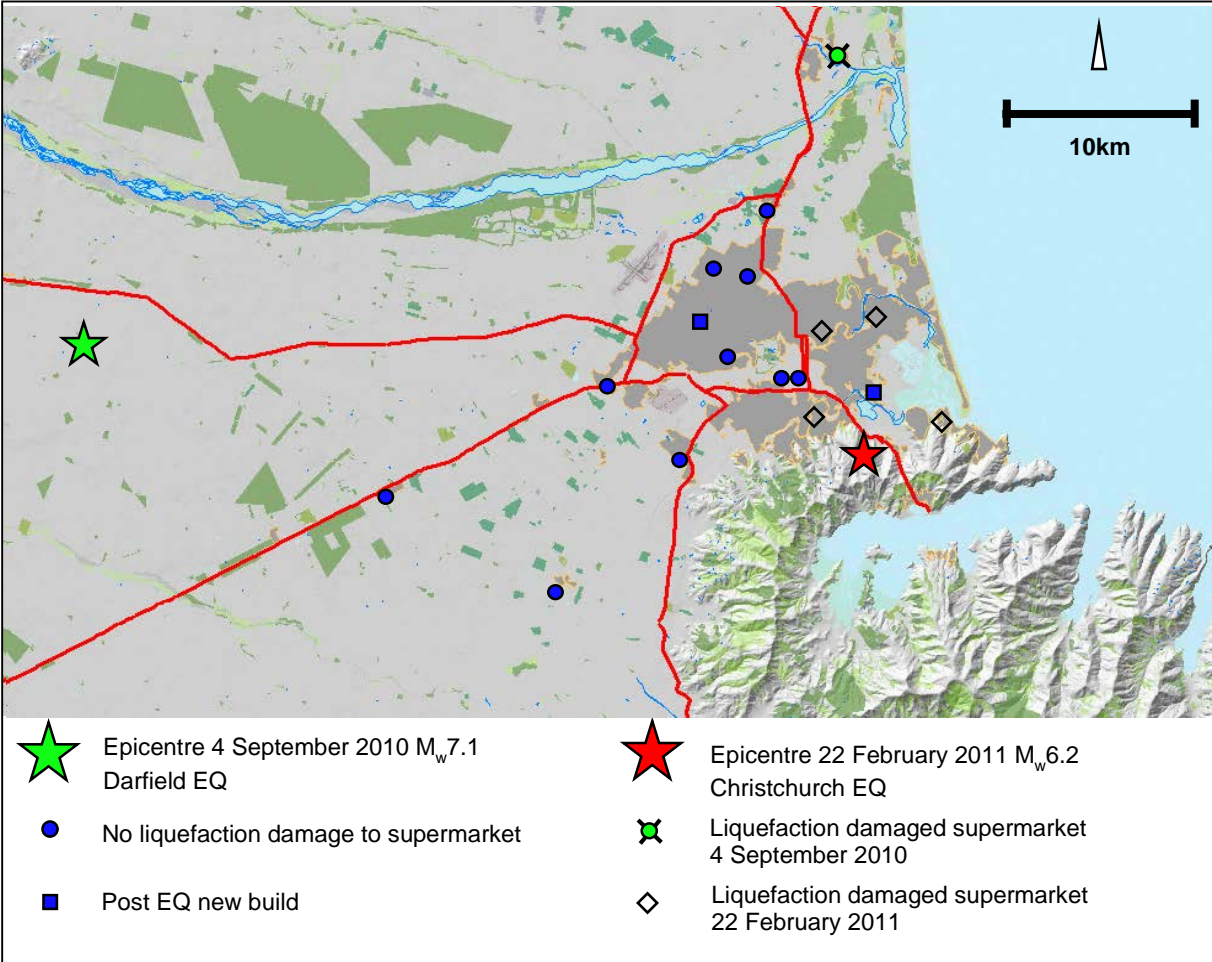
The location of the various supermarket sites and damage levels are shown in Figure 1 below. The damage resulted in the complete rebuild of four supermarket buildings and major repairs and revelling to one.

Figure 1 – Earthquake epicentres and supermarket locations

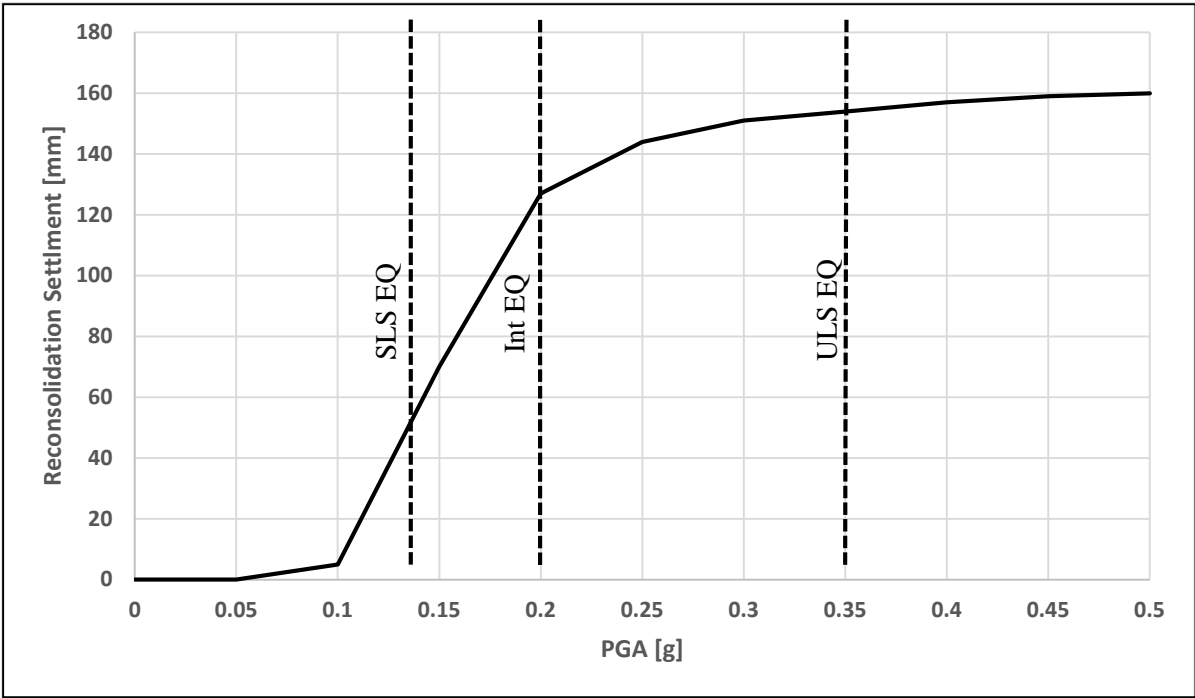
Using reconsolidation settlement provides a qualitative method to demonstrate the binary nature of liquefaction response as shown in Figure 2 for Foodstuffs' St Martin site.

Figure 2 demonstrates that onset of liquefaction occurs just before the nominal Serviceability level earthquake (0.13g & M_w 7.5 - 25 year event), while approximately 90% of ULS earthquake (0.35g & M_w 7.5 - 500 year event) settlement/damage has occurred at say 0.20g & M_w 7.5 (150 year) event. Therefore from a geotechnical perspective, ULS level ground damage is occurring long before a ULS event has occurred. Thus an expected linear increase in structural damage, with a linear increase in ground shaking will not occur at sites susceptible to seismically induced liquefaction.

Figure 2 – Reconsolidation Settlement over the upper 10m with PGA St Martins Supermarket
