Environmentally Sensitive Electricity Infrastructure and the 1989 Newcastle Earthquake

David Beale¹

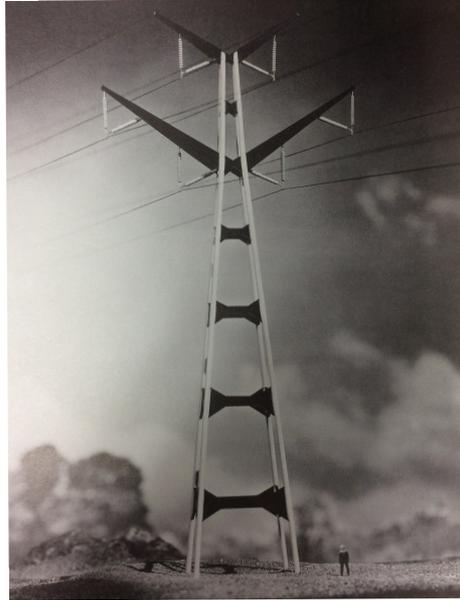
Figure 1. Scale model of proposed steel tower design 230kV for Edison Electric Institute 1966 -1968 (Flinchum, 1997).

Some pole and tower designs were not successful due to their higher cost involved and, ironically, they were considered to be too visually prominent, for example, those in figure 1 and figure 2. Hybrid single pole designs with a simpler, stronger structure, with selected colour finishes, at a more acceptable higher cost to conventional poles were adopted. Due to their extra costs, especially in the case of the very tall high voltage tapered poles, they were only adopted at visually critical locations.

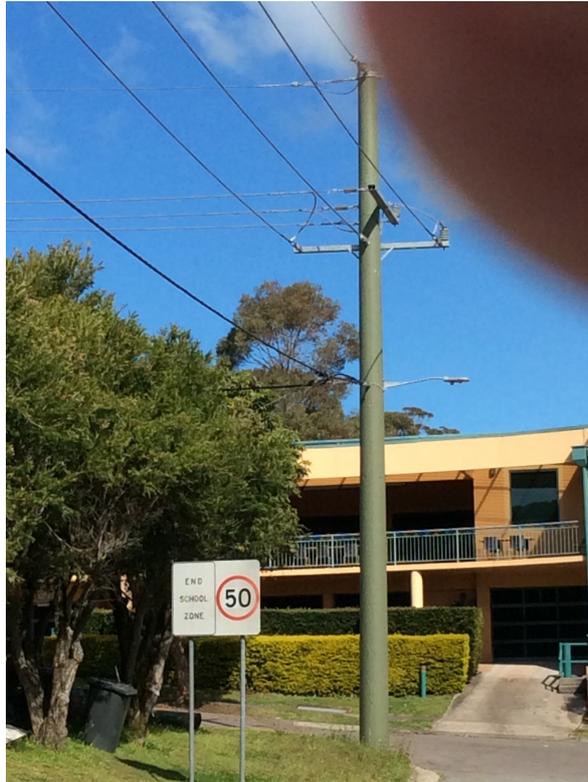
Figure 3. Tapered steel electricity pole painted green at a street corner. The tapered pole has lightning protection above electricity conductors and fibre optic cable below them. Dibbs Street and Gow Street, Adamstown, Newcastle (photo 2019).

Standard wooden straight-sided poles have uneven material strength (material defects) along the poles that can affect earthquake performance and their top assemblies have negative visual impact. Some newer standard poles were coloured green to have more visual appeal. The solution to both strength issues and environmental appeal was to use freestanding strong coated tapered steel poles, figure 3, such as at street corners, road bends, and at the end of overhead lines. Rather than wooden poles with bracing, the tapered poles are self-supporting. The tapered poles appear more natural (in strength and appearance). The poles earthquake performance depends on their foundations.

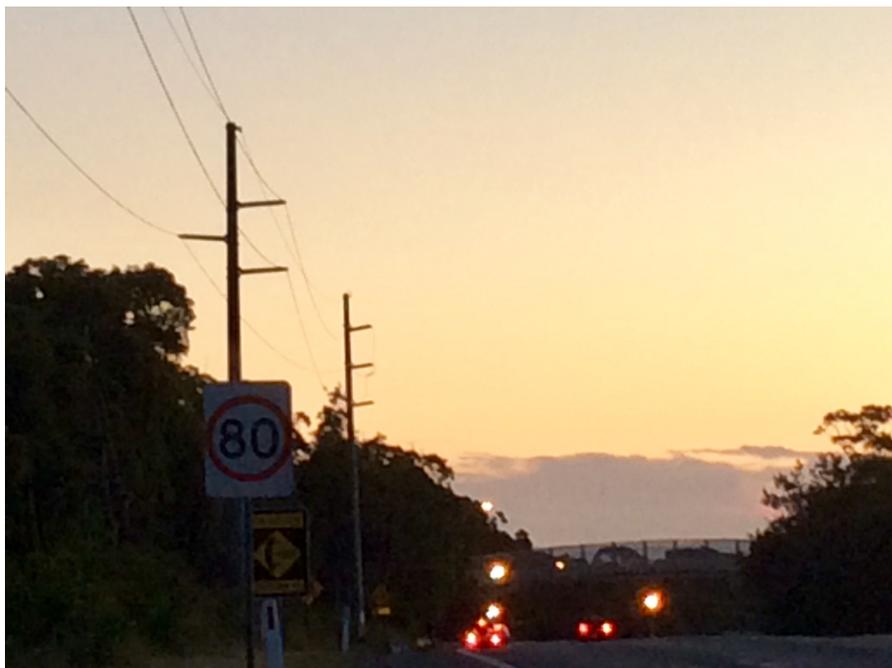
Figure 4. Rigid horizontal insulators in two configurations, alternate sides and same side, along Pacific Highway A43 (was numbered 1), Newcastle (photo 2019).

One major change brought about by environmental considerations was insulator angles. The traditional insulator application is hanging down insulators. New low profile equipment used stronger standing or horizontal projecting insulators, figure 4. The simpler upward and outward projections appear more natural, like tapered trunks and branching of trees. Their earthquake performance was better than the traditional design insulators.

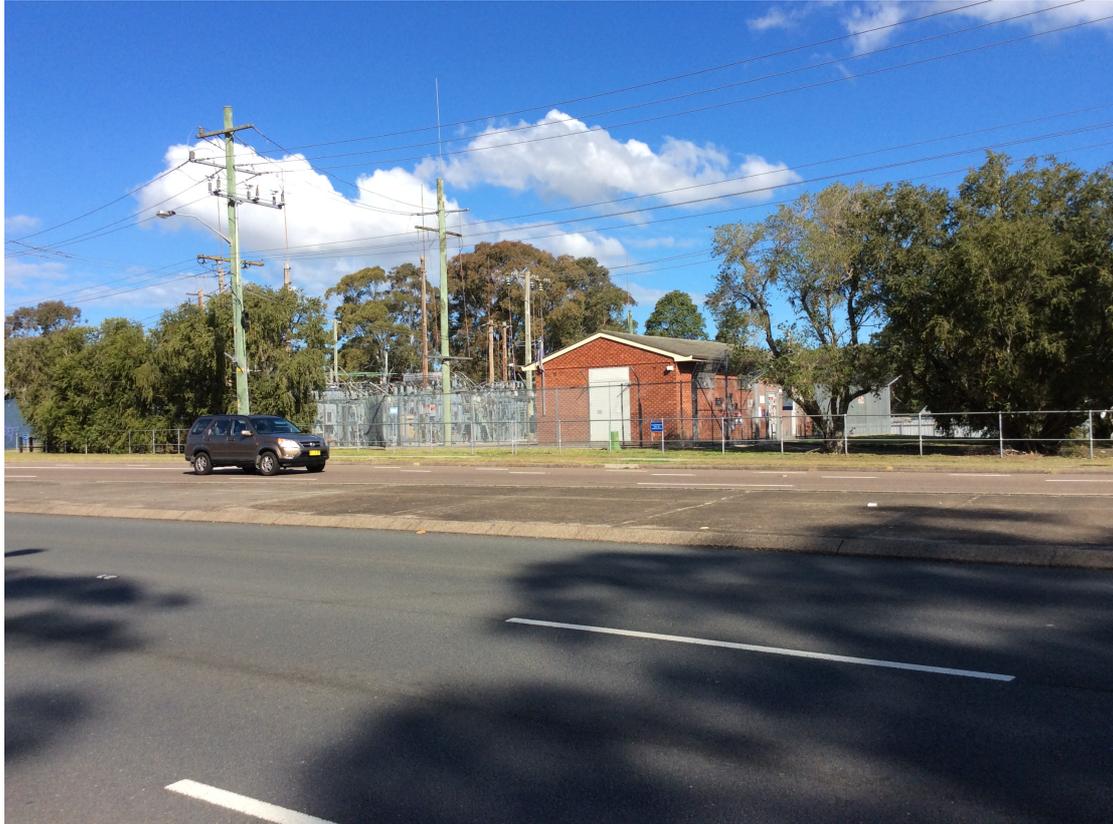
Figure 5. Urban substation with low profile equipment and some underground cables. Main Road and Charles Street, Edgeworth, Newcastle, (photo 2019)

The low profile substations are less visually dominant of the local neighbourhood. In Newcastle, the urban substation at Edgeworth has a low visual impact. Referring to figure 5, some of the design features are noted here. In the centre, fenced urban substation with low profile equipment and plain steel roofed brick building. Nearby, two low tree screened approaches. One screen in front of substation near on Main Road and adjacent to creek reserve south of the road. A second screen after substation along Charles Street a western side road with urban housing. At the southern rear are areas of larger trees. The northern location of the figure 5 photograph, on the opposite side of the six lane Main Road, is a park reserve of the creek. There is some reduced concentration of overhead conductors by using underground cables to dispersed poles.
