Curtainwalls; Seismic Experience, Design and Assessment

P. Lalas

Abstract

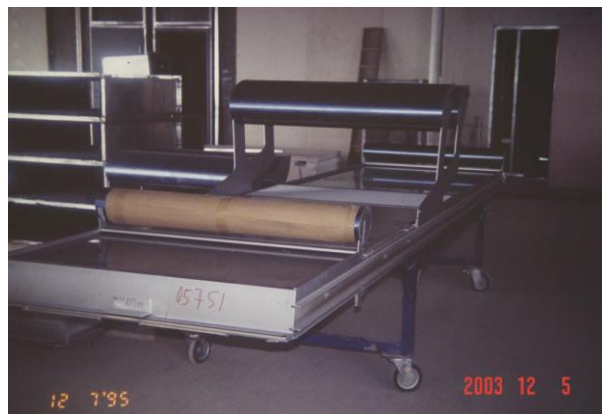
Figure 7; Unitised curtainwall panel; KLCC Twin Towers, Kuala Lumpur

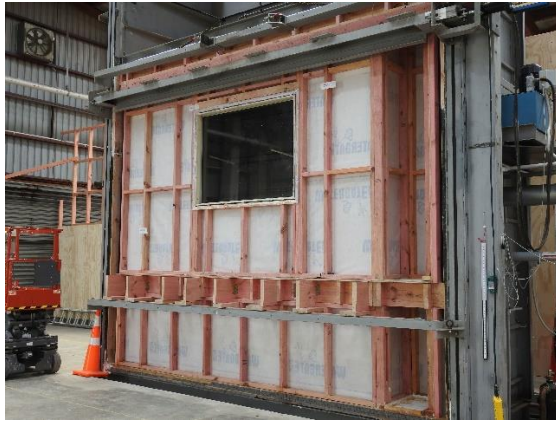
Figure 9; AS/NZS 4284⁵ Testing a cladding sample.

The method of testing AS/NZS 4284⁵ is to install the test prototype to the test chamber with its outside face into the chamber. Looking at Figure 9, the internal face of the specimen is seen.

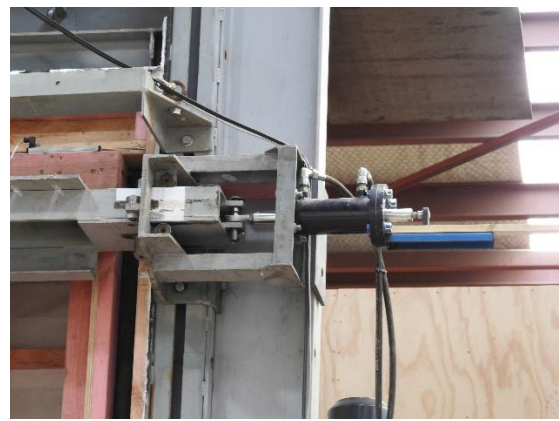
Figure 10; This is a close up of the top right corner of the test prototype of Figure 9.

Figure 10 is a close-up of the hydraulic ram which is used to move the top support beam to simulate inter-storey drift.

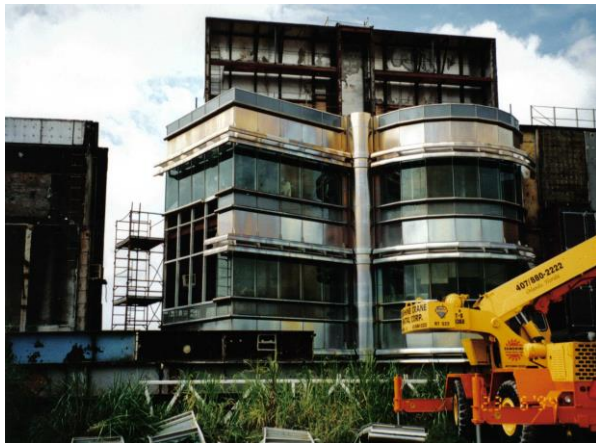
Figure 11; Test prototype; KLCC Twin Towers unitised curtainwall

Figure 11 shows the first test prototype built for the KLCC Twin Towers. It was 3 floors tall and included 44 panels. Seismic inter-storey drift was applied by moving the middle floor sideways. Figure 12 shows a recent test of a prototype for the Von Haast building, UC, Christchurch.

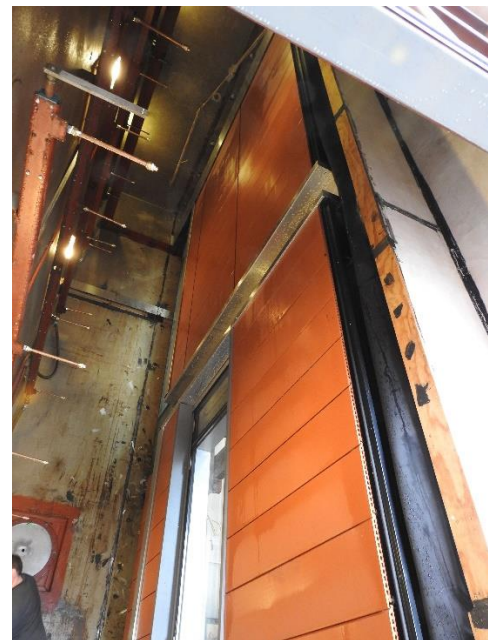
Figure 12; Von Haast Test Prototype

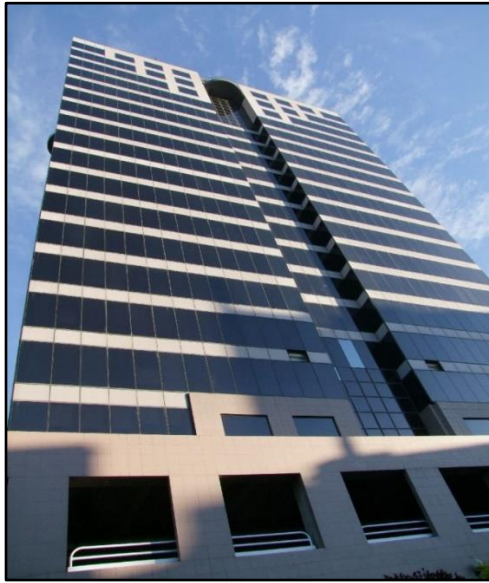
Figure 13; PWC Tower; the south face on 9 May 2011.

Looking at the PWC Tower from the street, no obvious damage was visible. However, inspection from inside and when glass spandrels were removed, as in Figure 14, there was obvious structural damage. The curtainwall and its brackets at the corners of the building were damaged such that replacement was necessary.

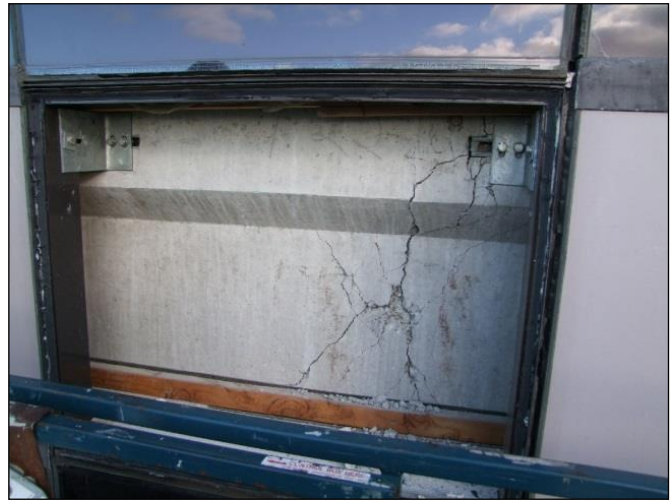
Figure 14; This is a concrete beam near the corner column.

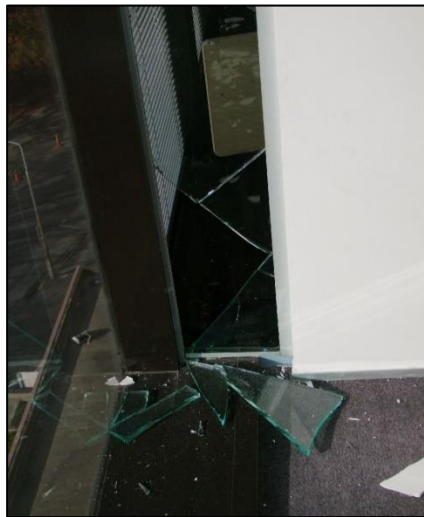
Figure 15; PWC Tower; this glass panel was positioned between a curtainwall mullion and an internal wall.

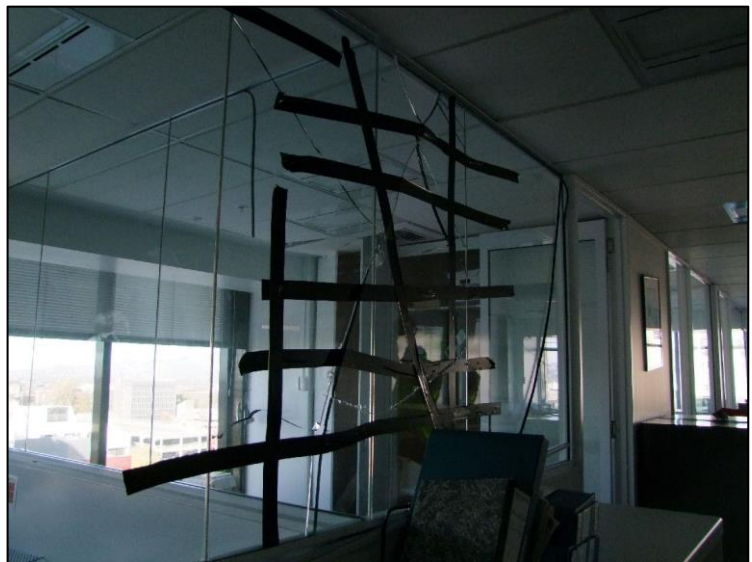
Figure 16; PWC Tower; This is a broken internal partition; there were more broken glass panels inside than outside.

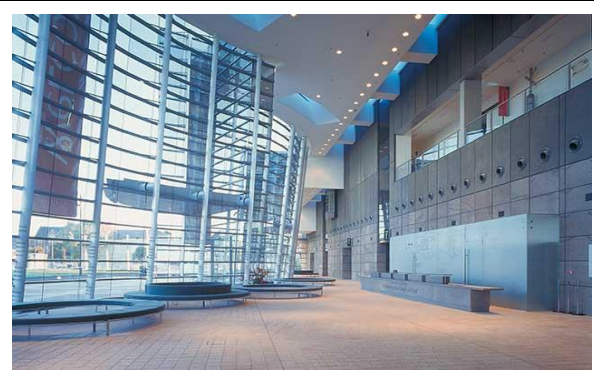
Figure 18; Christchurch Art gallery Glass wall, viewed from inside the lobby.

The other curtainwall I was asked to inspect was a hybrid design on the Christchurch Art Gallery. Again, there was very little damage despite the earthquake having exceeded all design parameters. The main damage was that all the transoms were attached to the structure with self-tapping screws. The aluminium around the screws was damaged such that most of the screws could be removed by hand.
