URM cavity walls: Simple and experimentally proof-tested retrofit

Hamish Tocher¹, Nicholas Slavin², Anton Stanišić³ and Dmytro Dizhur⁴

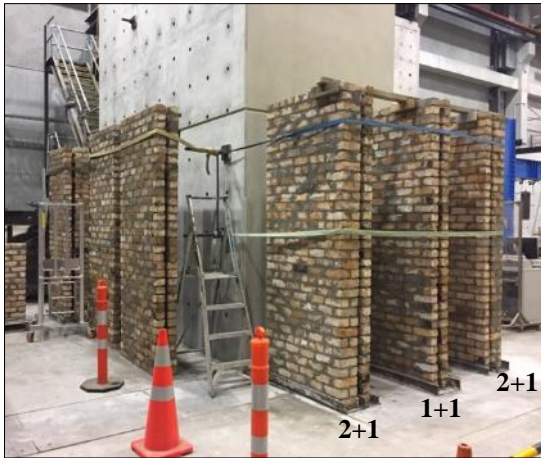
Figure 1: Wall specimens and material testing

(a) Wall specimens following construction (showing different wall typologies)

The experimental testing programme was conducted using four purpose-built full-scale URM walls (see Figure 1a). The walls were 3000 mm high and 1150 mm wide, with wall height chosen to approximate a typical upper storey in a URM building. Two of the walls were single-single cavity walls, meaning two single leaves of bricks separated by a 55 mm wide air cavity. The other two walls were double-single cavity walls, meaning a double leaf of brick, a 55 mm air cavity, and a single leaf of brick. These walls were denoted “1+1” and “2+1” respectively. These type of wall configurations are frequently found in New Zealand URM buildings, with the double-single cavity walls commonly but not exclusively found on lower floors. The cavity width in all the walls was specified as 50 mm, or approximately half the thickness of a brick. As was common practice in historical URM construction, the outer faces of the walls were made flush. As a result, there was minor variability in the cavity thickness over the height of the wall.

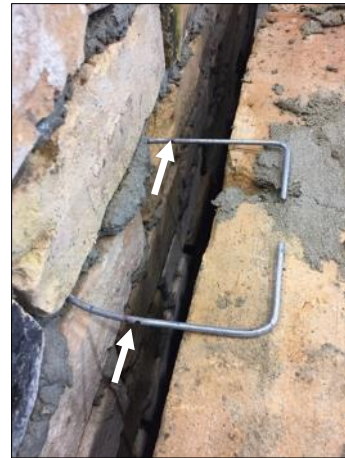
(b) Notched wire hoop simulating historical as-built ties.

In typical URM cavity wall construction, flexible wire ties were inserted into the walls to connect the leaves across the cavities. Following the methodology employed by Giaretton (2016c), these as-built wire ties were simulated in the specimen walls using 4.0 mm steel wire bent into open hoops. Deterioration of the as-built ties was simulated by notching the wire hoops which were built into the specimen walls (see Figure 1b). Wire hoops were inserted every six courses, alternating between a pair of hoops and a single hoop to create an offset pattern. In retrofitted wall specimens, Python C ties were used to transfer shear and improve composite action between the leaves. The retrofit ties were 6 mm diameter screws with a length of approximately 240 mm and have significantly higher axial and flexural capacity than as-built ties. Python C tie spacing was varied for each retrofit test.

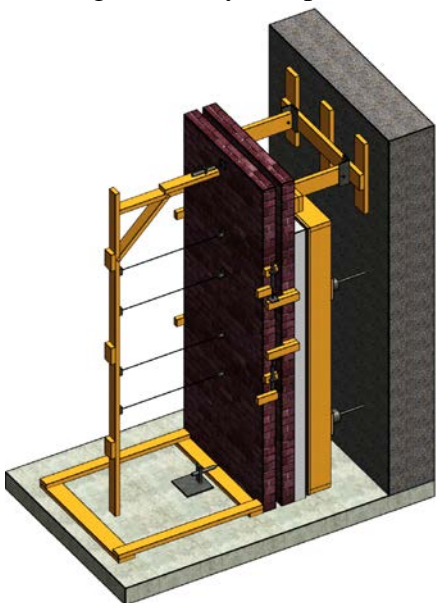
Figure 2: Test setup and instrumentation plan

(a) Isometric schematic of setup

The wall specimens were tested using a system of airbags to apply a uniformly distributed semi-cyclic loading, with the test setup is shown in Figure 2a. Each wall was restrained at its base with timber

members bolted to a concrete strong floor and bearing directly on the first course of bricks. At the top of the wall specimen, a timber stringer was connected to brick course 31 using Python MT screws, and timber joists connected the stringer to a concrete strong wall. A loose bolted connection between the joists and the strong wall allowed free rotation of the top of the wall but prevented horizontal translation. The upper and lower connections were designed to recreate in-service conditions of URM walls in a post-retrofitted state and allowed each wall to be considered pinned at top and base.

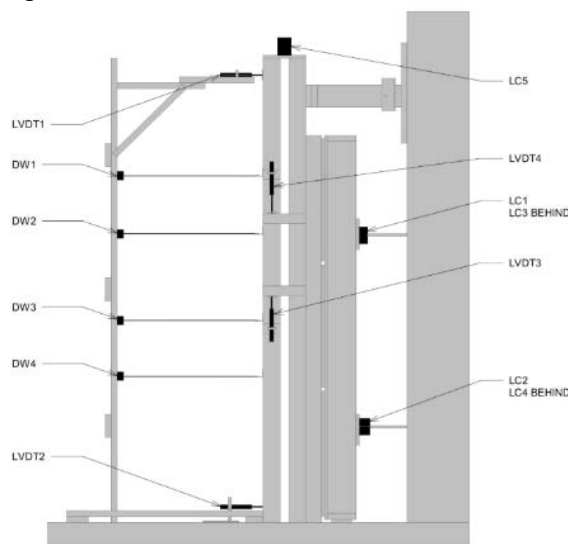
(b) Side elevation showing instrumentation plan

The airbags reacted against the timber reaction frame seen in Figure 2 to the right of the URM wall specimen and were sandwiched between the timber and a layer of polystyrene (shown in white in Figure 2c) to ensure a better distribution of applied pressure. When airbags were inflated, a force was exerted on the wall specimen which was measured by four load cells, located on the opposite side of the timber reaction frame. Loading was applied in a gradual manner by controlling the airflow into the airbags, and multiple loading/unloading cycles were applied to the wall specimens. The standard instrumentation plan is shown in Figure 2b.

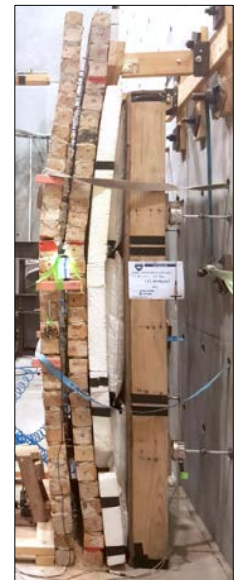
(c) Wall under test

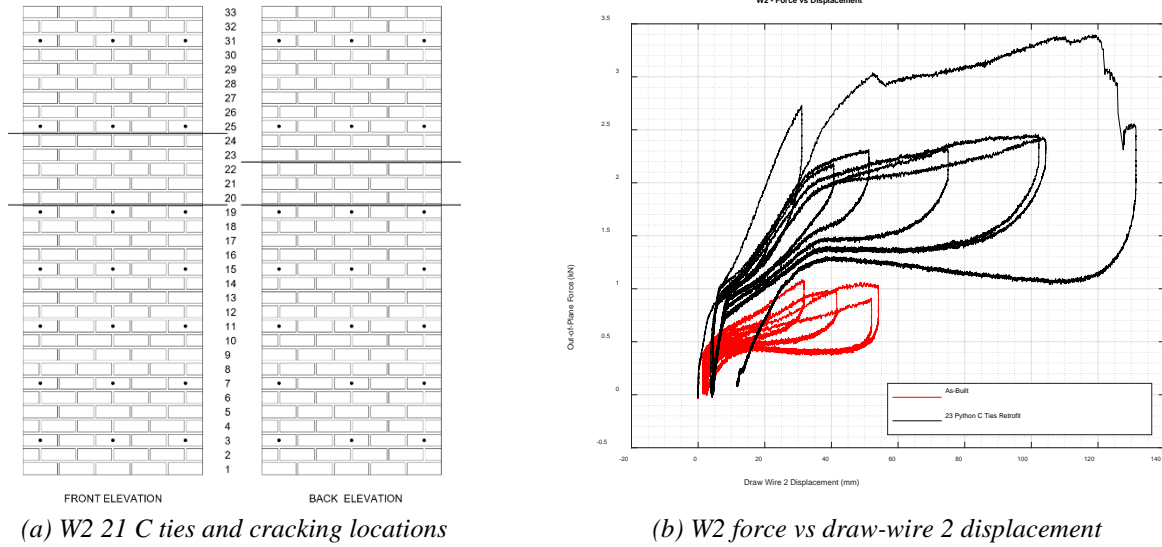
Figure 4: W2 Load-displacement relationship, tie layout, cracking

Wall 2 (W2) was a single-single (1+1) cavity wall of the same dimensions as W1. Because of the distributed cracking and tie flexure that occurred in W1, W2 was initially retrofitted with a more closely-spaced tie pattern in the lower half of the wall. Four rows of three ties were inserted below course 20, spaced at approximately 460 mm horizontally (every two bricks) and 400 mm vertically (every four courses). Above course 20 two rows of three ties were used, spaced vertically every six courses. During the 30 mm deflection cycle, the wall cracked in two places on the outer leaf, between two rows of ties. This cracking pattern indicates that bricks on the outer leaf between courses 19 and 25 were not connected to the rest of the cavity wall (see Figure 4a), threatening the break-off failure illustrated in Figure 8c.

Two additional ties were added at course 22 to secure the masonry upper block. With the addition of these ties the wall underwent rocking and recovery cycles up to displacements of approximately 100 mm (see Figure 4b). During the last cycle, the wall was displaced to 127 mm at draw wire 2, corresponding to a deflection of approximately 150 mm at the crack between courses 19 and 20. The wall then returned to a stable equilibrium position with minor residual displacement.

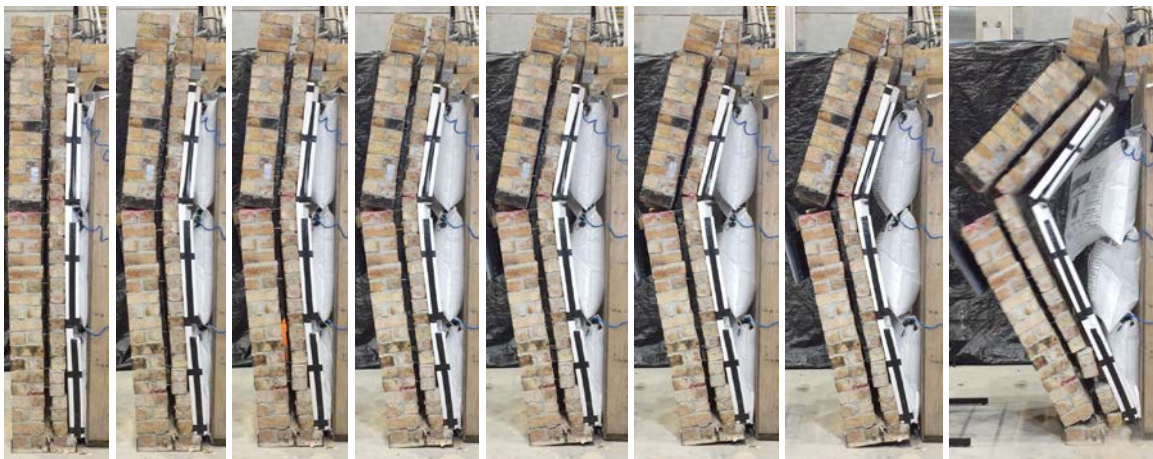
Figure 7: W4 collapse time sequence

24 Python C ties were reinstalled in wall W4 and a series of displacement cycles was conducted. The maximum displacement reached was approximately 105 mm in the 2+1 retrofit condition. Peak loading reached a plateau of approximately 8.0 kN, an increase of 23% from the as-built load capacity of 6.5 kN in the previous test. However, this loading was consistently lower than that measured in the 1+2 test, suggesting that the shorter lever arms between the masses and the pivots affect lateral capacity as predicted by the model in Section 4.2. Finally, instrumentation was removed, and the wall was loaded in its retrofit condition until collapse at a displacement of approximately 350 mm, governed by reaching the geometric instability point of the wall (see Figure 5d, and Figure 7).

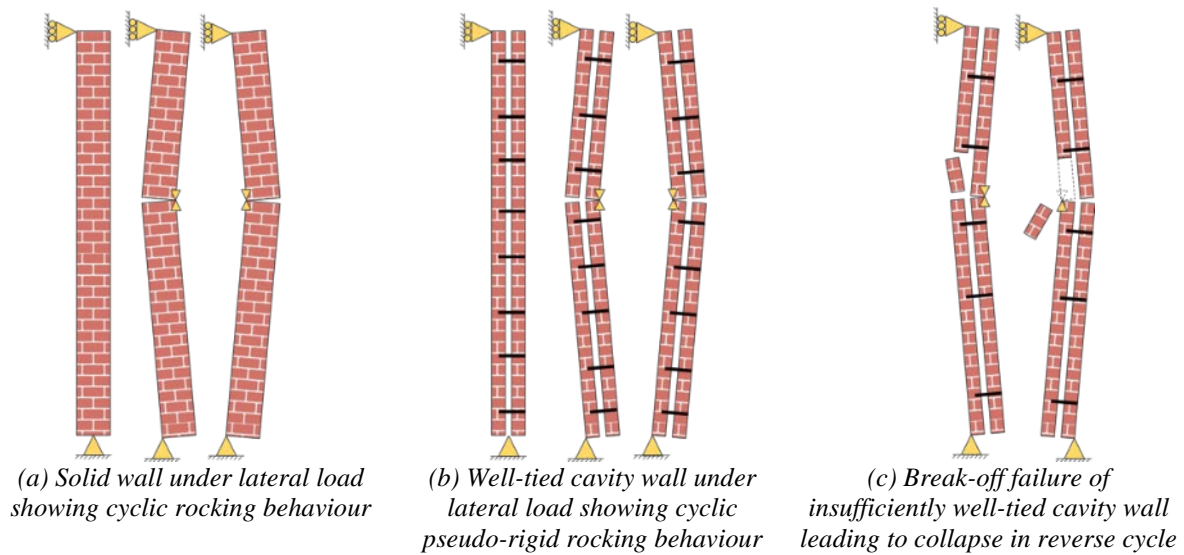
Figure 8: Schematic drawings of rocking behaviour and failures

By observation, the lower blocks of cracked walls did not exhibit classical rocking behaviour in the manner illustrated in Figure 8b. The wall bases tended to stay level, except under extreme lateral displacements. Cracking occurred a few courses above the base at moderate displacements, but classical rocking occurred at higher displacements and above the first few courses. The upper and lower wall sections demonstrated the self-centring behaviour encoded in the rocking model, and so the practical difference between pure rocking and the observed behaviour is small.

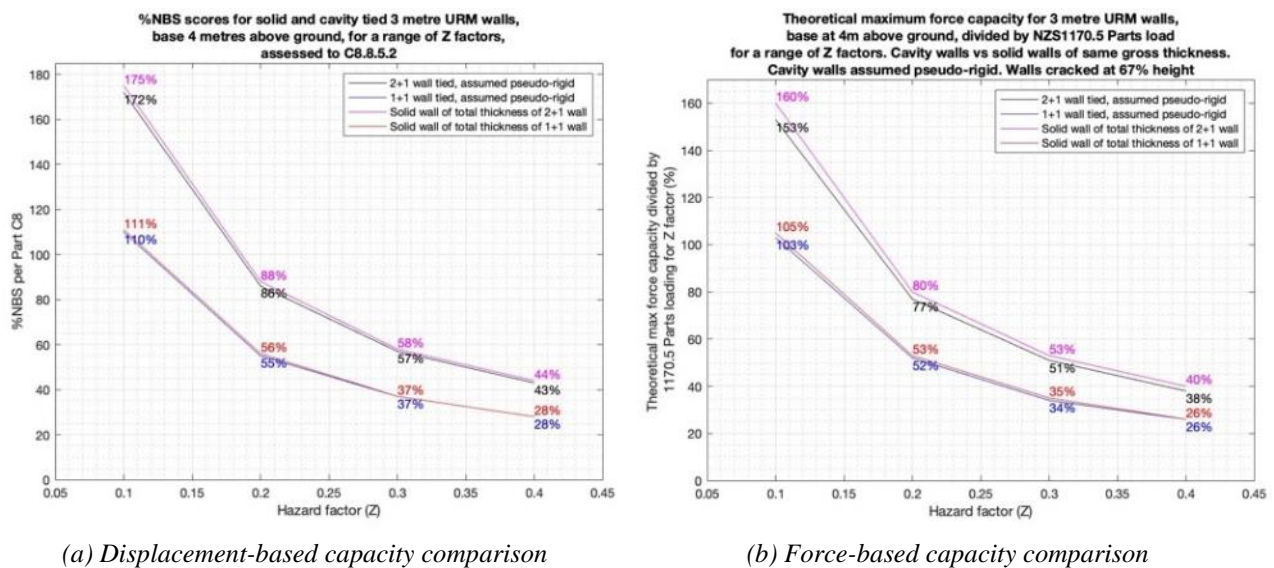
Figure 9: Comparison of calculated capacity of solid walls vs well-tied cavity walls

Walsh (2015a, 2015b) and others have provided calculations for determining the capacity of individual ties, on the basis of multiple potential tie failure modes, and have also offered equations to describe the effective thickness of cavity walls relative to solid ones. However, if walls are well-tied, tie failure modes are irrelevant in the assessment of wall capacity. Testing and calculations have demonstrated that axially-directed tie failure modes like pull-out and buckling are sufficiently far up the failure hierarchy that they are extremely unlikely to occur. For rocking to be sustained, flexure is the critical tie failure mode. The critical loading case for flexure is at the initiation of uplift, when the maximum proportion of weight force is directed perpendicular to the ties' central axis (see Figures 8b and 10a). The magnitude of this demand is related to the geometry of the wall, not to the out-of-plane load applied to the wall. Significant lateral loading will cause uplift of the outer leaf above the mid-height crack and thus will impose maximum demand upon the ties. Thus, the number of ties required for any predicted out-of-plane load is the number of ties required to allow rocking to occur through uplift of the outer leaf.

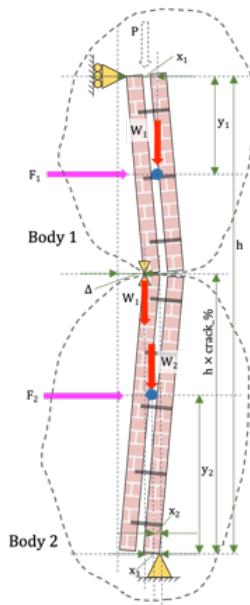
Figure 10: Force-based analysis of well-tied cavity walls

(a) Force-based model of wall system

A simplified model of wall behaviour from a force-based perspective is presented in Figure 10a. In the model, the wall cracks into two bodies, which rock cyclically, one atop the other. The model assumes that maximum lateral load capacity occurs at first displacement, when the lever arms are longest between the weight forces in the wall and the pivots. Based on this assumption, a theoretical maximum out-of-plane load capacity for the cavity walls can be calculated. When this theoretical maximum is compared to loads generated by the New Zealand Loadings Standard, a force/capacity ratio can be found which is analogous to the %NBS score generated in the displacement realm. Comparing theoretical capacity/demand ratios of solid walls and cavity walls, analysis shows that they are predicted to perform very similarly, supporting the proposition that if cavity walls are well-tied they can be assessed as solid walls of the same gross thickness (see Figure 9b). When these theoretical loads are compared to experimental results, there is good agreement, with theoretical loads appearing somewhat conservative (see Figure 10b).

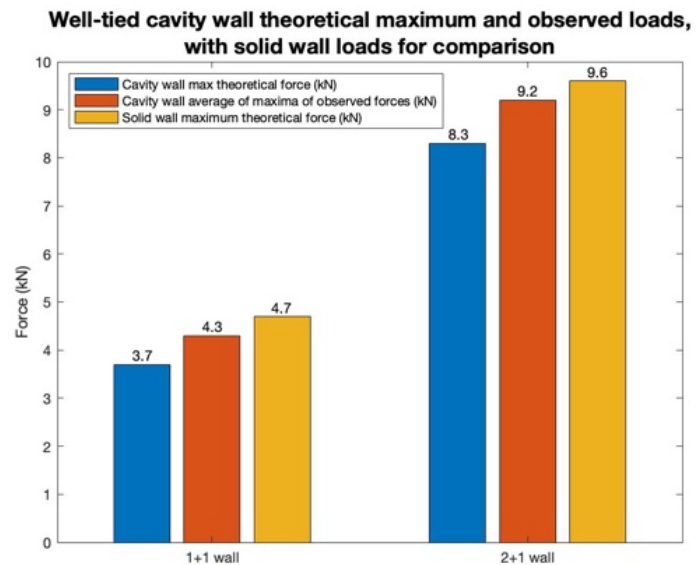
(b) Comparison between theoretical loads and observed loads
