# **Flat-based wine tank buckling predictions using NZSEE recommendations and 2016 Kaikōura earthquake damage observations**

## **Abstract**

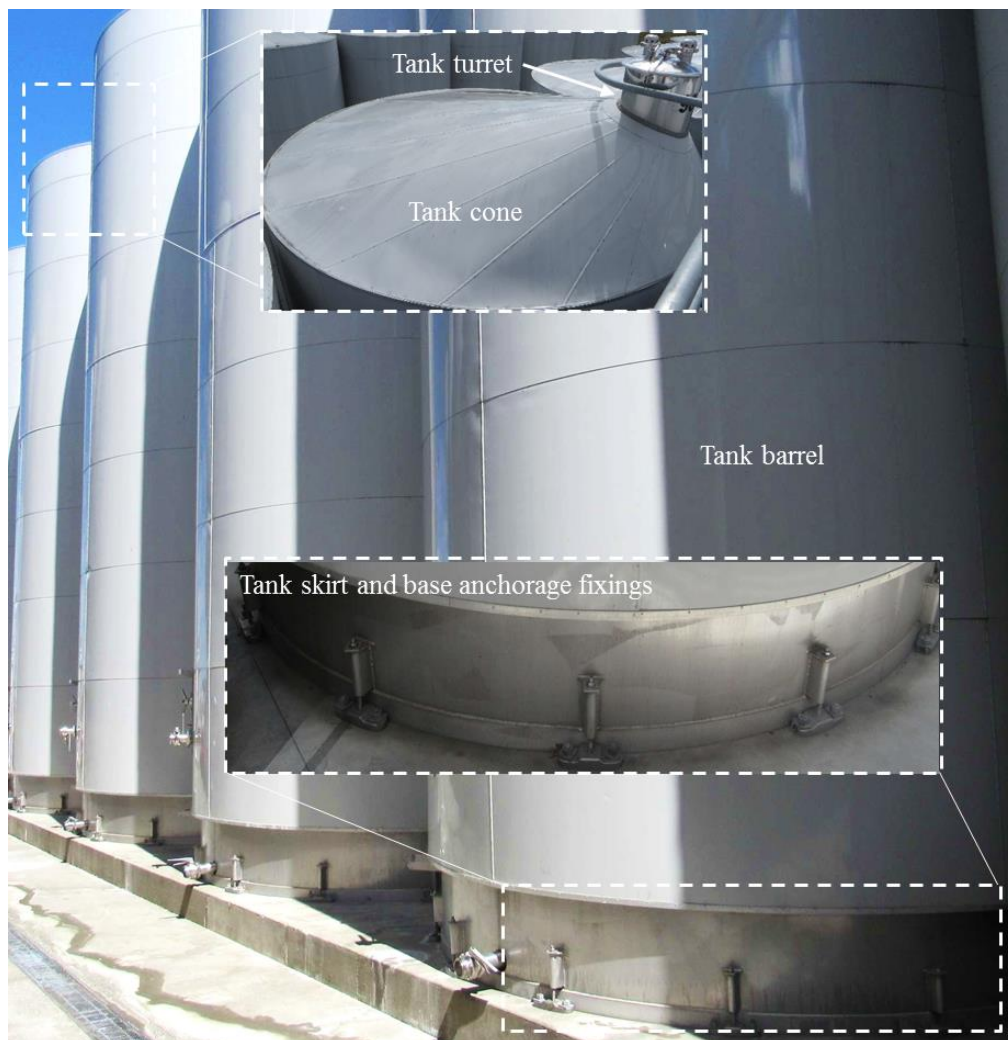
*Figure 1. Different parts of typical flat-based wine tanks*

Wine tanks are typically composed of different parts, including the barrel, top cone, turret and skirt (see Figure 1). Examples of elephant-foot buckling and diamond shaped buckling to three of the tanks in a Marlborough region winery following the 2016 Kaikōura earthquake are shown in Figure 2. Tank #1 (see Figure 2) sustained both elephant-foot and diamond shaped buckling, with elephant-foot buckling as observed in Tank #1 and shown in Figure 2 likely being due to variations in tank wall thickness up the tank height. Wine tanks may be insulated, and in some cases the exterior insulation of tanks may prevent direct visual inspection of tank wall buckling such that an interior tank inspection is required (see Figure 3). Skirt elephant-foot buckling is similar to elephant-foot buckling in barrels and typically occurs above the anchorage system (see Figure 4).

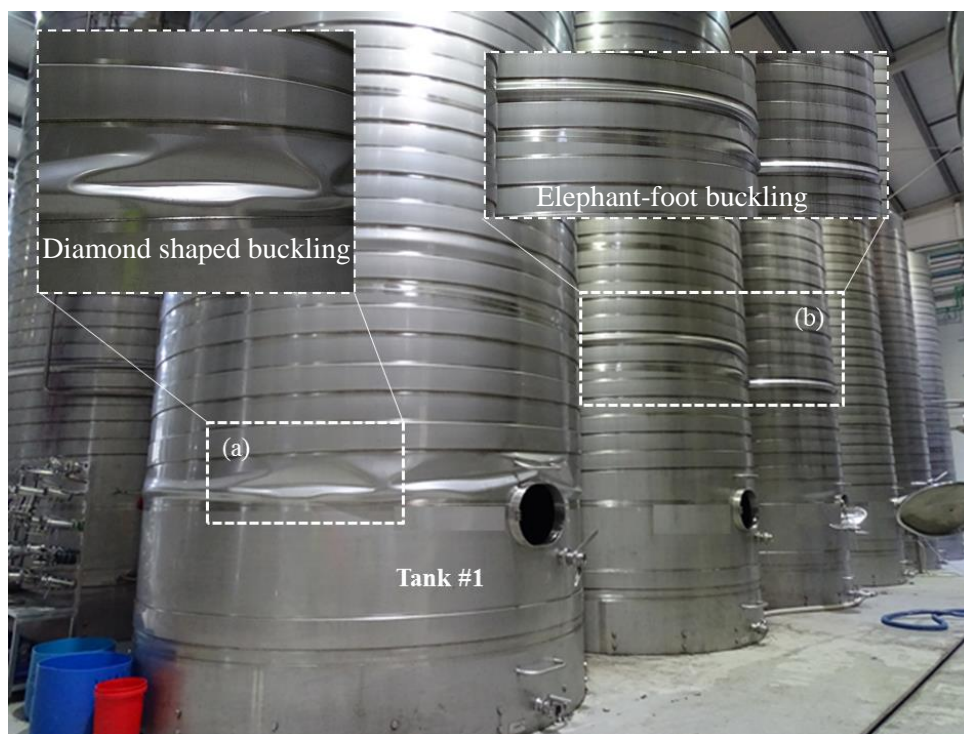
Figure 2. Example of buckling in flat-based tanks (capacity of 100 kL): (a) diamond shaped buckling; (b) elephant-foot buckling

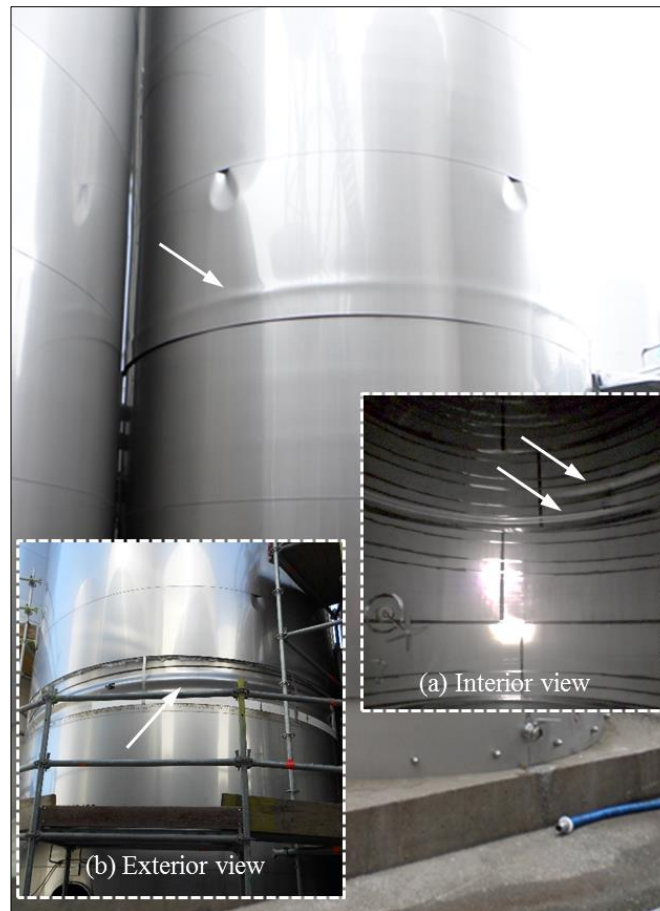
Figure 6. The case study tank (240 kL) showing elephant-foot buckling (indicated with arrows) following the 2016 Kaikōura earthquake. (a) Interior view of the tanks showing elephant-foot buckling, (b) Exterior view showing the extent of buckling when the external insulation layer was removed.

A prototypical cylindrical closed-top wine tank was selected as a case study to investigate the effects of various parameters on the tank design and its seismic performance. The case study tank was in operation prior to the 2016 Kaikōura earthquake (the exact construction date of the case study tank is unknown). General geometrical and material properties of the case study tanks are reported in Table 1. During the 2016 Kaikōura earthquake the case study tank sustained severe elephant-foot buckling (see Figure 6) and was later retrofitted using new energy dissipation devices, with the buckled parts of barrel sections being replaced with new shell courses. The exterior view of the tank in Figure 6.b shows the extent of retrofitting works undertaken for the
