In-plane Testing of URM Wall Panels Retrofitted Using Timber strong-backs

Uchenna J. Maduh, Devina Shedde, Jason Ingham and Dmytro Dizhur

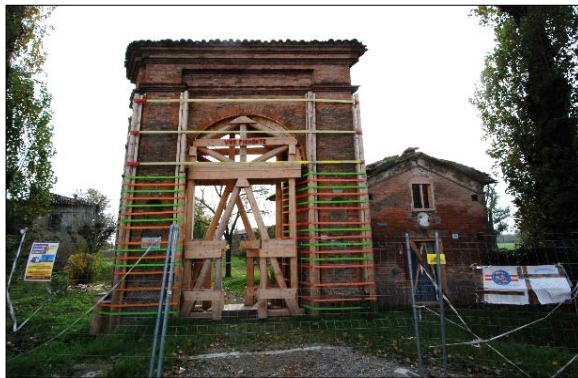
(a) Use of ratchet ties to secure damaged masonry arch, Cavezzo

attempts for two walls were performed and also entailed two methods: (1) timber strong-backs and (2) ratchet tie-down straps (see Fig. 1). The testing apparatus, procedure and results are reported herein.

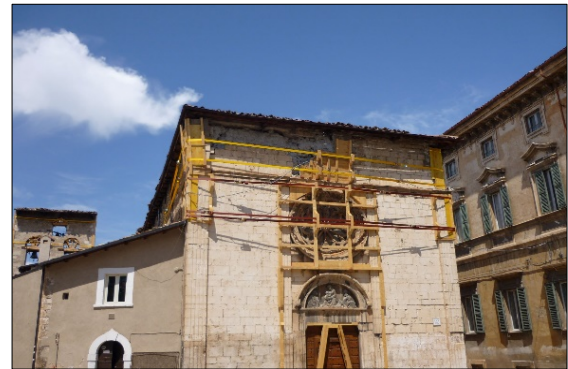
(b) Use of timber elements and ratchet ties to secure damaged masonry, L'Aquila Santa Maria di Roio

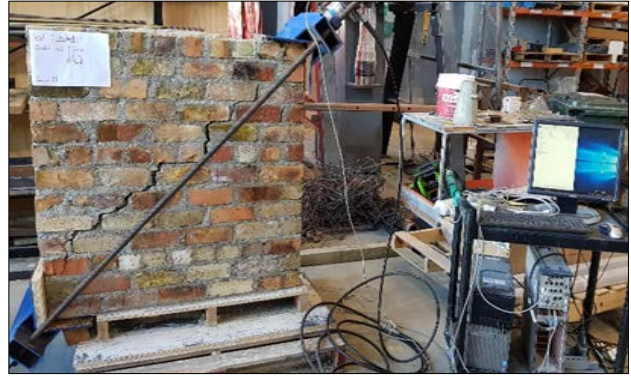
Figure 4: Test set up

Although testing was undertaken as per ASTM methodology (ASTM, 2007), the testing procedure was altered by performing a 45° rotation of the loading mechanism as opposed to a rotation of the walls. This modification was easily implemented and was performed in order to prevent the risk of crack development which would have an increased potential under rotational manoeuvring of the walls. The installation of the load mechanism involved the placement of two loading shoes at the diagonally opposite corners of the wall (see Fig. 4), which had dimensions of approximately 230 mm length and 350 mm width. The URM walls were initially cantilevered on one side at 230 mm to allow for the placement of one shoe on the bottom corner of the wall. The two loading shoes were connected on both sides of the walls using a high tensile steel rod of 30 mm diameter, which was thus oriented diagonally along the wall. A 300 kN hydraulic actuator positioned between the load cell and the loading plate exerted tension forces on the two steel rods as load was applied, causing the loading shoe located diagonally opposite at the bottom of the wall to exert a compressive force. Load was applied at a uniform rate via a 300 kN hydraulic actuator until an approximate load reduction of 20% in conjunction with visible displacement was observed, thereby indicating failure had occurred. Finally, displacements observed from the two potentiometers attached to the wall were recorded.

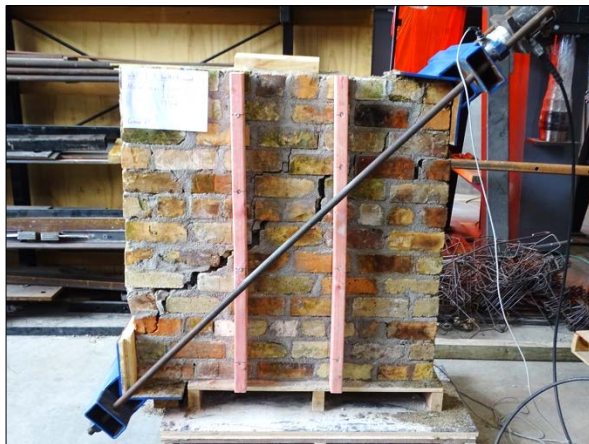
(a) Wall W1-R response showing timber strong-back deformation

transfer between the timber strong-backs and the unreinforced masonry wall. The existing cracks also grew in size during loading, and the timber strong-backs underwent deformation (see Fig. 6a).

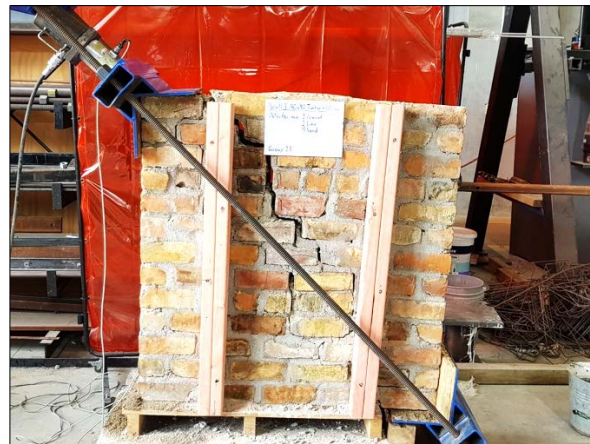
(b) W3 response showing rigid response of double timber strong-backs

Wall W3 exhibited two diagonal cracks that ran parallel to the line of action of the applied load (see Fig. 5e). The amount of cracking significantly increased as the applied load increased which was attributed to the double timber strong-backs inducing greater wall rigidity, and it was observed to concentrate around the Ø-8 mm screw ties connecting the strong-backs to the wall (see Fig. 6c). The double timber strong-backs remained rigid throughout the test compared to the single member strong-backs in wall W1-R (see Fig. 6b). Due to the restriction of lateral displacement, the wall gradually lifted at its unrestrained corner as it attained shear stress capacity.

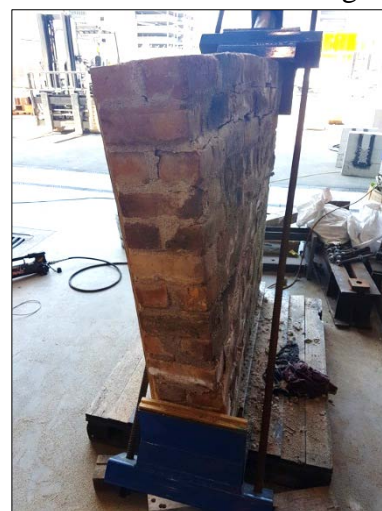
(d) Plywood retrofitted W4 response showing induced torsional effect at unrestrained corner

The plywood retrofit wall W4 developed the largest proportion of cracks which ran in the diagonal loading direction (see Fig. 5f). Due to an increased shear transfer, the ultimate shear stress of the wall contributed to the development of the diagonal crack. Toe crushing was observed at the lower corner of the wall where the bond between mortar and brick was lost. There was also a torsional effect at the unrestrained upper corner of the wall (see Fig. 6d) which was due to a pulling force that buckled the plywood, promoting shear sliding and the formation of a diagonal shear crack.
