Pull out capacity of chemical and mechanical anchors in clay masonry under quasi-static, cyclic and impact loading

Burton, C.¹, Vaculik, J.^{1,2}, Visintin, P.^{1,2}, Griffith, M.^{1,2}, Sheikh, A.^{1,2}

1. School of Civil, Environmental and Mining Engineering, The University of Adelaide
2. Bushfire and Natural Hazards Cooperative Research Centre

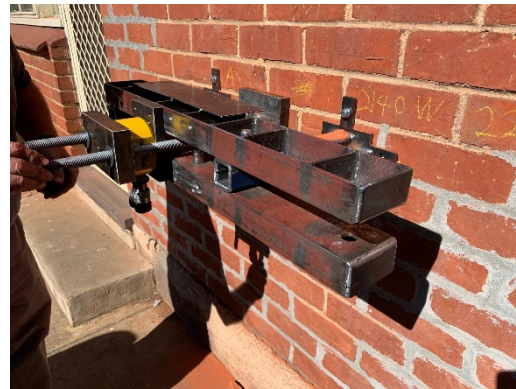
Figure 2 - Anchor pull out test

(b) Test apparatus

The testing rig is similar to that of the anchor pulling frame shown in Figure 2 with the actual test rig shown in Figure 4. This test is to determine the shear capacity of the brick/mortar interface, eliminating interaction with the masonry units. The close spacing of the base plates of the puller frame minimises any bending effects. It is being trialled as an alternative to the in-plane shear test.

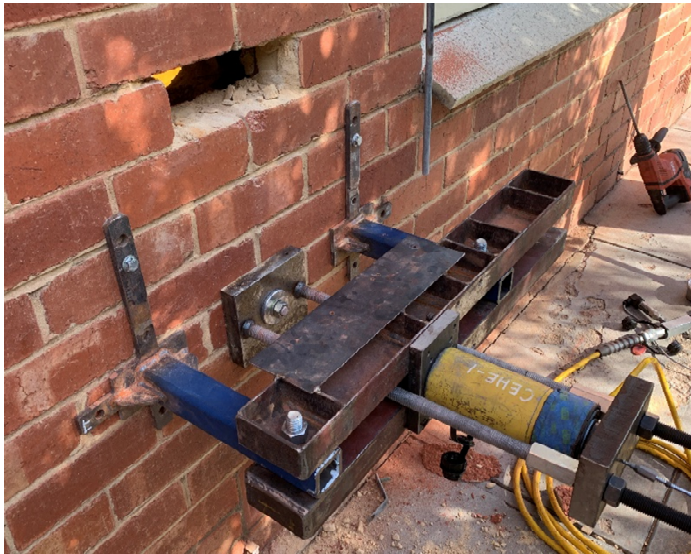
Figure 4 - Brick pull out test

3.3 Brick “pull out” – this “quasi static” test is intended to extract a single masonry unit “squarely” from the masonry. A heavy steel plate with dimensions approximating those of the masonry unit is mounted on a through bolt onto the back of the wall and hydraulically pulled out of the

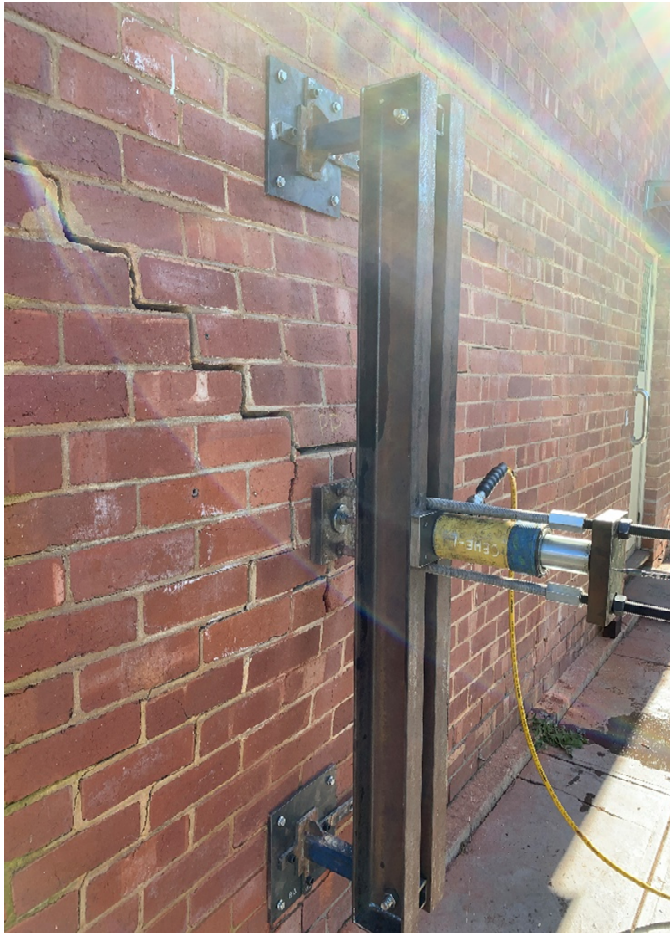
Figure 9 - Punching shear test in progress

One of the difficulties that we have experienced in this test is that there is not necessarily adequate bending strength in the masonry to achieve a punching shear failure. Figure 9 shows one of the tests on the South Road house where the wall deflection was close to 80mm out of plane with two way bending cracking evident, but no shear failure.
