Using simplified indices to forecast the seismic vulnerability of New Zealand unreinforced masonry churches

Jason M. Ingham¹, Paulo B. Lourenço², João Leite³, Saahil Castelino⁴ and Edlyn Colaco⁵

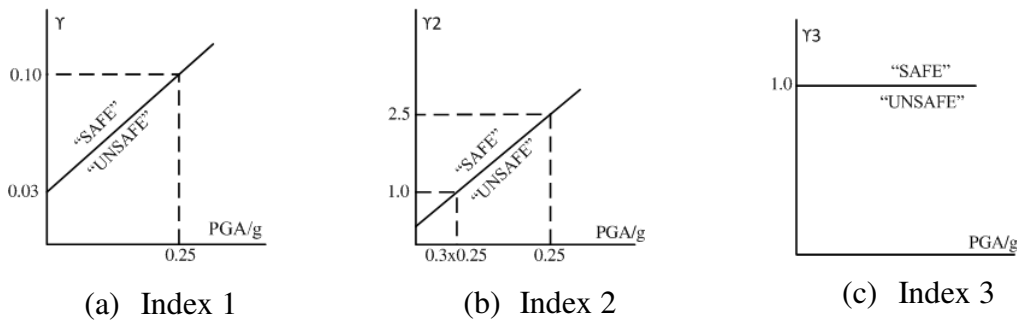
Figure 1. Assumed thresholds for indices 1, 2 and 3 as a function of PGA/g

For indices 1 and 2, the seismicity is taken into account by considering that the threshold value given above is valid for a PGA/g value of 0.25 and assuming a linear variation with PGA/g, as illustrated in Figure 1. Conversely, Index 3 should be constant in different seismic zones, as the effect of seismicity is incorporated. This index format is close to the traditional safety approach adopted for structural design, with a threshold value equal to 1 (see Figure 1).

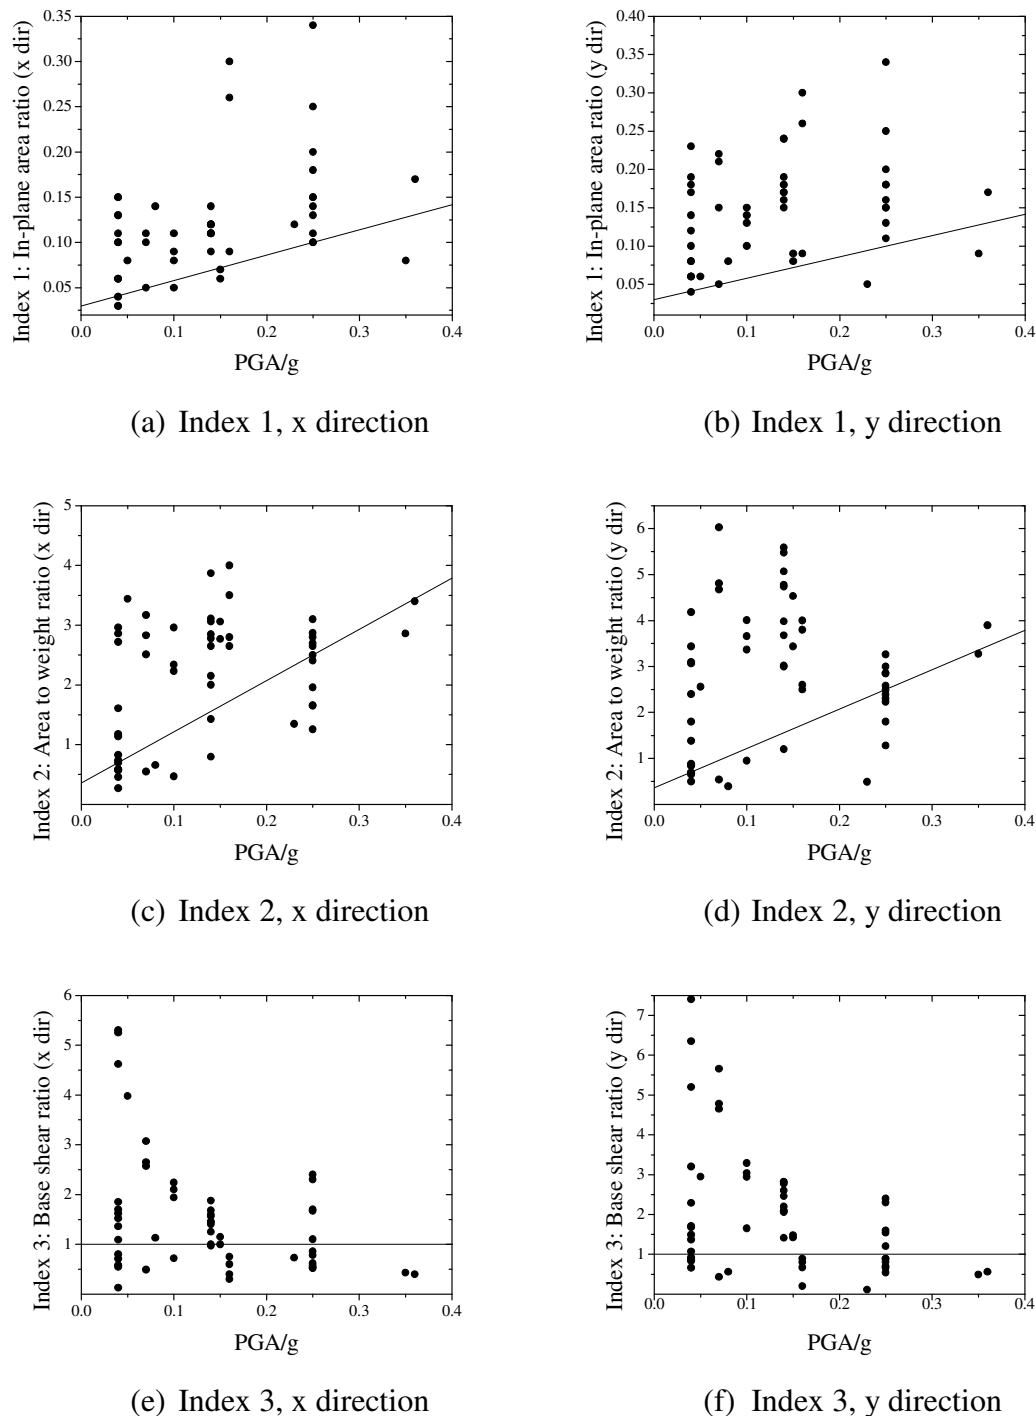
Figure 2. Relationship between in-plane indices and PGA/g for 44 European URM churches

From Figure 2 it is found that Index 1 average values are lower (less safe) in the transversal (x) direction of the church nave, which is expected due to church geometry, although Italian indices were found to be similar in both directions. Index 1 data do not exhibit a clear variation with seismicity, even if the Index value tends to grow roughly with increasing seismicity. It was found that 25% of the churches violated the proposed threshold in the x direction and that 9% violated the threshold in the y direction. This finding suggests that the cases that may merit further investigation are those churches demonstrating deficient earthquake resistance along the transversal direction of the church nave.

Index 2, although being inversely proportional to building height, presents a situation similar to Index 1. Again, the calculated values shown in Figure 2 do not exhibit a visible trend with respect to seismicity, although there is a tendency associated with an increase in Index 2 with increasing PGA. On average, Index 2 data present lower values in the x direction, again justified by typical church geometry. Consequently, this index is violated by 39% and 30% of the churches in x and y directions, respectively. This index is mainly violated by Spanish churches.

Index 3 data show an alarming decreasing variation with the PGA parameter. For moderate and high seismicity areas (PGA greater than 0.15g), Index 3 is violated by the majority of churches, in both directions. For low seismicity areas, Index 3 is also not entirely fulfilled. Individually, 41% and 32% of the churches in the x and y directions respectively violate the Index 3 threshold, which denotes a deficient earthquake resistance along both the transversal and longitudinal directions. This index is mainly violated by Italian churches.

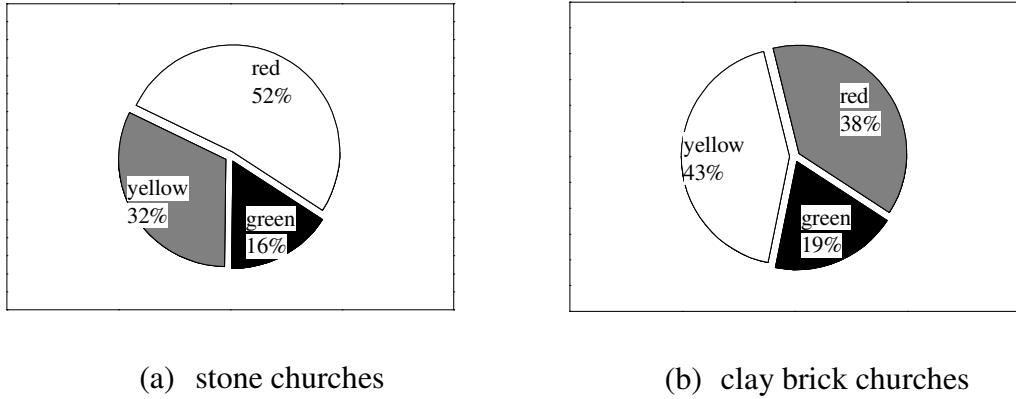
Figure 3. Placard classification for assessed URM churches following the Canterbury earthquakes

A comprehensive statistical analysis of the performance of churches in the Canterbury earthquakes is reported by Leite et al. (2012), including the in situ damage observed, the structural assessment classification assigned by the local authorities and a comparison with the structural classification used in Italy, where a specific survey form for churches is used. For stone URM churches, more than half of the churches (52%) were assigned a red placard and only 16% of the churches had a green placard assigned (see Figure 3(a)). Figure 3(b) shows that a red placard was assigned to 38% of the clay brick URM churches, while a yellow placard was assigned to 42% of those churches. The percentage of red placards assigned for the clay brick typology was smaller than the percentage assigned for the stone churches, but the sum of the red and yellow placards was similar for both masonry typologies and exceeded 80%.

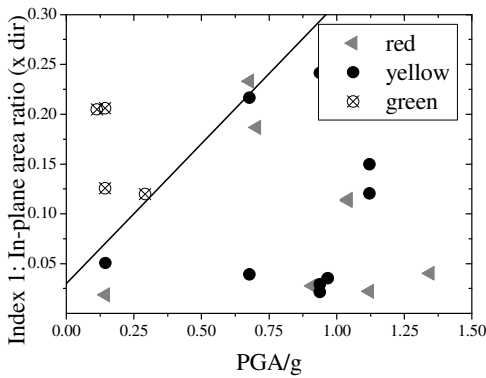
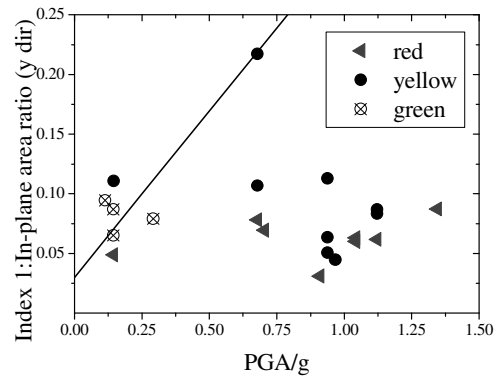
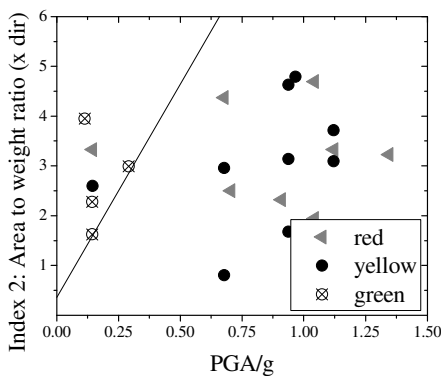
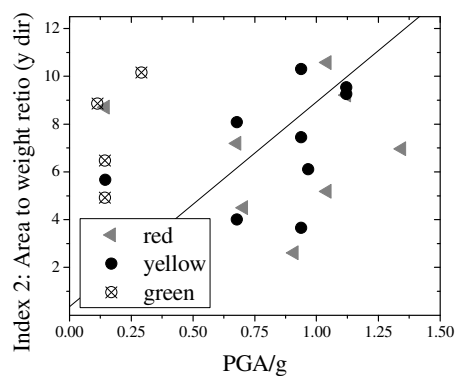
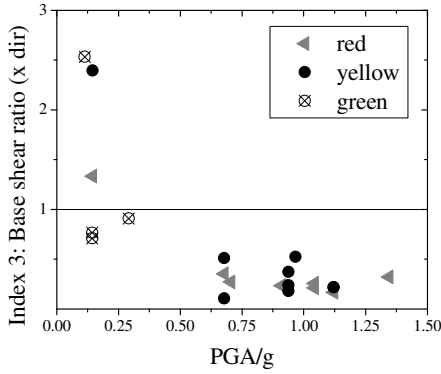
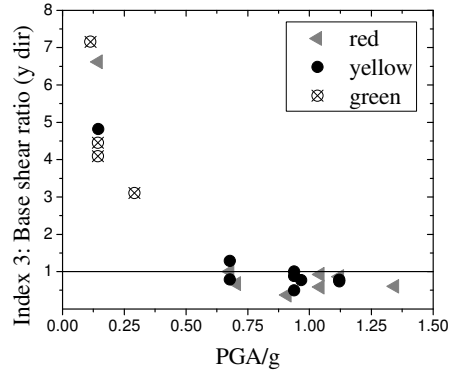
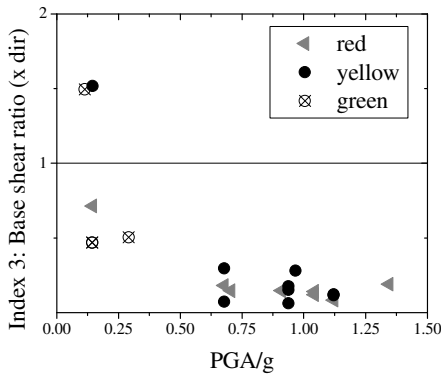
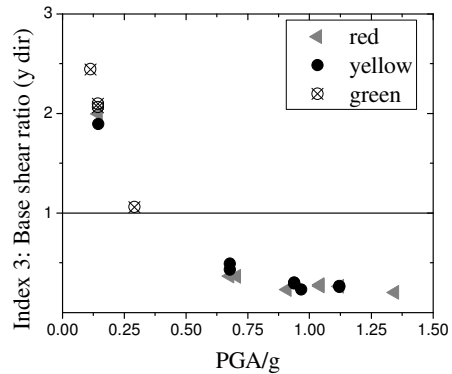
Figure 4. Indices for clay brick URM churches in the Canterbury earthquakes

The indices related to the above mentioned simplified method of analysis were computed for all the stone and clay brick URM churches that were surveyed following the Canterbury earthquakes. Figure 4 presents the scatter plots of each index and the horizontal PGA of the 22 February 2011 event interpolated at each site for clay brick URM churches, as well as the proposed thresholds from Figure 1. The threshold for Index 1 is excellent, with all the green tagged churches falling above or near the line and one yellow and one red church incorrectly identified. The yellow tagged church had only minor cracking with the exception of a large shear crack on one longitudinal wall of the main nave. The red tagged church was also a particular case, as it had pinnacles overhanging from the transversal walls. The thresholds for Index 2 and Index 3 also have acceptable results. The x (transverse) direction provides better results for all three indices, and this is the critical direction. Index 3 exhibits the worse correlation if cohesion is taken into consideration, with better results obtained for zero cohesion.

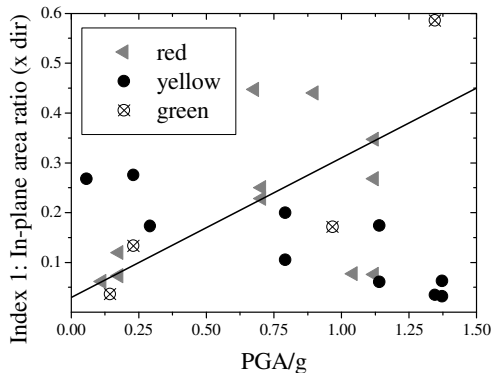
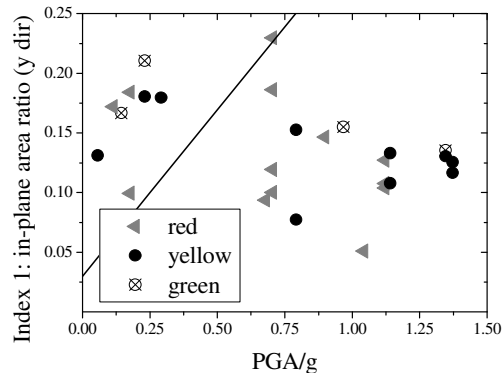
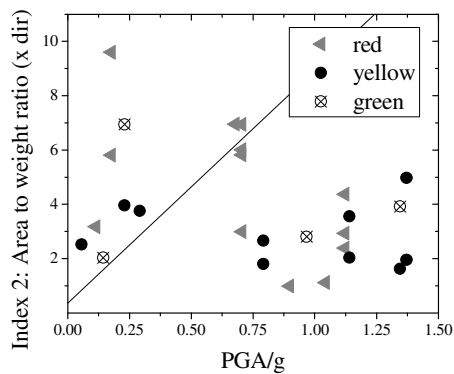
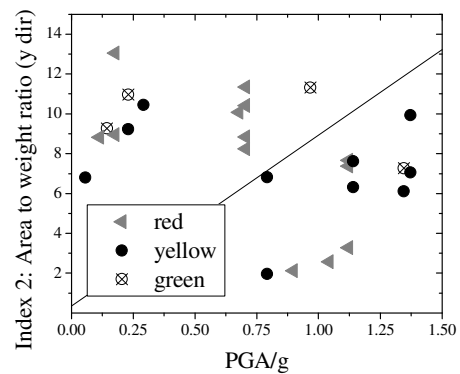
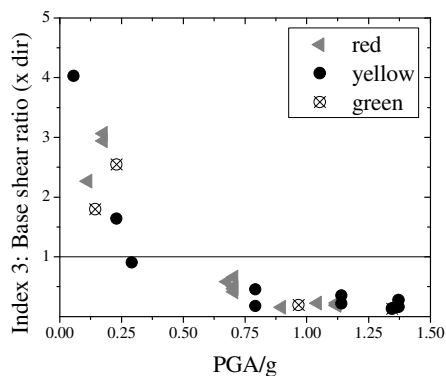
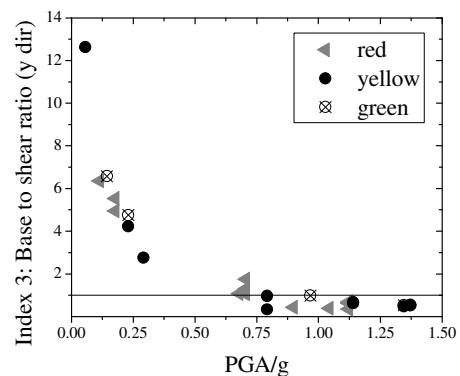
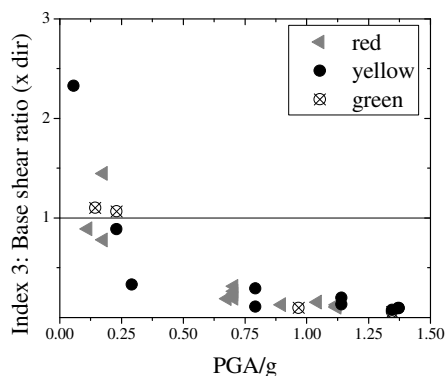
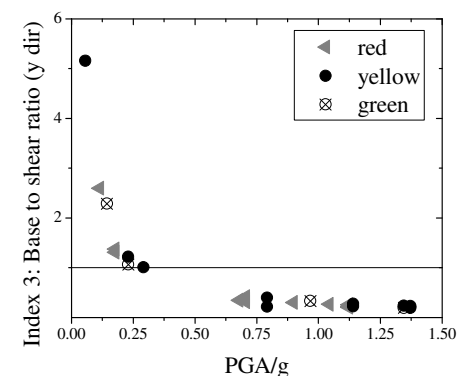
Figure 5. Indices for stone URM churches in the Canterbury earthquakes

The thresholds for the stone URM churches are not as good as those for the clay brick URM churches (see Figure 5). For all indices in both directions, there are green tagged churches that lie under the threshold, and red tagged churches that lie above the threshold. The lack of homogeneity of the stone URM churches justifies the lack of agreement with the thresholds, as the seismic behavior of these churches is rather different. Monumental good quality stone URM churches can present a seismic behavior similar to clay brick URM churches, while weak rubble stone URM masonry lacks interlocking and disaggregates, even for low PGA values, suggesting that it could be helpful to consider sub-sets of typologies for this class of church. Also, the data merits revisiting to establish if any of the stone URM churches had received prior seismic improvements. As for the clay brick URM churches, there is a better agreement with the threshold of Index 3 if cohesion is not taken into consideration.

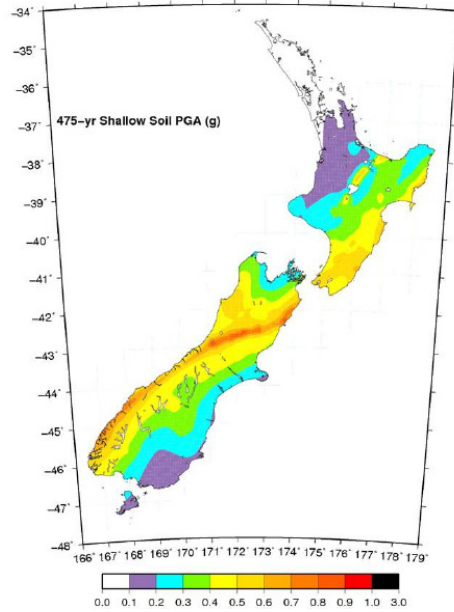
Figure 6. PGA/g values for a 500 year return period earthquake (from Stirling et al. (2012))

development of the city was somewhat comparable to that of Christchurch, with an expectation that the stock of URM churches in Dunedin was analogous to that of Christchurch. 29 URM churches were inspected in Dunedin. Christophersen et al. (2011) report that for a 500 year return period, the 2010 New Zealand National Seismic Hazard Model (2010 NSHM) results in values of PGA/g of 0.540 for Wellington and of 0.192 for Dunedin. The PGA data is also shown in Figure 6.

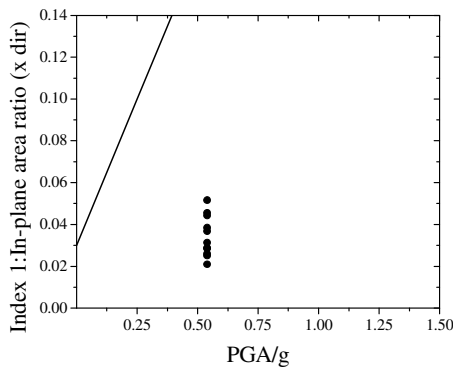
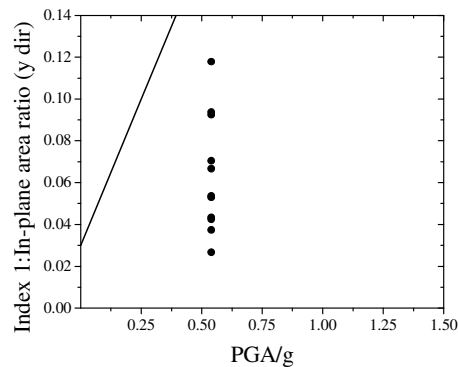
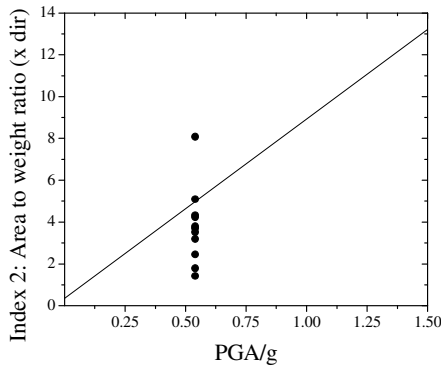
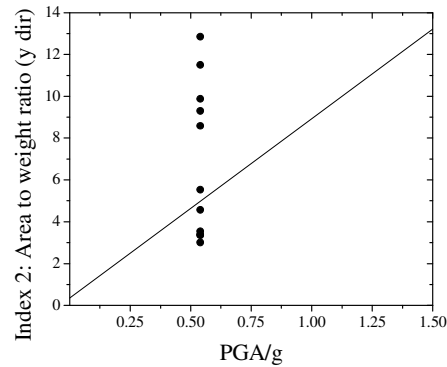
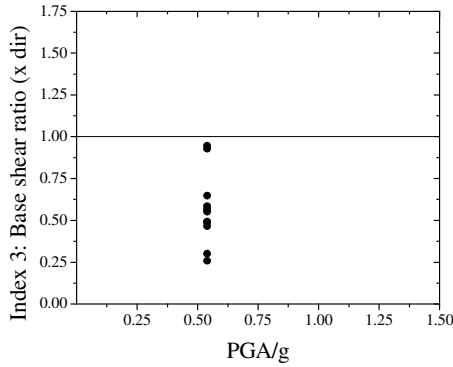
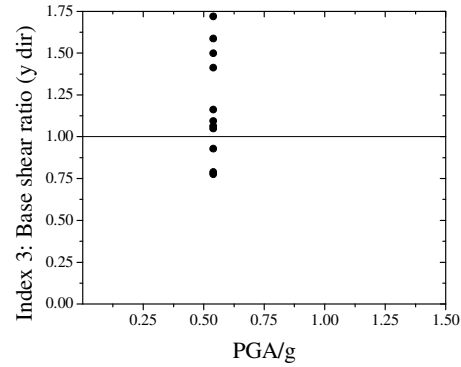
Figure 7. Indices for URM churches in Wellington

From Figure 7 it may be established that all URM churches in Wellington failed Index 1, for both loading directions. This outcome is largely a result of the high PGA for the region. For Index 2 82% (9 of 11) of Wellington URM churches failed in the x (transversal) direction and 45% (5 of 11) failed in the y (longitudinal direction). For Index 3 100% and 73% (8 of 11) failed in the x and y directions respectively. From this data it is evident that most Wellington URM churches can be expected to perform poorly in a design level earthquake. Recognising that Wellington is a region of high seismicity, this finding is in general agreement with the damage reported to Christchurch URM churches as shown in Figure 3.

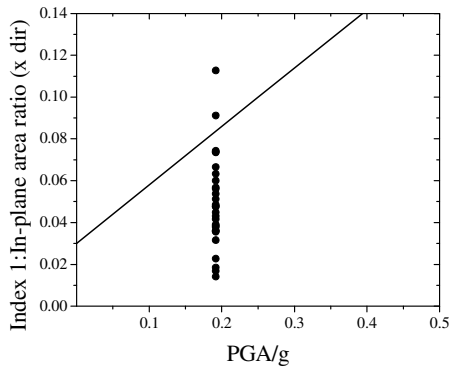
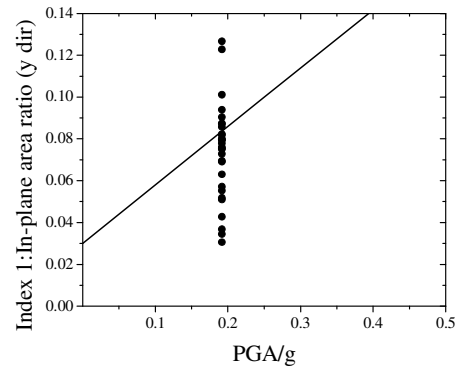
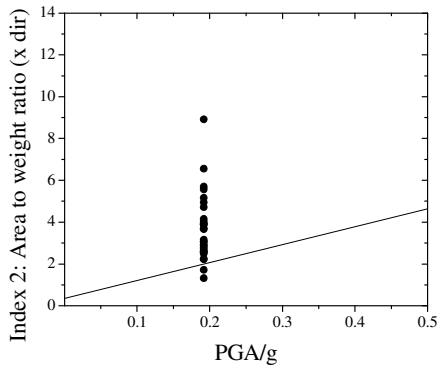
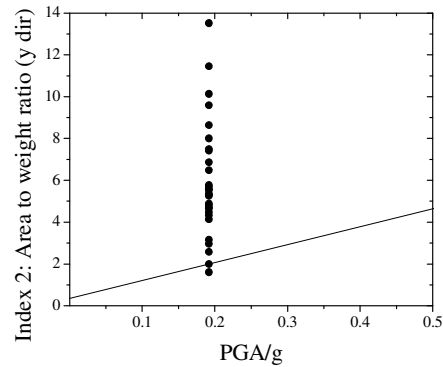
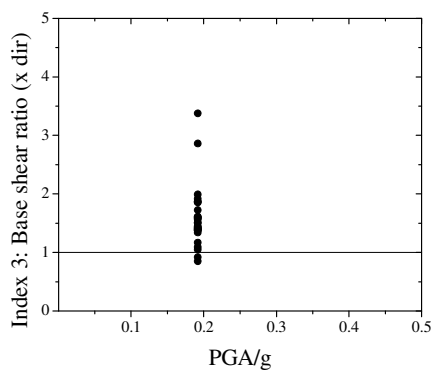
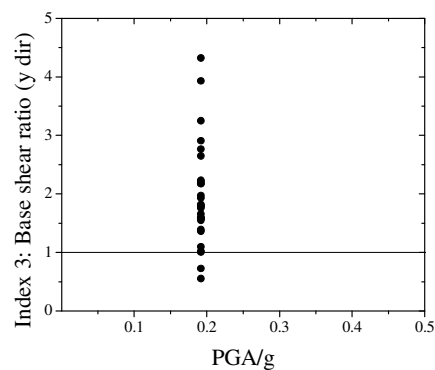
Figure 8. Indices for URM churches in Dunedin

From Figure 8 it is evident that 93% (27 of 29) of Dunedin URM churches fail Index 1 in the x direction and 72% (21 of 29) fail Index 1 in the y direction. However, this finding is in contrast with Index 2 where only 7% (2 of 29) fail in each of the two directions. For Index 3 only 7% (2 of 29) of Dunedin URM churches fail for each orientation. Overall the results from the Dunedin study are an excellent endorsement of the simplified index method, as the procedure has resulted in the identification of a small subset of URM churches that specifically merit priority attention for seismic improvement in a region that by New Zealand standards is of moderate/low seismicity. Images of the three churches that were identified using the simplified index method as most seismically vulnerable are shown in Figure 9.

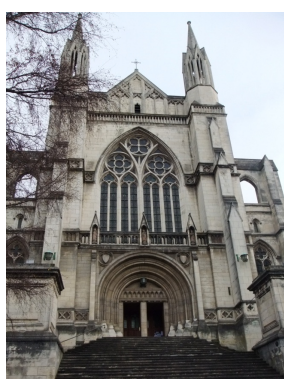
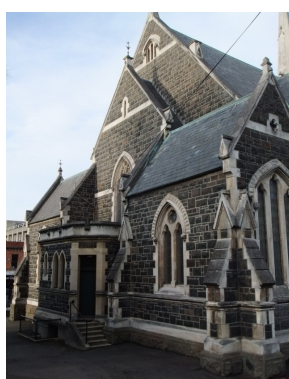
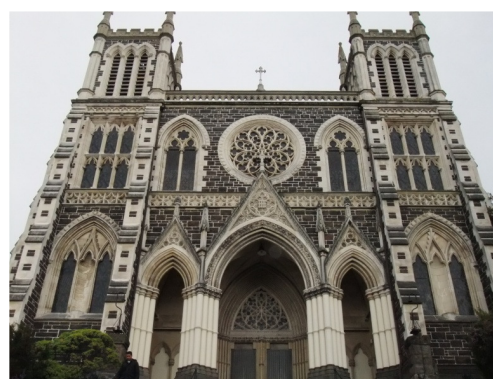
Figure 9. Three Dunedin URM churches that score poorly on all indices

(a) St Paul's Cathedral

(b) Knox Church

(c) St Joseph's Basilica
