Tsunami Effects along the Western Australian coastline

By Brian Gaull of *Guria Consulting*; PO Box A122 Australind, W.A. 6233

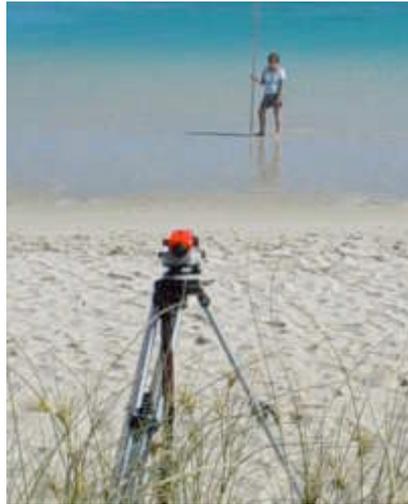
A digital photograph was taken at each levelling observation site. For consistency this photograph was taken from behind the levelling instrument showing the setup of the instrument on the tripod, the staff at the water’s edge and the surroundings, as seen in the example below.

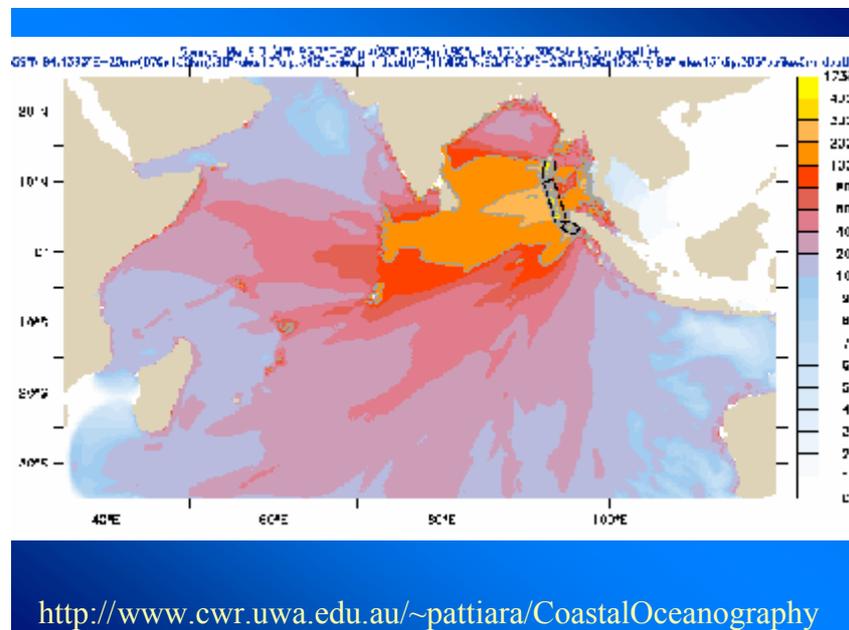
It is seen from the above slide (from Professor Pattiaratchi at UWA) that the greatest tsunami wave amplitudes was directed primarily to the east towards Banda Aceh in Sumatra (up to 35 m) and the west towards the sub-continent (up to 5-10 m). This bias can be explained by the focal mechanism and strike of the 1200 km submarine mega-thrust fault which was generated by the Mw 9.3 earthquake. Australia was fortunate not to be in the path of these large tsunamigenic amplitudes.

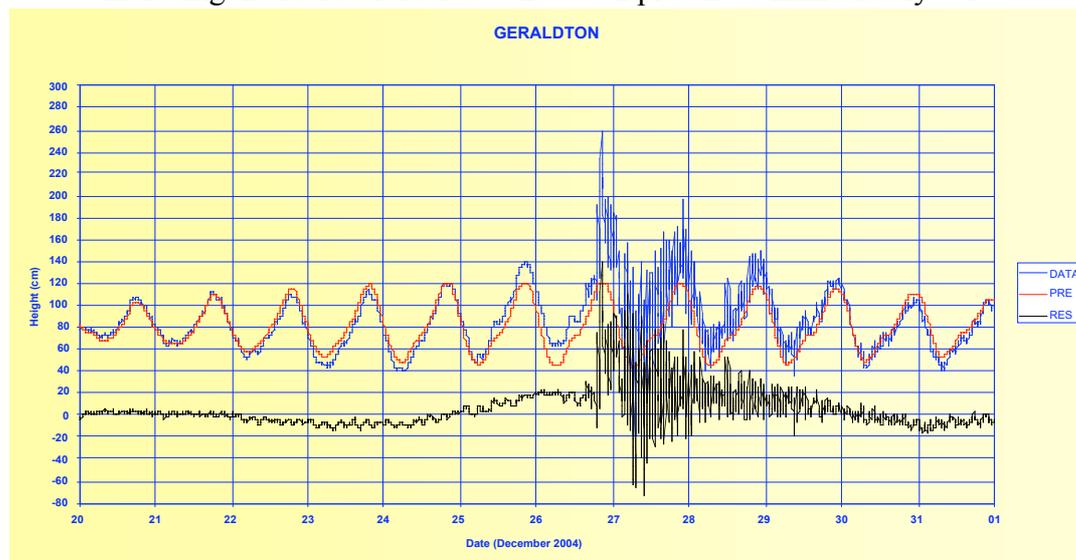
- 1) Tidal movements were visibly disturbed for several days at most gauges;
- 2) No significant effects could be seen at Wyndham and Broome;
- 3) Residual tidal effects from Pt Hedland to Carnarvon were of the order of half a metre, the smallest amplitudes seen were at Exmouth Gulf.
- 4) Geraldton was the standout with residual tidal amplitudes up to one and a half metres registered. This together with a peak tide in the evening of the 26/12/04 gave rise to a water level 0.6 metre greater than had hitherto been recorded. It was suggested by Matt Eliot (personal communication, 2005) that entrapment and resonance between the Abrolhos and the Central Coast of W.A. may have been the cause of these exceptional wave amplitudes. The full DPI chart data including the residual tidal data has been presented immediately below.

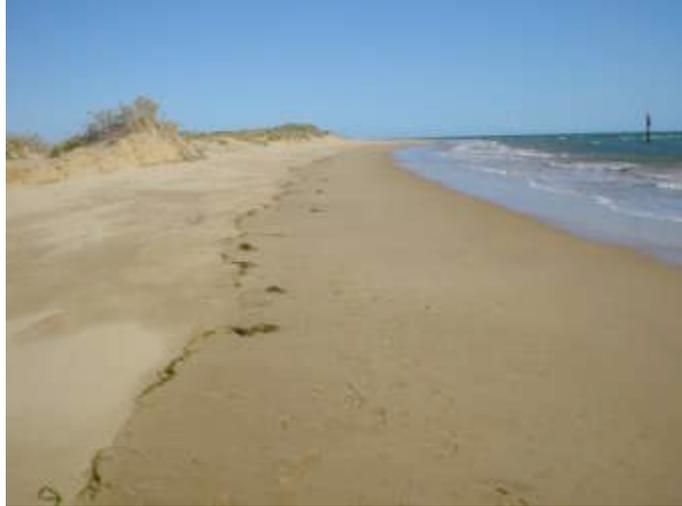
- 1) Credible anecdotal evidence suggests that the water from the tsunami crossed the isthmus at Pelican Point beach near Carnarvon (see photo below).

For this to take place, minimum water heights estimated were between 2.66 and 2.89 metres above MSL. This compares with a runup on the other side of the isthmus of the order of 0.5m, which is consistent with the tide gauge observations. It is thought that because the coastline at Pelican Point is unprotected and the sand spit (See marker on RHS of photograph above) may have directed the water towards the beach and in so doing the surge height was amplified.

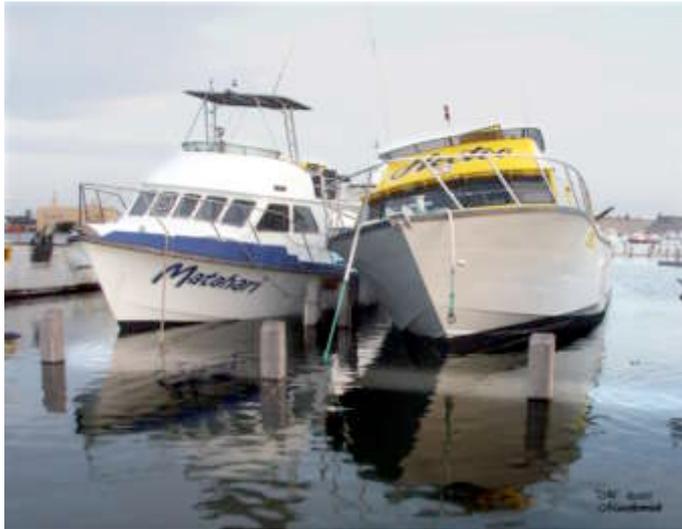
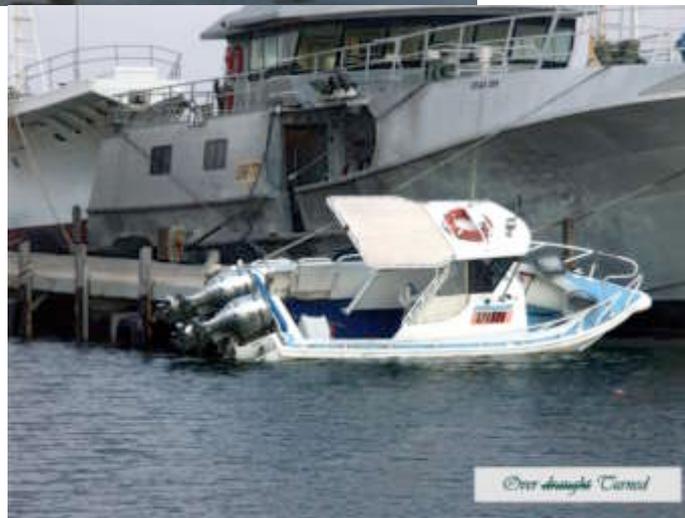
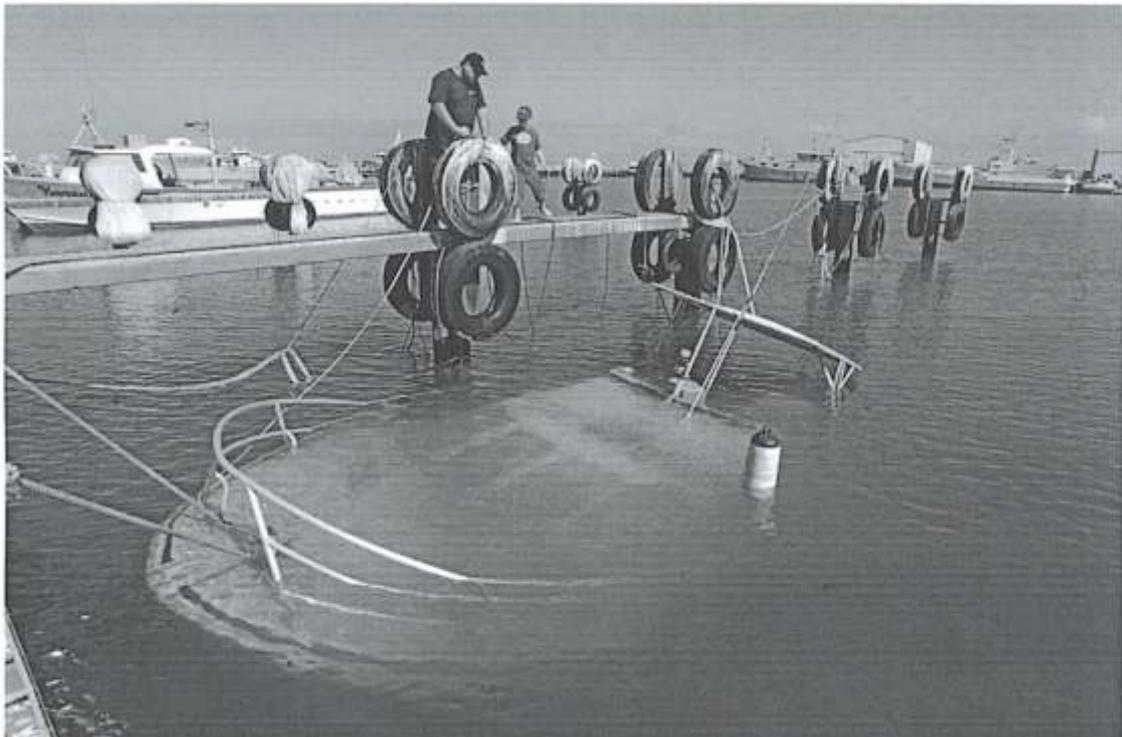
- 4) Anecdotal and photographic evidence showed that the (preliminary) corrected runup estimates at various places in Geraldton varied between about 1.0-2.0 metres. Considerable damage was incurred at the "Fisherman's wharf"; eg water inundated the local "fish-n-chip" shop to a reported 0.8 m and caused havoc for the boats tied to the wharf (see photographs on the next page).

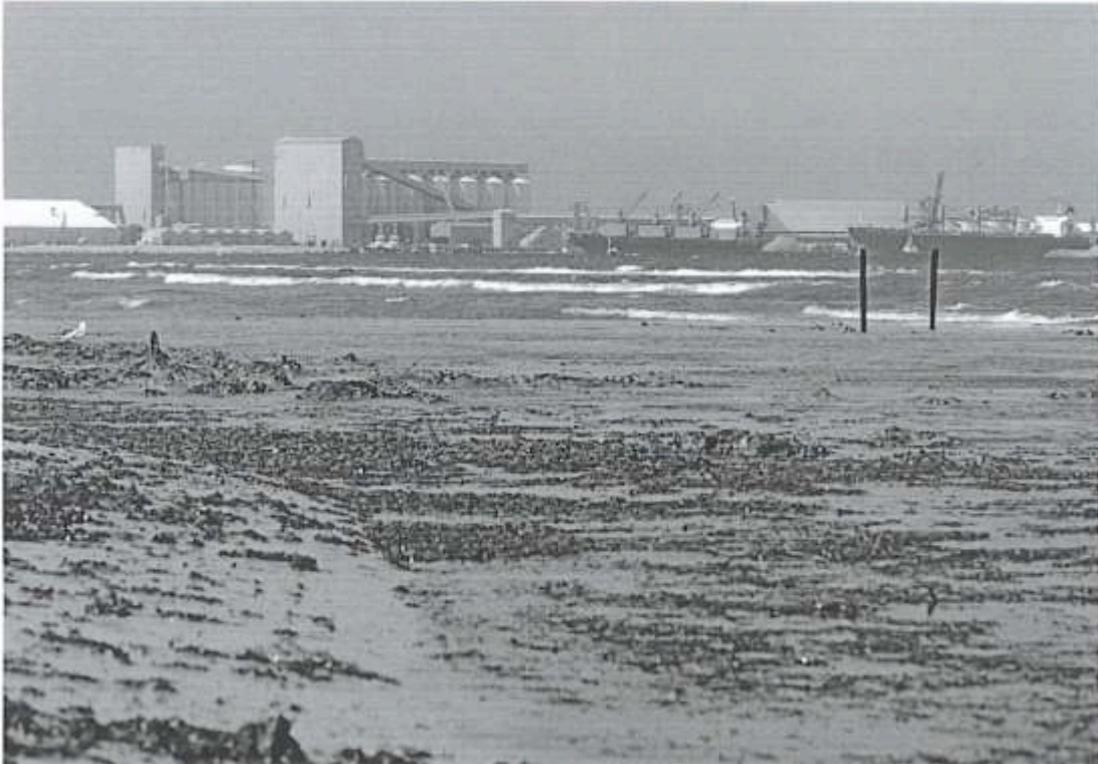
- 5) The newspaper photograph following the boat photos mentioned in point 4) above, was taken looking towards the main wharf in Geraldton and depicts perhaps the lowest tide experienced during the tsunami. On the 27/12/04 the tide receded to equal Geraldton's historical low tide (DPI staff, Fremantle).

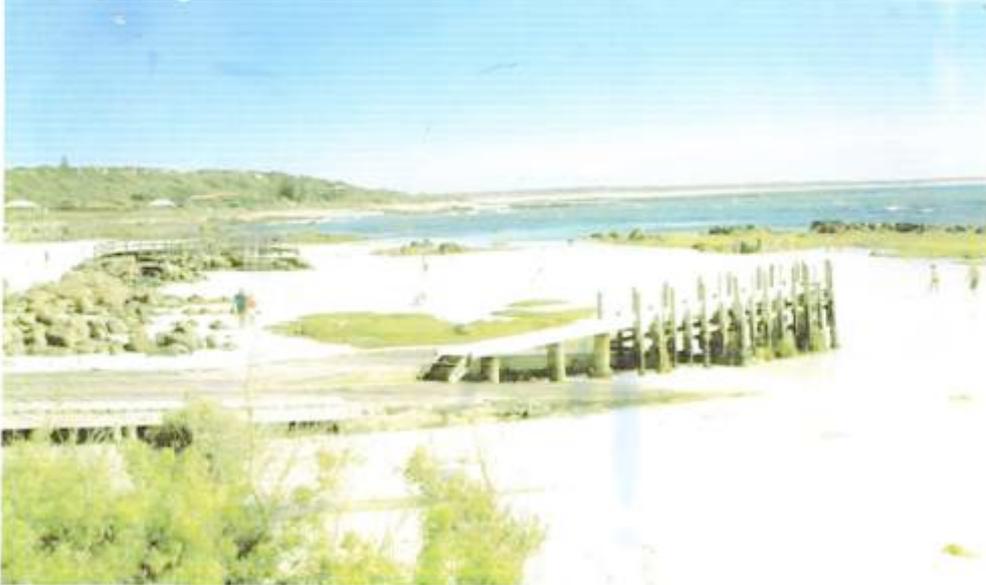
FLINDERS BAY — BOXING DAY 2004

- 10) The Flinders Bay boat ramp and jetty was left high and dry (see photo below), showing that extremes of tide were common along the west coast of Australia.
