Out-of-plane testing of seismically retrofitted URM walls using posttensioning

The out-of-plane flexural testing of two (02) full scale unreinforced masonry (URM) walls seismically retrofitted using post-tensioning is reported. The selected wall configuration was representative of a common out-of-plane URM wall, achieving a percentage new building standard (% NBS) of 57 when evaluated using the New Zealand Society for Earthquake Engineering (NZSEE) guidelines. The test walls imitated heritage New Zealand URM construction by using recycled clay brick masonry laid in common bond pattern, with one header course after every three stretcher courses, and ASTM type O mortar was used. A low level pre-compression was applied using a single mechanically restrained tendon inserted into a cavity at the centre of the walls. Threaded mild steel bar with a coupler system (with tensile yield strength of 500 MPa) and sheathed greased seven-wire strand (with tensile yield strength of 1300 MPa) were tensioned with an initial force of 50 kN and 100 kN respectively. Behaviour of the seismically retrofitted URM walls using posttensioning was compared to the response of a non-retrofitted URM wall, with

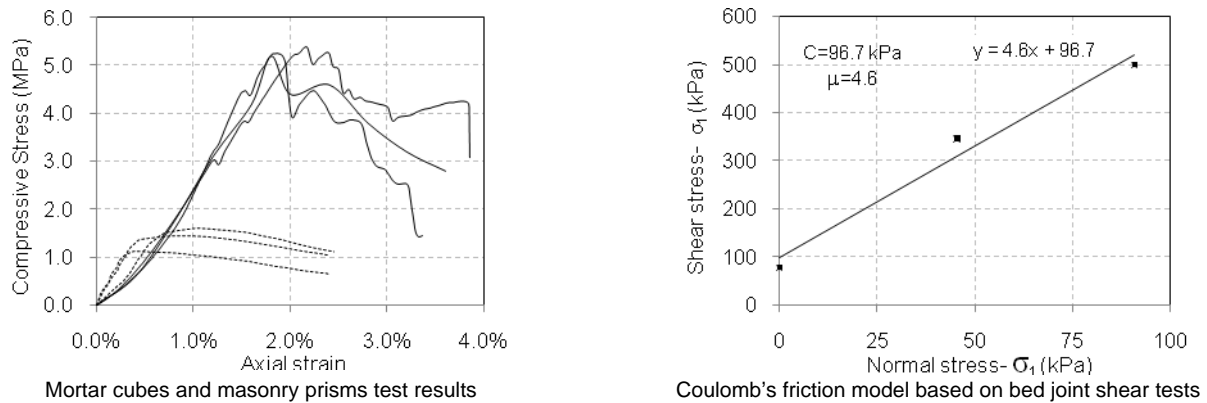
**Figure 2.** Material test results

Average URM material properties were determined by material testing consistent with ASTM standards, typically in samples of three. Masonry compressive strength f'_m and masonry elastic modulus E_m were determined by testing three brick high prisms and mortar compressive strength f'_j was determined by testing three 50 mm by 50 mm cubes subjected to compression loading. Masonry cohesion C and coefficient of friction μ were investigated by bed joint shear testing of six three bricks high prisms with varying axial compression. Axial compression was applied to brick prisms using external posttensioned high strength bars. Table 2 shows the material properties and Figure 2 shows the graphical results of the tests.

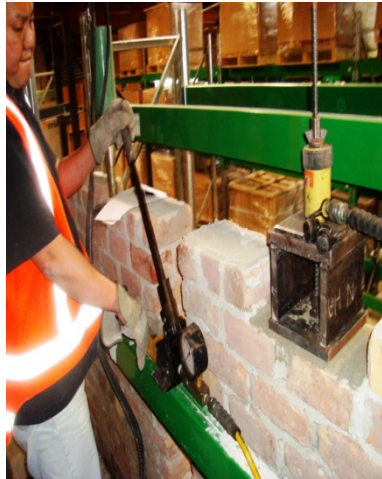
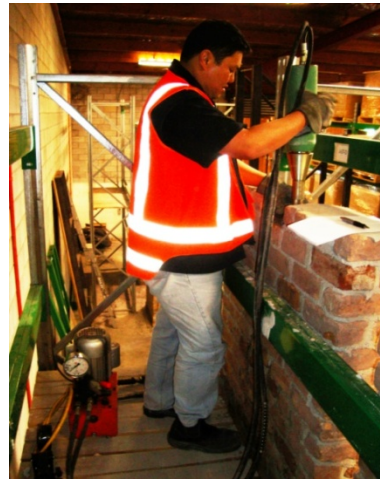
Figure 3. Posttensioning of test walls

Test wall PTB-01 was posttensioned using a 10 kN hydraulic jack which was removed after tightening the nut to clasp the posttensioning bar. For test wall PTS-02 an electronic hydraulic jack was used to apply the initial posttensioning force and the taut strand was clasped by wedge interlocking. Prestress levels detailed previously were ensured by applying required stress immediately before testing. Figure 3 shows photographs taken whilst the tendons were being tensioned.

(a) Posttensioning of PTB-01

(b) Posttensioning of PTS-02

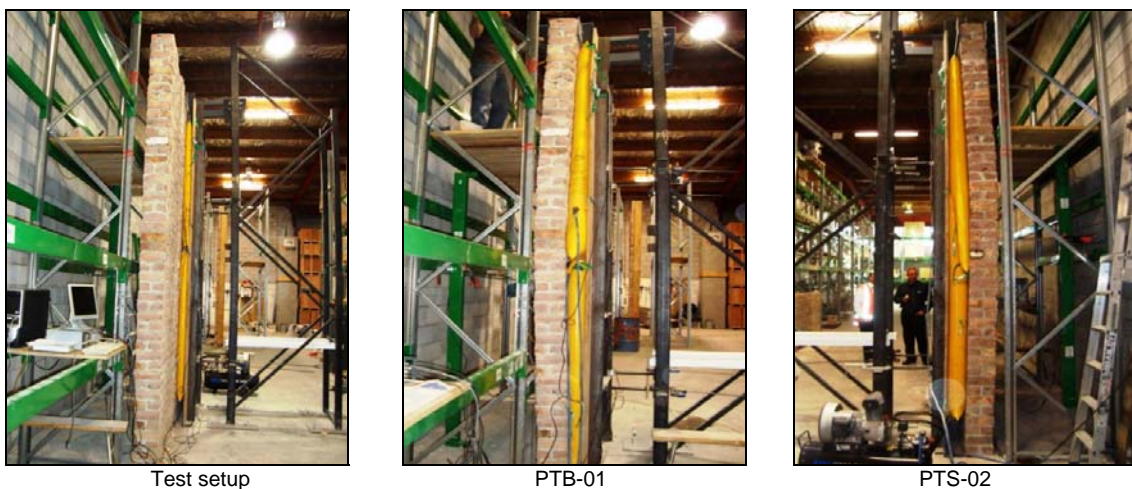
Figure 5. Photographs of testing

Test wall PTS-02 did not reach its ultimate flexural capacity before the test was stopped due to safety concerns and test wall PTB-01 was loaded up to its flexural capacity. A single large crack at or near mid-height and no flexurally distributed cracks were observed in both wall tests. However, localized brick punching was observed at some locations. Figure 5 shows photographs of the test setup and deflected test walls.

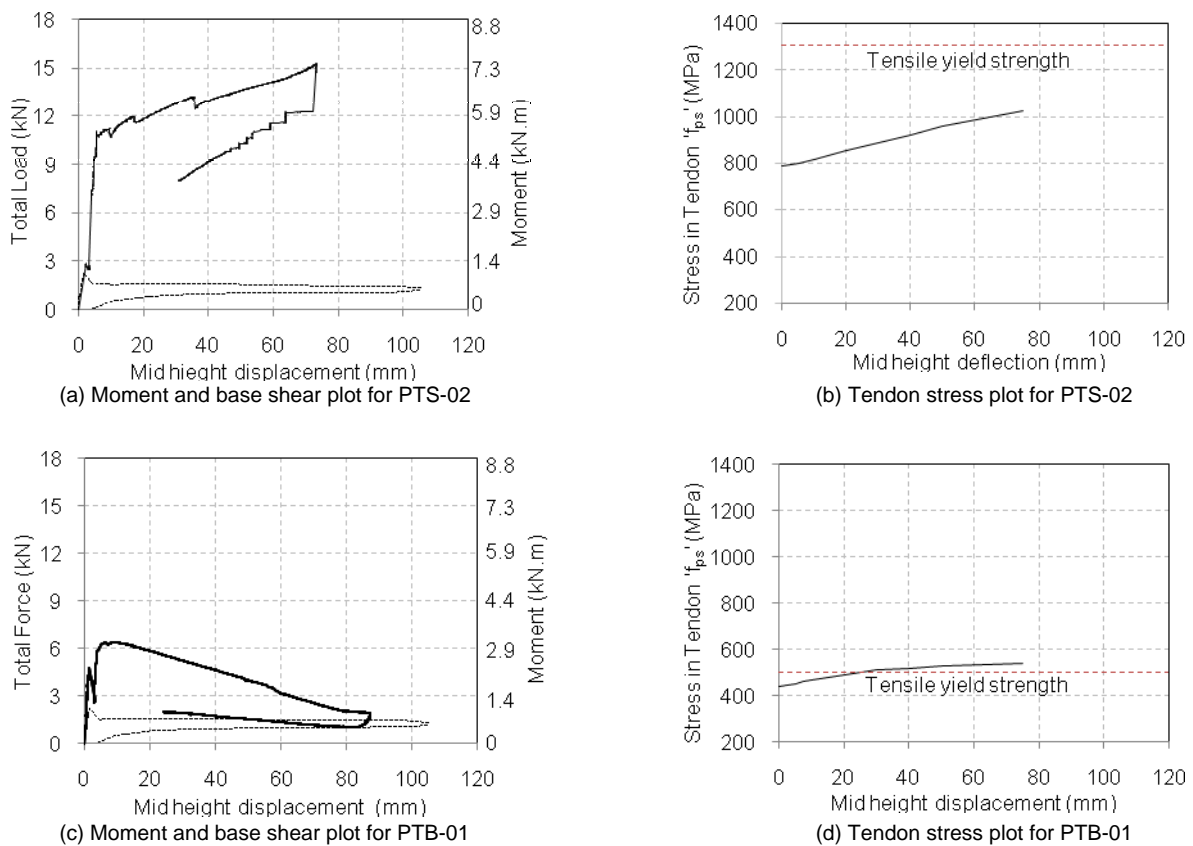
Figure 6. Wall response

A positively sloped unloading branch was observed for wall PTS-02, which was attributable to the mechanics of the cross section details. When wall PTS-02 was subjected to large displacement, the prestressing tendon did not exceed its elastic limit and strand returned to its original position due to the restoring force, which was shown as the positive sloped unloading limb, following the same gradient as that of loading limb. Negatively sloped post peak behaviour of PTB-01, demonstrates the strength degradation due to mortar crushing at compression face and yielding of the mild steel bar. Negatively sloped post-peak branch has been observed in previous studies (Bean Popehn et al. 2008; Lacika and Drysdale 1995). Figure 6 (a and c) shows the force-displacement response for walls PTB-01 and PTS-02, with response of the non-retrofitted URM wall, C-01, depicted by a dotted line.

Figure 6 (b and d) shows the tendon stress histories plotted against the displacement at hinge location, which developed at or near wall mid-height in one way out-of-plane bending. It is noted that the dotted lines represent the tensile yield strength of tendons, which was 500 MPa for the threaded bar and 1300 MPa for the seven-wire strand. For wall PTB-01 the tendon stress started to increase at a faster rate after 25 mm displacement at the hinge location, corresponding to probable contact between the tendon and the face of the conduit, and reached its yield strength at nearly 28 mm mid-height displacement but did not reach its ultimate strength of 680 MPa. For wall PTS-02 strand stress increased linearly well within its elastic limit and no signs of strength degradation in the wall were observed. The increase in strand stress was nearly 30% of its initial stress.

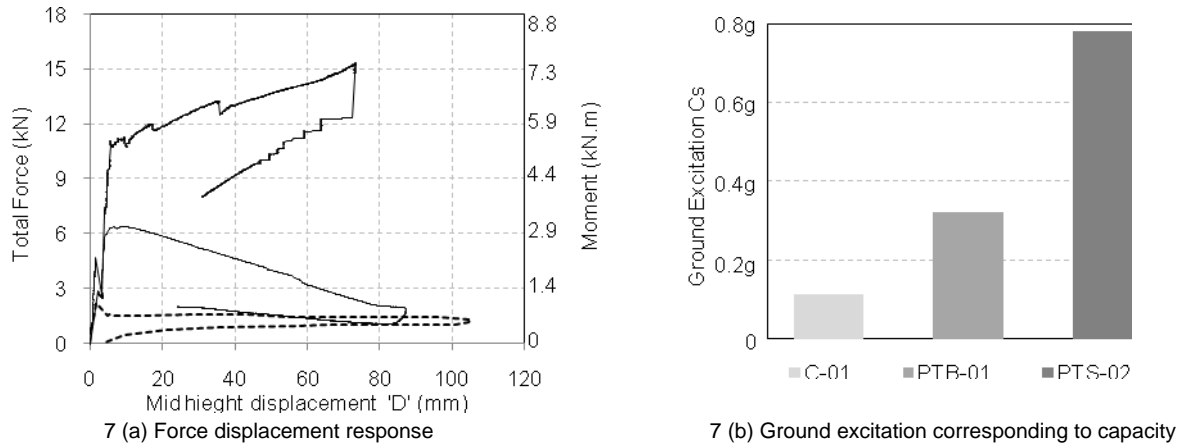
Figure 7. Comparison of wall response

Figure 7(a) shows the force-displacement plots for both posttensioned test walls. Test wall PTS-02 exhibited larger flexural capacity and less sensitivity to cracking than did wall PTB-01. Comparing results from the non-retrofitted wall and the posttensioned walls, it was determined that the nominal out-of-plane flexural strength of test walls PTB-01 and PTS-02 was respectively 2.9 times and 7.1 times the strength of the non-retrofitted URM wall. In order to correlate flexural capacities to corresponding ground excitations, results were transformed to ground accelerations using the ASCE 7-05 section 12 prescribed procedure. It was contemplated that the test walls belong to a URM building structure with potential historic value (i.e., $I=1.25$) which is resting over soft clay soil (i.e., $C_{DS}=0.864$ for site class E) and flexural capacities in terms of ground acceleration values were calculated using Equation 3, where W is the weight of the wall, C_s is the ground acceleration, F is the force at flexural failure in the test and h_w is the effective height.

Figure 7(b) shows the ground acceleration values calculated by the procedure detailed in previous paragraph. It was inferred that the URM non-retrofitted wall was most likely to fail even under moderate intensity ground excitation of 0.11g, whereas, retrofitted walls PTB-01 and PTS-02 can sustain relatively high ground excitations of 0.32g and 0.78g respectively.

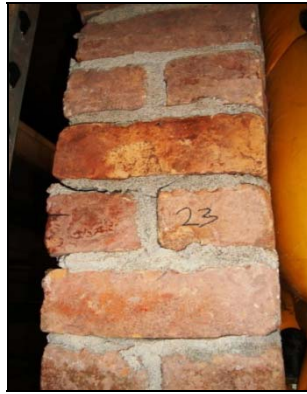
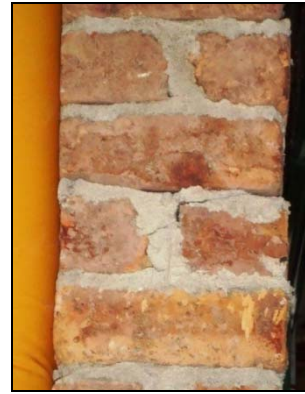
Figure 8. Photographs of damage pattern

As discussed previously a horizontal crack opened at or near mid-height, and Figure 8 shows the photographs of the cracked wall sections.

Wall PTB-01

Wall BTS-02
