Progressive collapse analysis of Hongqi Viaduct: a multi-span simply-supported bridge

Hongqi Viaduct, a multi-span simply-supported bridge in Zhuzhou, China, collapsed progressively during the mechanical demolishing of the bridge on May 17, 2009. The accident resulted in the loss of 9 lives and 16 injuries. This paper numerically simulates the collapse process of the bridge by using explicit finite element code LS-DYNA. The domino-type progressive collapse of the bridge is clearly captured, and the reason for the failure is discussed.

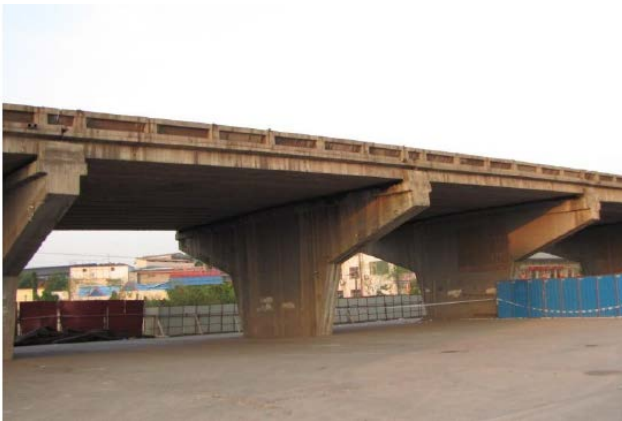
Fig.1. Typical view of Hongqi Viaduct (before collapse).

Hongqi Viaduct is a multi-span simply-supported bridge located in Zhuzhou, China. It includes 121 piers and 122 spans, with 15 spans of length 13 m, 3 spans of 18 m and 104 spans of 20 m. The total length of the bridge reaches 2329 m. Fig. 1 shows the bridge before collapse. Each span consists of 16 prestressed concrete hollow slabs. The height of each slab is 0.85 m and the width is 1 m. The total width of the superstructure is 16.5 m with an equivalent density of 2241 kg/m^3 . The height of the wall-type pier is 7.875 m from the pile cap and the thickness is 0.8 m. Fig. 2 shows the numbering of the slabs and the cross sections of the pier.

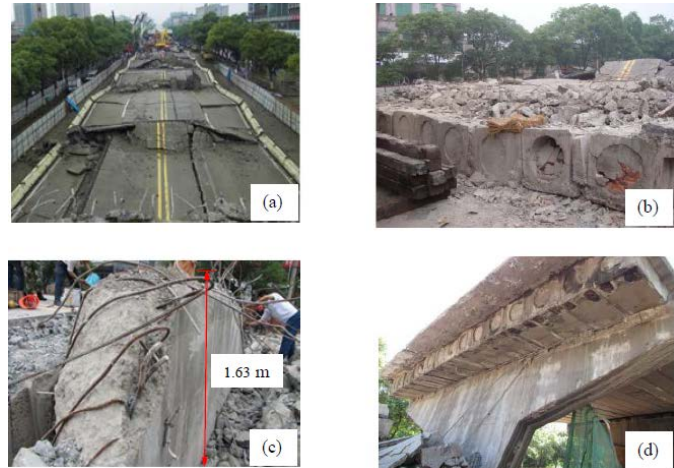
The original scheme of mechanical demolishing was to remove the connections between two hollow slabs first, and then a hydraulic breaker located on the adjacent span would be used to break the first hollow slab. The broken hollow slab would drop to the ground due to the gravity load. Then the hydraulic breaker would move to break the second slab. This process would be repeated until the total 16 slabs being demolished successively. The breaking location of the slab by the breaker is about 1.4 m to the left end of the slab. Unfortunately the actual demolishing process did not exactly follow the original plan. On May 17, 2009, when demolishing the slabs between piers #110 and #109, the last 4 slabs, i.e. slabs 13-16 in Fig. 2, were demolished together first, and then the hydraulic breaker was moved to break the remaining 12 slabs, which resulted in the 12 slabs dropping to the ground simultaneously. The left ends of these 12 slabs dropped to the ground but their right ends collided with pier #109, generating a huge impacting force on the pier. The huge impacting force from the collapsing slabs on the pier, which was not designed to resist such an impacting force, seriously damaged pier #109 and made it collapse toward pier #108. Consequently, the left ends of the slabs between piers #109 and #108 dropped to the ground due to the loss of support (pier #109), and the right ends collide with pier #108, which in turn resulted in the collapse of pier #108. The following spans followed the same pattern and formed the domino-type progressive collapse as illustrated in Figure 6 below. However, the collapse did not progress to the whole remaining bridge spans but stopped at pier #101, which deformed toward pier #100 with an

angle of 30 degrees due to impact by the collapsed span but did not collapse as shown in Figure 4(d). The collapsed spans and piers are designed and constructed the same, the reason why pier #101 did not completely collapse as piers #109 to #102 is not exactly known. Because the post incident investigation concentrated on the collapsed spans, no further information is available on pier #101. In this study, only the collapse mechanism is investigated. Totally 8 piers and 9 spans collapsed in the incident, and the collapsed length reached 180 m. Fig. 4 shows the bridge after collapse. 9 people died and 16 were injured in the incident.

Fig. 4. Hongqi Viaduct after collapse: (a) overview, (b) collapsed slabs, (c) remaining pier (#109) and (d) pier #101.

The lower part of pier #109 below the shear failure section remains on the ground as shown in Fig. 7. The height of the remaining part is about 1.56 m in the numerical study, which is almost the same as that in Fig. 4(c), where the remaining part is about 1.63 m. This result also demonstrates that the model developed in the present study gives good predictions of the bridge failure.
