## Lateral load on site testing of a two story masonry building up to near collapse

**ABSTRACT:** Masonry structures constitute a significant portion of the building stock in many countries with high seismic regions. Understanding the load carrying mechanisms of such buildings as a system and estimating the deformation capacities still remains as an important task for seismic assessment and retrofit. In this research, one-way cyclic test of an existing masonry building was performed to determine its lateral load resisting behaviour. The test building was sliced approximately in the middle and one side was strengthened with the objective of obtaining a strong reaction wall. The other side of the structure was taken as the test structure with a floor plan of approximately 10 m x 8 m. Hydraulic actuators located in the two stories were employed to impose one-way cyclic displacement excursions. The structure was tested up to a lateral strength drop of approximately twenty percent from its ultimate load, which occurred at a drift ratio of about 1%. The failure of the walls in the building, which were mostly diagonal tension, was concentrated on the first story. Results provide importan

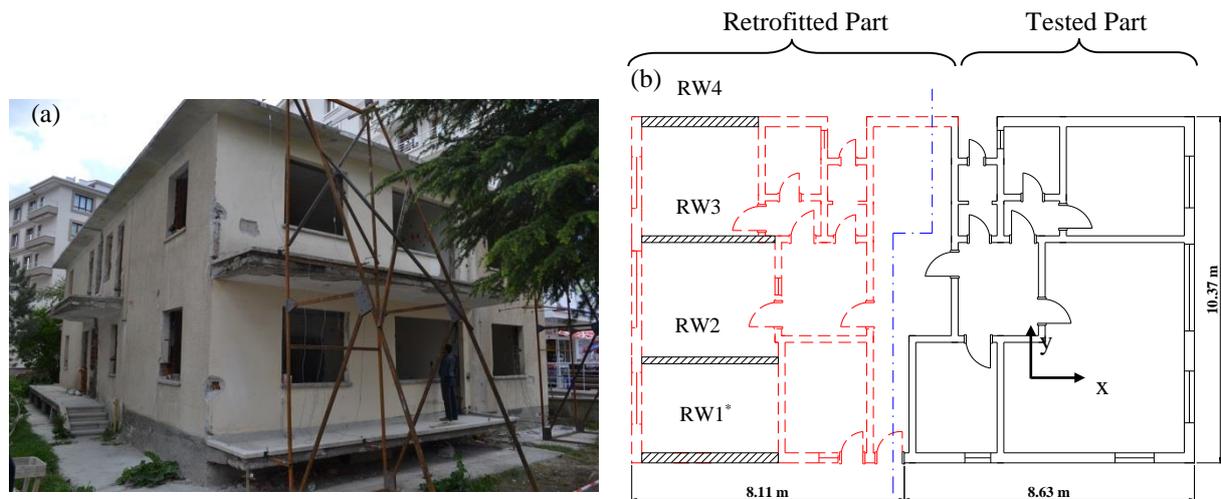
**Fig. 1 – Test structure : (a) Photo and (b) Plan view of tested masonry structure (\*: Retrofitted Wall)**

The test building is located in the Northern part of Ankara. The building is a two-story masonry structure with a floor plan area of about 17 m x 10 m made of hollow clay bricks. The floor plan of the test building is shown in Fig. 1. The building composed of masonry walls with reinforced concrete beams supporting slabs with thickness of 0.12 and 0.10 m in the first and second stories, respectively. In order to estimate the material properties prior to testing, wallettes having 0.90m x 0.90m dimensions were extracted underneath window openings and tested to determine uniaxial compression, diagonal tension, shear strength as well as the modulus of elasticity. Material testing apparatus and results are presented in Fig. 2. The average uniaxial compressive, diagonal tensile, shear strength and modulus of elasticity were determined as 1.0 MPa, 0.27 MPa, 0.17 MPa and 842 MPa, respectively.

A stiff reaction wall should be built to apply lateral loads by hydraulic actuators. To this end, the test building was sliced into two parts, having nearly equal sizes (Fig. 3). The west side of the building was then employed as a stiff reaction wall upon strengthening four walls shown as hatched areas in Fig.1 with external mesh reinforced mortar. In this way, reactions from the application of the load to the east side of the building could be sustained without any significant deflections and damage. Prior to lateral load testing of the building, a forced vibration test was performed in order to estimate the fundamental frequency of the building. The FFT of transfer function for recorded acceleration are shown in Fig. 4. The fundamental vibration period of the building was determined as 0.125 sec from forced vibration test. This result showed a good agreement with the analytical estimation of 0.128 sec obtained from finite element model employing a modulus of elasticity of 842 MPa (Fig 2.d). In the finite element model, approximately 55,700 eight-node shell elements are utilized by assuming the base

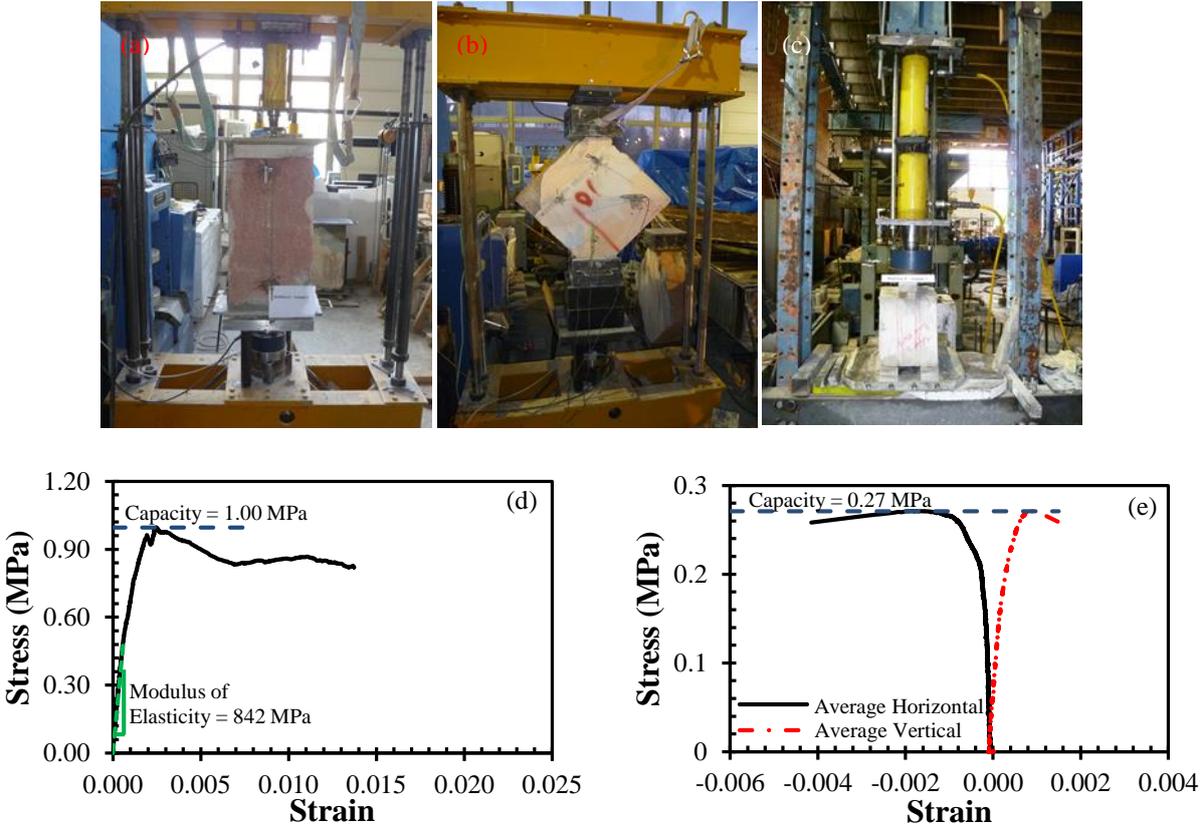
**Fig. 2 – Material test setups and test results : (a) Compression test setup , (b) Diagonal tension test setup, (c) Triplet test setup, (d) Compressive stress-strain curve and (e) Diagonal tension stress-strain curves**

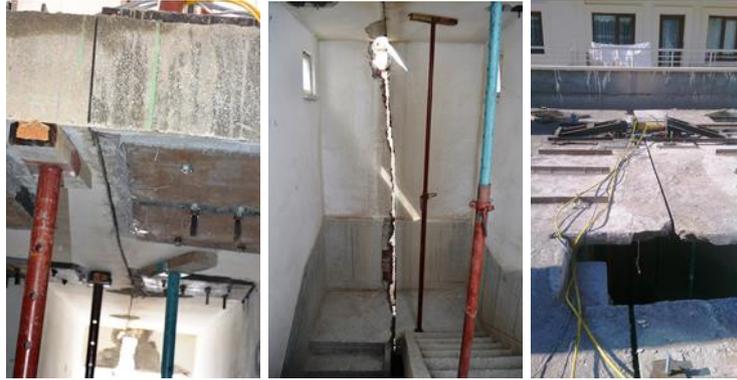
**Fig. 3 – Photos of interface between retrofitted and tested structures**

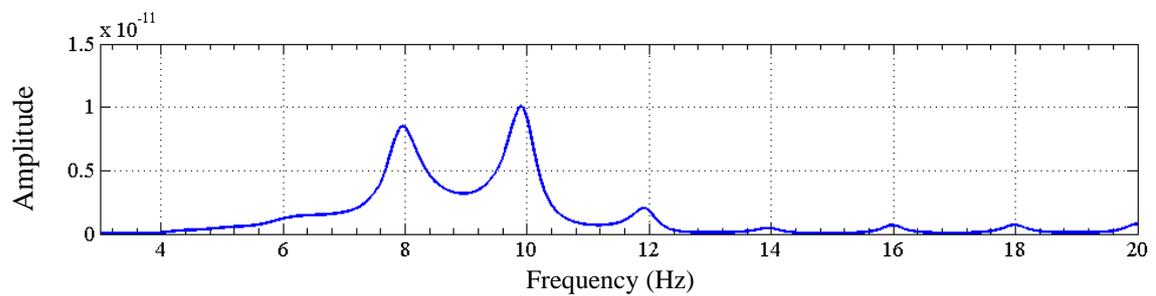
**Fig. 4 – FFT of transfer function for recorded accelerations**

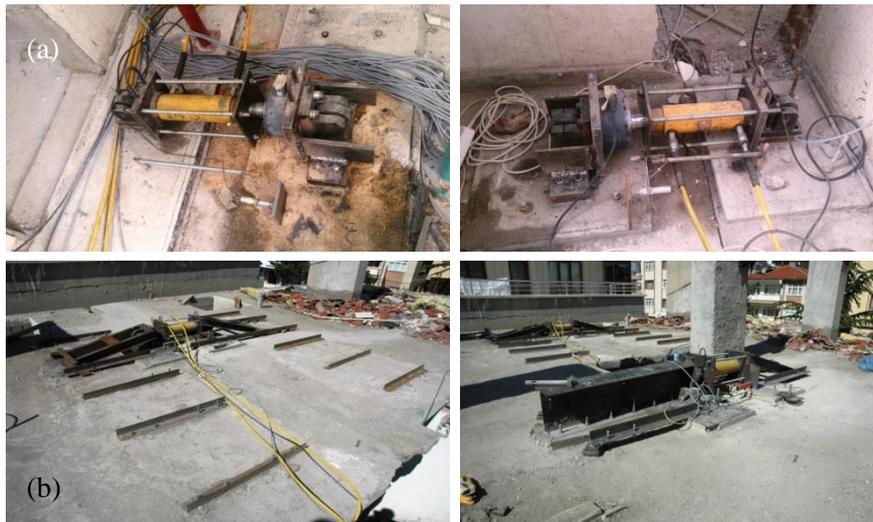
**Fig. 5 – Photos of hydraulic actuators at each story : (a) First story and (b) Roof**

Firstly, four hydraulic actuators were attached along the slice locations on both floor slabs. At this point, the resultant of the force at each floor caused by hydraulic actuators was enforced to coincide with the center of mass of each floor. The hydraulic actuators were connected by steel attachments that ensured proper transfer of shear forces without any local failures (Fig. 5). The loading was adjusted by an electric controlled oil pump in order to apply the imposed displacements. The lateral load ratio of the second floor to that of the first floor was 1.7. This ratio was determined from the estimation of the shape of the first fundamental mode obtained from finite element analysis. The lateral displacements of each story level are recorded with Linear Variable Differential Transformer (LVDTs) installed at four different points.

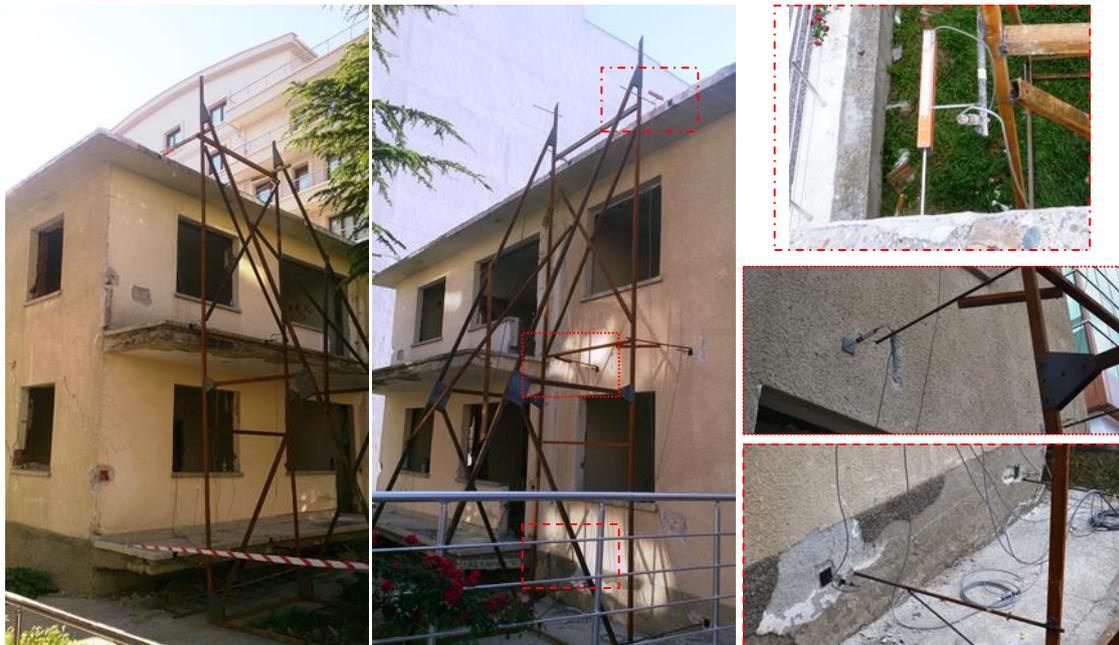
**Fig. 6 – Photos of LVDT's installed at each story level**

The locations of these LVDT’s are also presented in Fig. 6. In addition, the deformations of the walls were measured by using four LVDTs, two measuring vertical deformations, two recording diagonal deformations as shown in Fig. 7.a for a representative wall. The testing was conducted by controlling the interstory drift ratio of the first floor in a one way cyclic manner. The applied displacement protocol on the first floor and roof of the building are shown in Fig. 7.b.

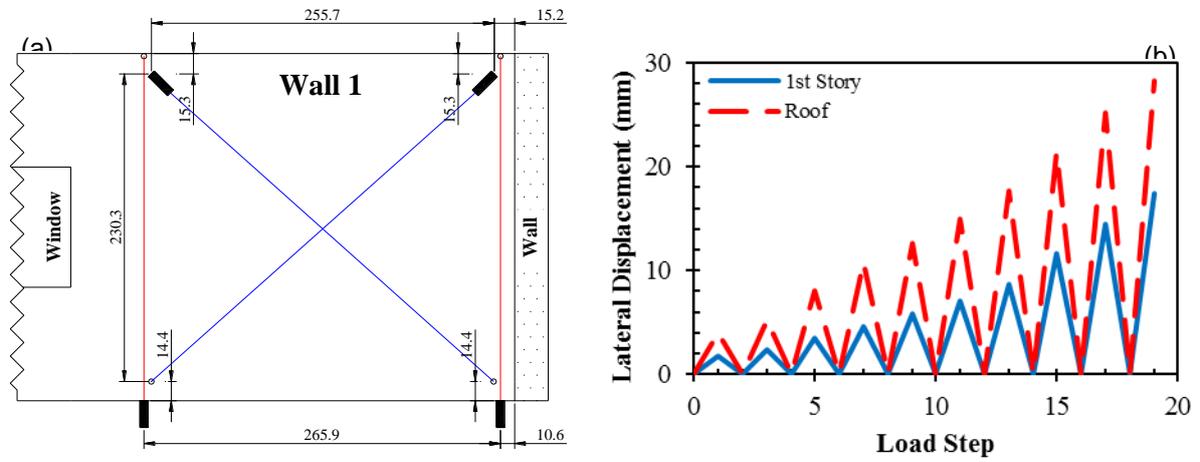
Fig. 7 – (a) The installed LVDT's for a representative wall and (b) Control displacements applied to each story \*All units are in cm.

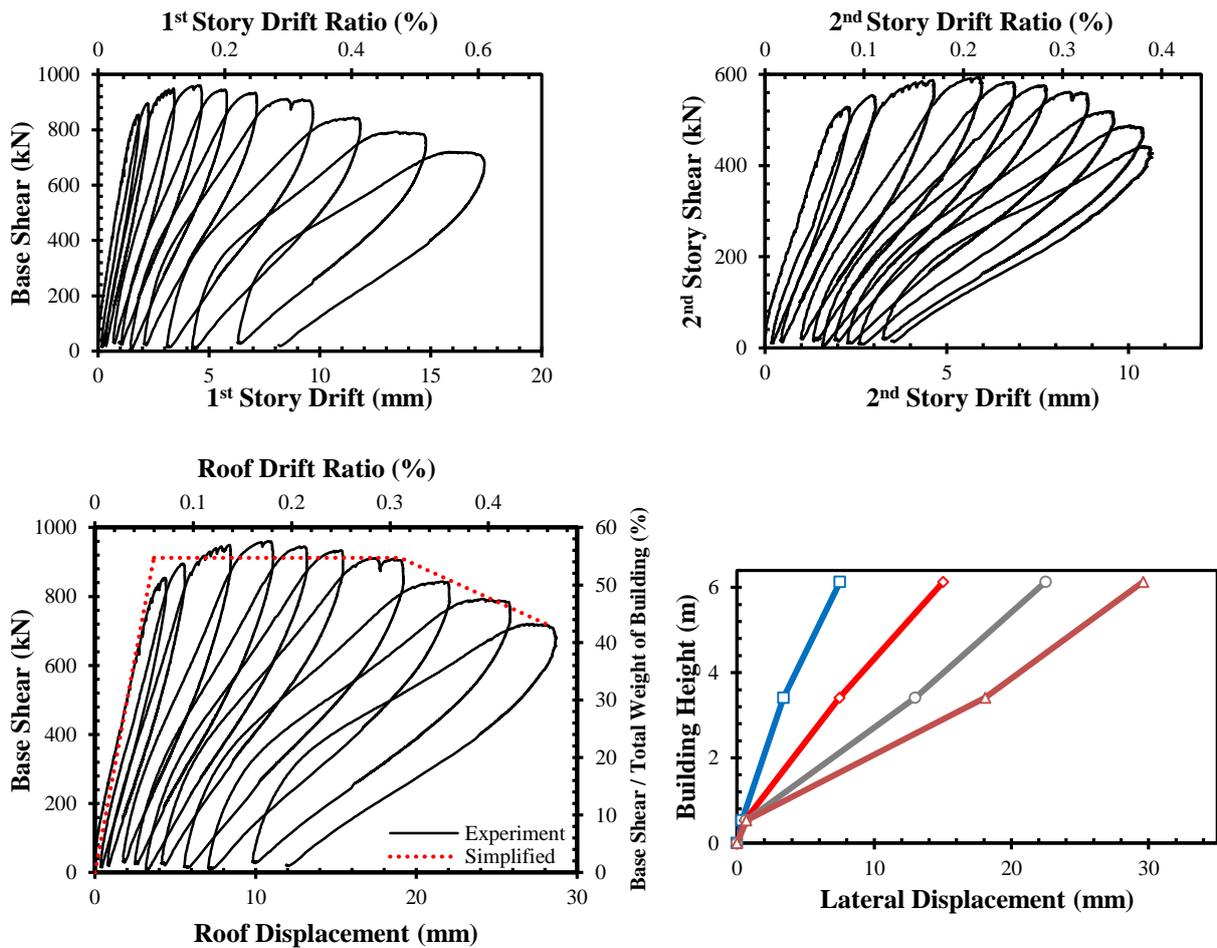
Fig. 8 – Recorded load – deformation responses

Measured load deformation response of the building is shown in Fig. 8.a-8.c in terms of first drift - base shear force, second story drift - second story shear force and roof displacement – base shear force. The deformation measurements at the center of mass are also presented as interstory drift ratios which were found by dividing the story displacement with the story height in those graphs. The deformation profile along the height of the building is presented in Fig. 8.d. The damage pictures of the selected walls are shown in Fig. 9. The building behaved in an elastic manner up to a total base shear of about 200 kN beyond which crack initiation started resulting in a reduction of tangent stiffness. The interstory drift profile along the height of the building was nearly uniform throughout the testing except for the last drift profile which clearly demonstrates the relatively larger stiffness loss in the first story due to the enhanced damage accumulation on first story walls. Significant nonlinear response initiated at a base shear force of 800kN. The ultimate base shear force recorded during the test was 950kN at overall building drift ratio of about 0.18%. Force-displacement relationship of both floors exhibited softening beyond this drift ratio showing that the damage occurred on the walls of both stories with increasing displacements. The interstory drift ratio at 20% strength drop for the first and second stories occurred at about 0.5% and 0.38% interstory drift ratios. This result shows that the ductility capacity of the building was about 5.2 assuming the yield point obtained from the idealized bilinear response curve shown in Fig. 8.c. Cracking patterns observed in walls 1, 3, 7 and 9 are shown in Fig. 9. It can be observed that horizontal cracks occurred between the horizontal beams and walls followed by diagonal cracks. It is interesting to note that even for walls with relatively large aspect ratio (H/L), diagonal cracking was the dominant failure mode as opposed to expected rocking failures. This observations support the recent findings of Russell et al. (2014) who point out the importance of flange effects for accurate failure mode and strength estimation of masonry walls.

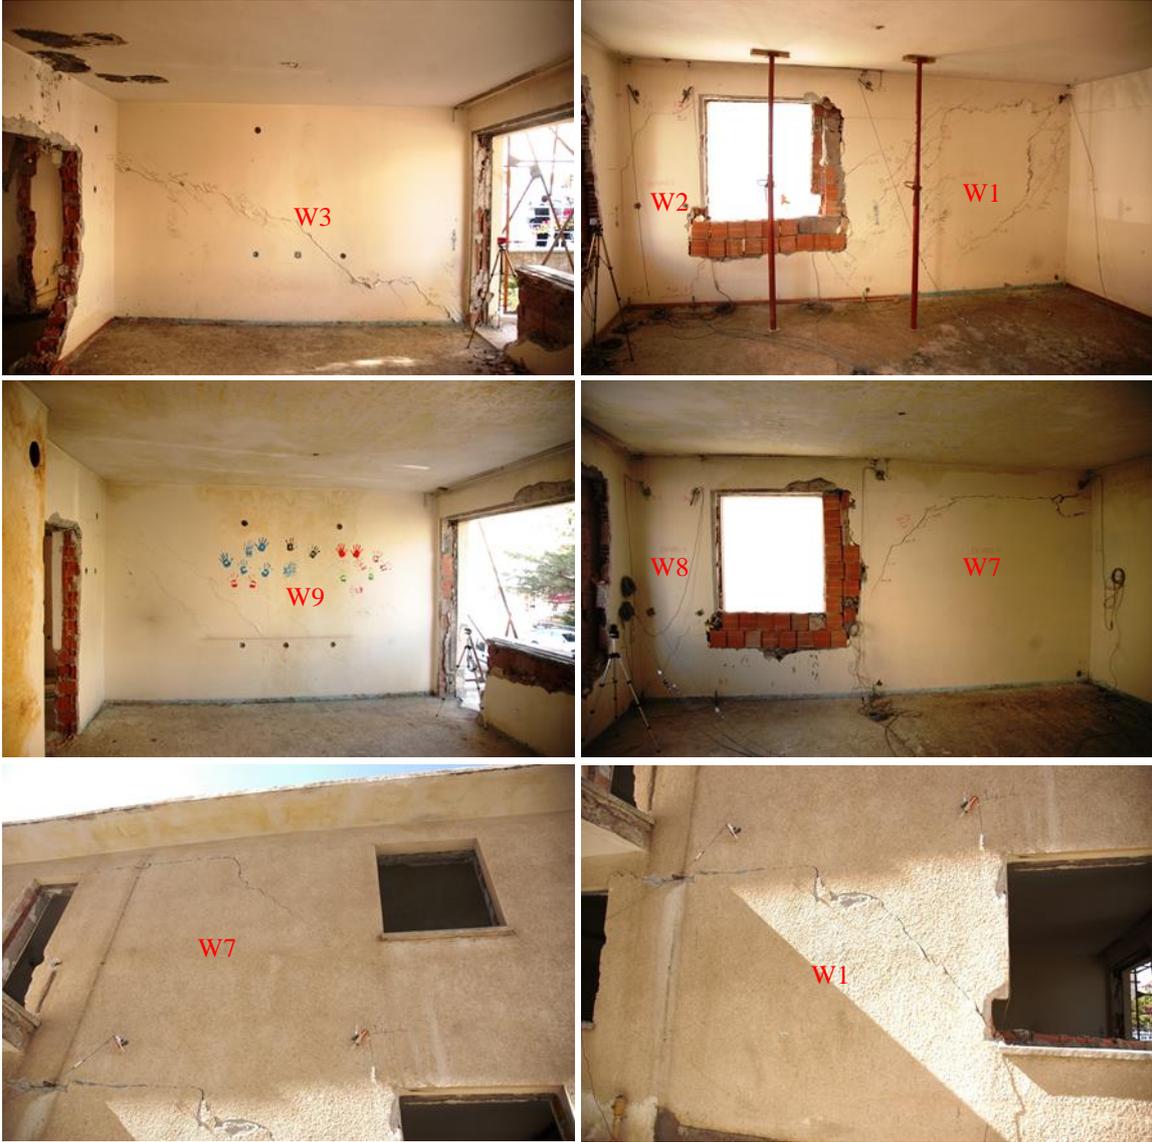
**Fig. 9 – Observed wall damages**
