Haiti – Five years after the 2010 earthquake

C. Higbie, C. Beauboeuf, & R.A. Green

Department of Civil and Environmental Engineering, Virginia Tech, Blacksburg, Virginia, USA.

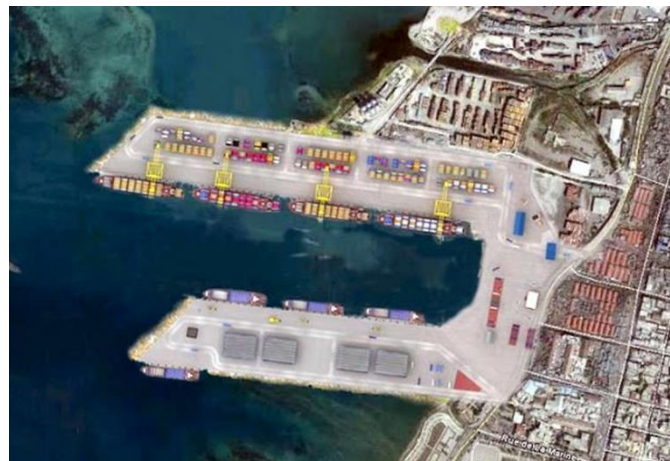
Figure 5. Final design of the Port de Port-au-Prince (APN, 2014)

- Construction of the new North Wharf that is ~460-m long to a water depth of roughly 11.6 m in order to accommodate the rails and equipment needed to operate the cranes
- Reconstruction of the south pier’s RO-RO bridge. It is to have a ramp roughly 30-m wide to a water depth of ~11.6 m
- A portion of the basin and ~100 m navigation channel are to be dredged to 11.6 m to access the dock
- The north wharf is to be completed 18 months after the contract has been signed

Figure 5 depicts the APN final design of the PPAP including a complete rehabilitation of the north wharf and south pier and docking area that suffered extensive lateral spreading.
