# Application of a Proposed Methodology on Performance-Based Assessment to a Reinforced Concrete Heritage Buildings in the Philippines

M.R. Del Prado & A.W.C. Oreta

*De La Salle University, Manila City, Philippines*

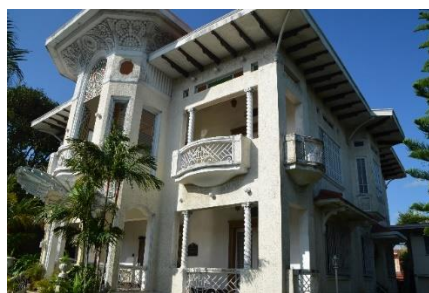
**Figure 1. Gala Rodriguez Ancestral Mansion**

The Gala Rodriguez Ancestral mansion (Fig. 1) was home to some of the prominent and well-respected citizens of Sariaya, Quezon. This house represents the history that Sariaya, Quezon has been through during the world war II and famine. Today this house is declared as a national treasure since it was declared by the National Historical Institute on 2008.

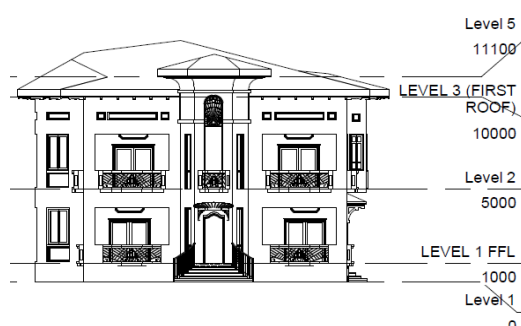
**Figure 4. Front Elevation**

Actual measurements were done to develop detailed structural plans of the heritage building. The front elevation of the heritage building is shown in Fig. 4. The yield strength of steel reinforcement that was used is the default value provided by ASCE 41(2013) for those building constructed during 1911-1959, which is 228 MPa. The summary of the modelling parameters are presented in Tab. 5. The over strength factor (R) was set to 3.5 to account for the Low Code Design taken from the study of Hernandez & Pascua (2012). The Low Code Design refers to the design method that assumes the elastic response of materials which is common for older buildings. The loads were taken from the National Structural Code of the Philippines of ASEP (2010).

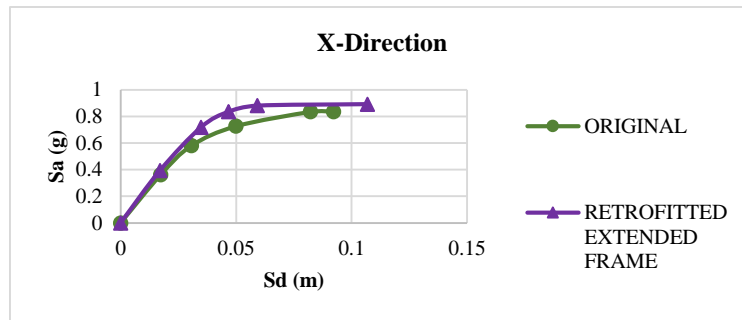
Figure 5. Comparison of Original and Retrofitted Heritage Building (X-Direction)

The pushover curves of the retrofitted and original analytical model are presented in Fig. 5. The performance state derived from yielding of hinges of the beams and columns of the retrofitted analytical model shows significant improvement compared from the original as presented in Tab.8. Significant improvement was also observed based from the decrease of damage index from 21.42% to 6.42% as presented in Tab.9.
