Seismic Assessment of Unreinforced Masonry Buildings in a Heritage-Listed Township

Abstract

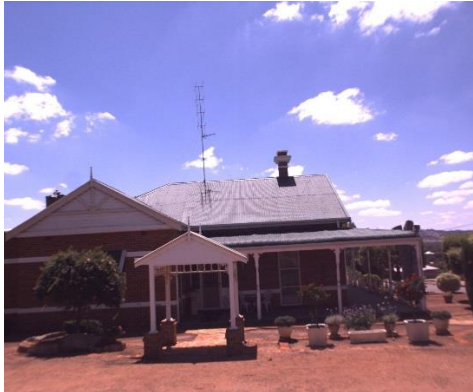
Type	Example photo	Typical vulnerabilities
House – 1 storey isolated building

Chimney; out-of-plane (OOP) failure gable walls
Pub – 2 storey corner building

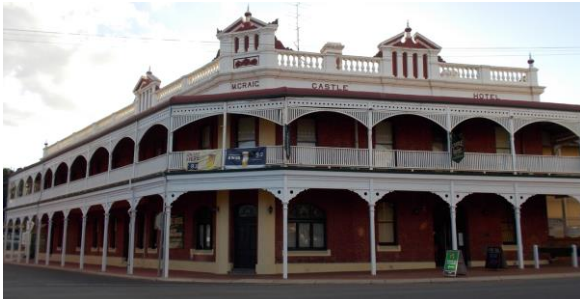
Parapets; chimneys; outward OOP failure of external leaf of cavity wall; collapse of these elements through awning and balcony
Single storey commercial – 1 storey row building

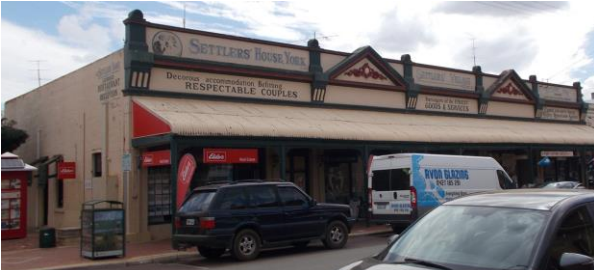
Parapet, possible failure through awning

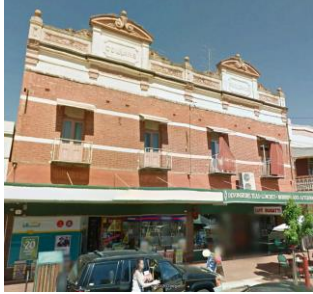
<p>Two storey commercial – row building</p>

<p>Parapet; OOP failure of upper storey wall</p>
<p>Two storey institutional – isolated building</p>

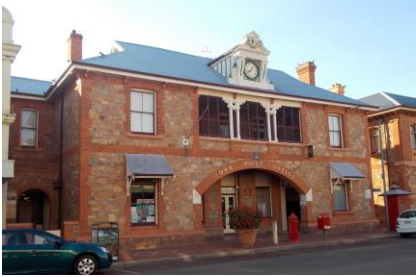
<p>Chimneys; OOP failure of upper storey wall</p>
<p>Two storey Bank – isolated building</p>

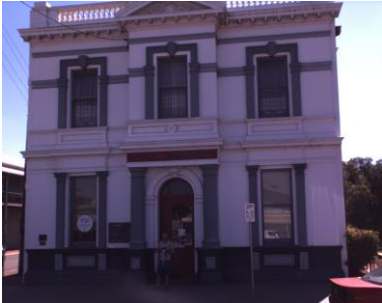
<p>Parapets; chimneys; OOP wall failure</p>

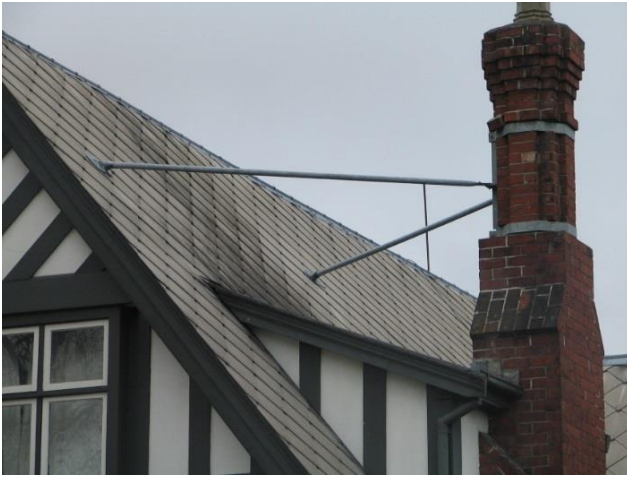
Chimneys: According to the survey, 141 URM buildings have one chimney, 117 have 2 chimneys, 45 have 3 chimneys, 16 have 4 chimneys, 3 have 5 chimneys, one has 6 and two have 7 chimneys. That is a large number of chimneys, however, the good news is that only 60 of them are ‘slender’ chimneys. The bad news is that chimneys with a height-to-thickness ratio of 3 or more may be liable to failure for earthquake ground motions with peak ground accelerations as low as 0.1g. The rest are relatively short in height and so less vulnerable to failure than the taller slender chimneys. Figure 2 shows an example of a successful chimney retrofit that survived the Mw7.1 September 2010 earthquake in Christchurch.

Figure 2: Successful chimney retrofit survived the $M_w7.1$ September 2010 earthquake.

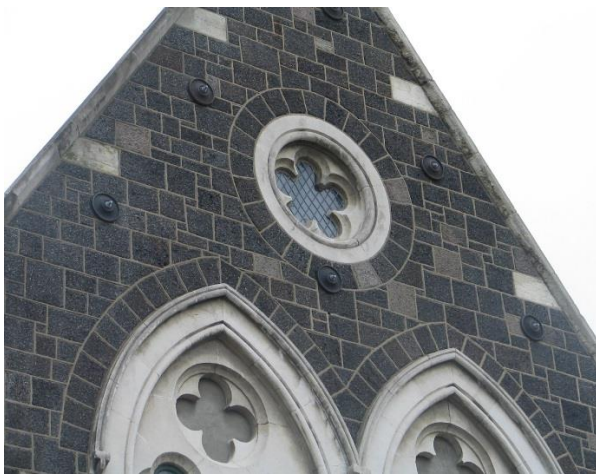
Gable end walls: There were not many gable walls observed in commercial premises on the main street of York, Avon Terrace, but many pitched roof houses have gable walls. If not well tied back to the roof structure, they can be highly vulnerable to outwards bending failures. See Figure 3 for photos of secured and unsecured gable walls in Christchurch.

(a) Gable wall ties to roof structure

Figure 3: Gable end walls after $M_w7.1$ September 2010 earthquake.

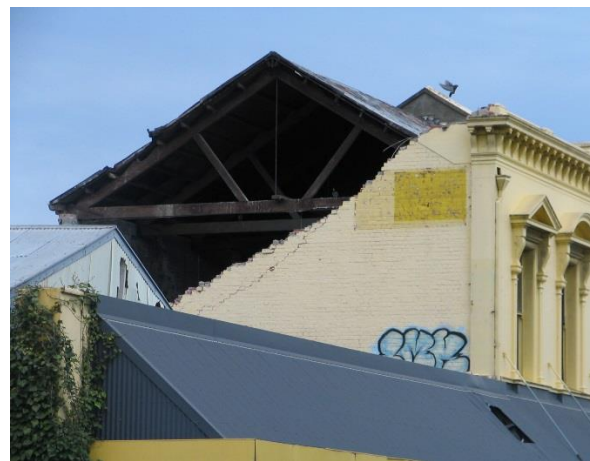
(b) Unsecured gable wall failure

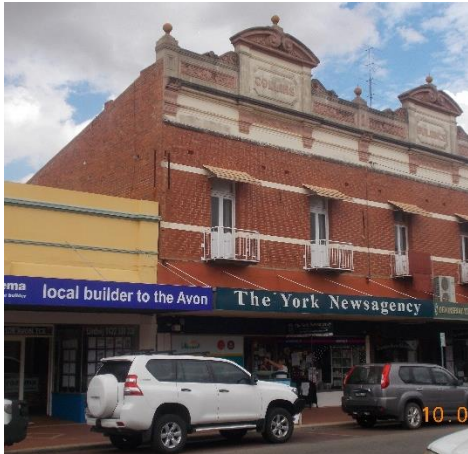
Parapets: Many commercial buildings on Avon Terrace have parapets. Some have existing retrofit in the form of cable ties connected back to the roof structure, but in most instances the ties are connected to the parapet only at a single point (refer Figure 4). Experience around Christchurch, and Newcastle, has shown that this manner of connection will be unsuccessful due to punching shear failure in the masonry around the connection point. More frequent, closely spaced ties are required to reduce the force imposed on the connection and keep it within the capacity of the masonry (see Figure 5).

(a) Parapet front view

Figure 4: Collins Building, Avon Terrace, York.

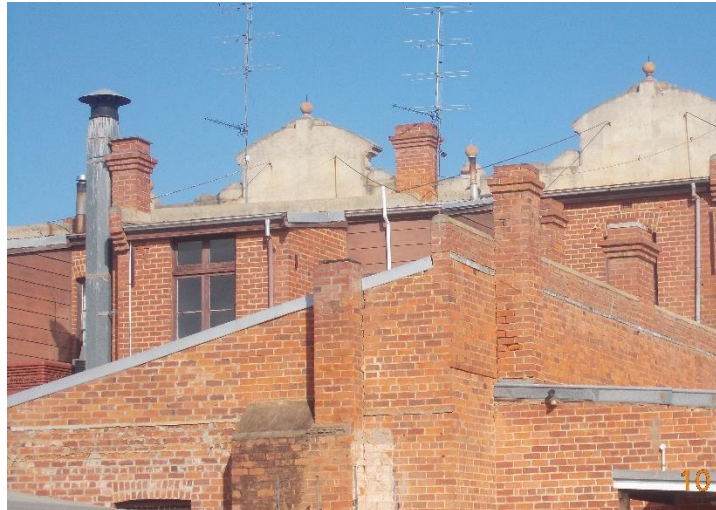
(b) Rear view, note point connection for parapet restraint

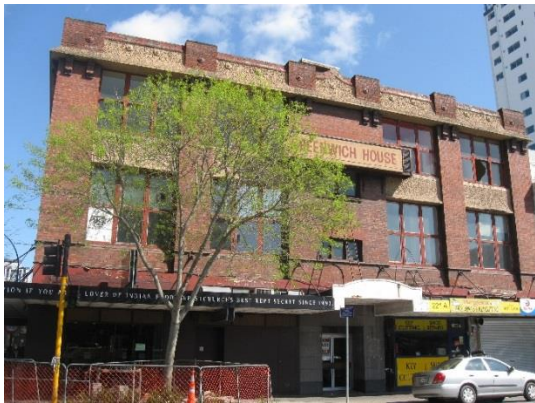
(a) Parapet with ties at ~1.5m spacing

Figure 5: Parapets after Mw7.1 September 2010 earthquake.

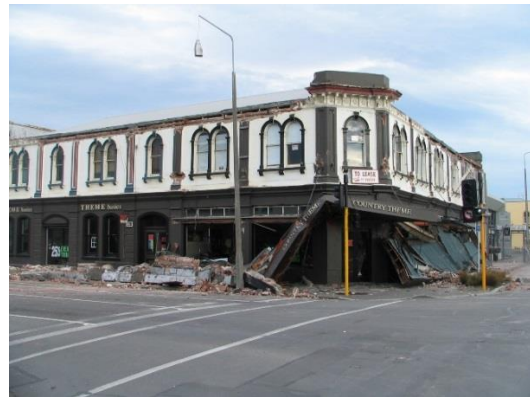
(b) Parapet with no ties back to roof

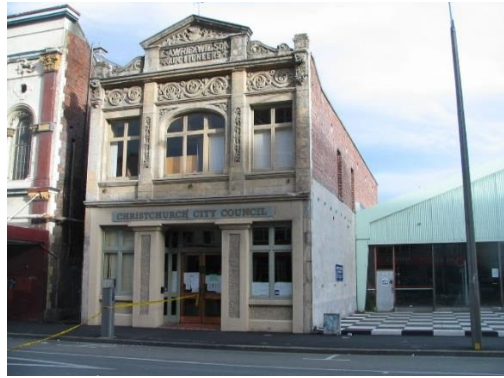
(a) Building with wall ties to floor/roof

Figure 6: URM walls after $M_w7.1$ September 2010 earthquake.

Walls: The external walls in URM buildings are particularly vulnerable to out-of-plane bending failure. Where brick cavity walls are in use, the external leaf of masonry can easily fall outwards if wall ties are absent or badly corroded as is common in coastal locations. This failure mode can be prevented by the use of wall ties that anchor the wall to the floor diaphragm at each level of the building and the roof diaphragm at the top as shown by Figure 6(a) where a heritage listed 2-storey URM building withstood all the earthquakes in Christchurch with no obvious damage. The building in Figure 6(b) had no wall ties and once the parapet commenced to fall outwards from the top the rest of the front wall went along with it, falling through the awning and crushing the taxi which was parked in front of the building.

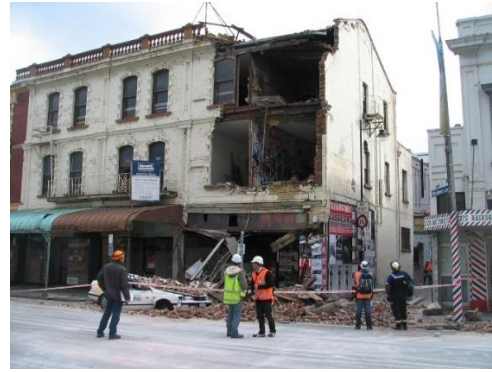
(b) Building without wall ties
