Seismic Capacity of Heritage Masonry Buildings in Australia – A Progress Report

J. Vaculik¹, M. Howlader², M. Masia³, J. Ingham⁴, and M. Griffith⁵

A three-year ARC funded research project featuring a collaboration between researchers at the University of Auckland in New Zealand and the Universities of Newcastle and Adelaide in Australia is now into its second year with some promising early results and exciting experimental tests to come in the near future. The overall aim of this project is to develop a practical method of analysis that accounts for the material properties used in heritage stone and clay brick masonry buildings that are most relevant to seismic response as well as the limited ductility inherent in the non-typical structural layouts used in these buildings. In order to achieve this, the first phase of the project characterised typical Australian heritage masonry buildings in terms of their most influential features for buildings listed within heritage registers in NSW and Adelaide. In the currently ongoing phase, experimental tests are being conducted to characterise the cyclic in-plane shear behaviour of clay brick and stone masonry walls as well as masonry porta

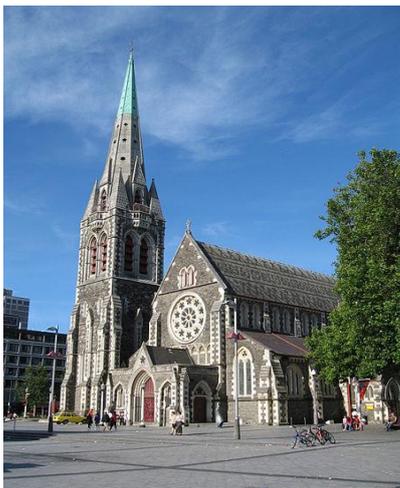
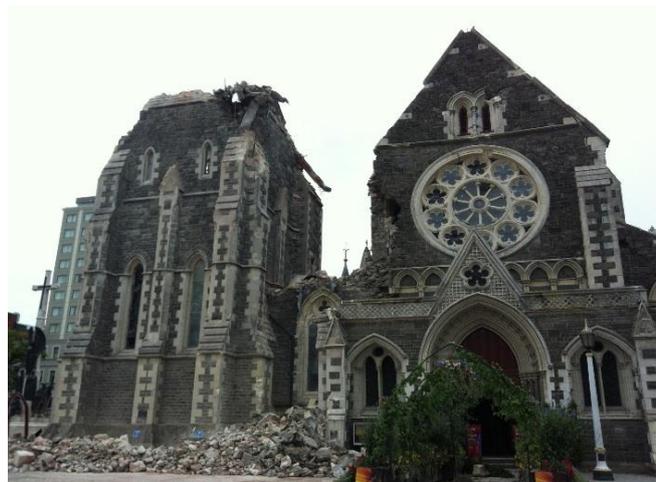
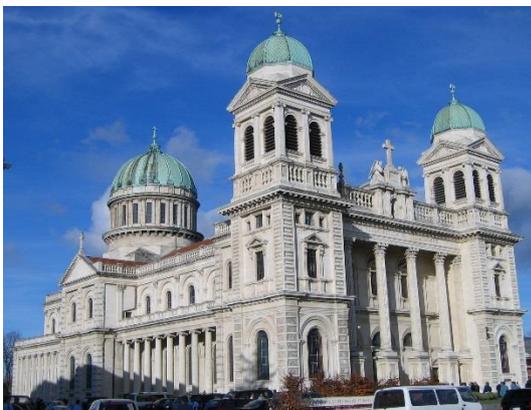
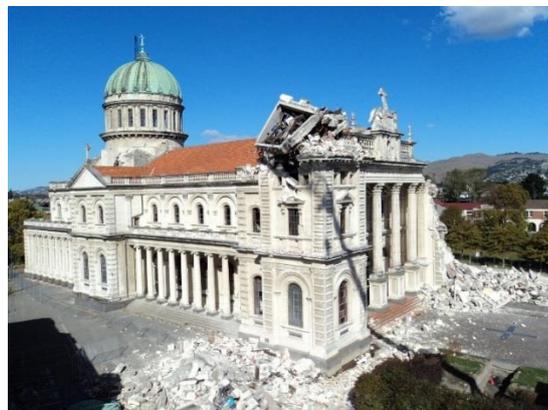
Figure 1: Damaged churches in Christchurch after February 2011 earthquake.

Anglican Cathedral, before Feb 2011

Anglican Cathedral, after Feb 2011 earthquake.

Catholic Basilica before Feb 2011

Catholic Basilica after Feb 2011

The tragic lessons from the Christchurch earthquakes, where the two main cathedrals in the city (Anglican Cathedral and Catholic Basilica – refer to Figure 1) were both heavily damaged by the M6.3 February 2011 earthquake (Ingham & Griffith 2011, Griffith et al. 2013; Moon et al. 2014; Brower, 2017) highlight that Australia also has a substantial stock of seismically-vulnerable URM buildings that are likely to lead to catastrophic economic damage and loss of human life should a major earthquake strike any of our densely populated areas where these buildings reside such as the State capitals. Whilst these reasons already form compelling motivation in order to better understand the expected performance of URM buildings in an earthquake—so that strengthening can be applied where required—the preservation of these old buildings is further motivated by the fact that many of them which were constructed between the early 1800s to the early-to-mid 1900s represent an irreplaceable part of Australia’s cultural and historical heritage.

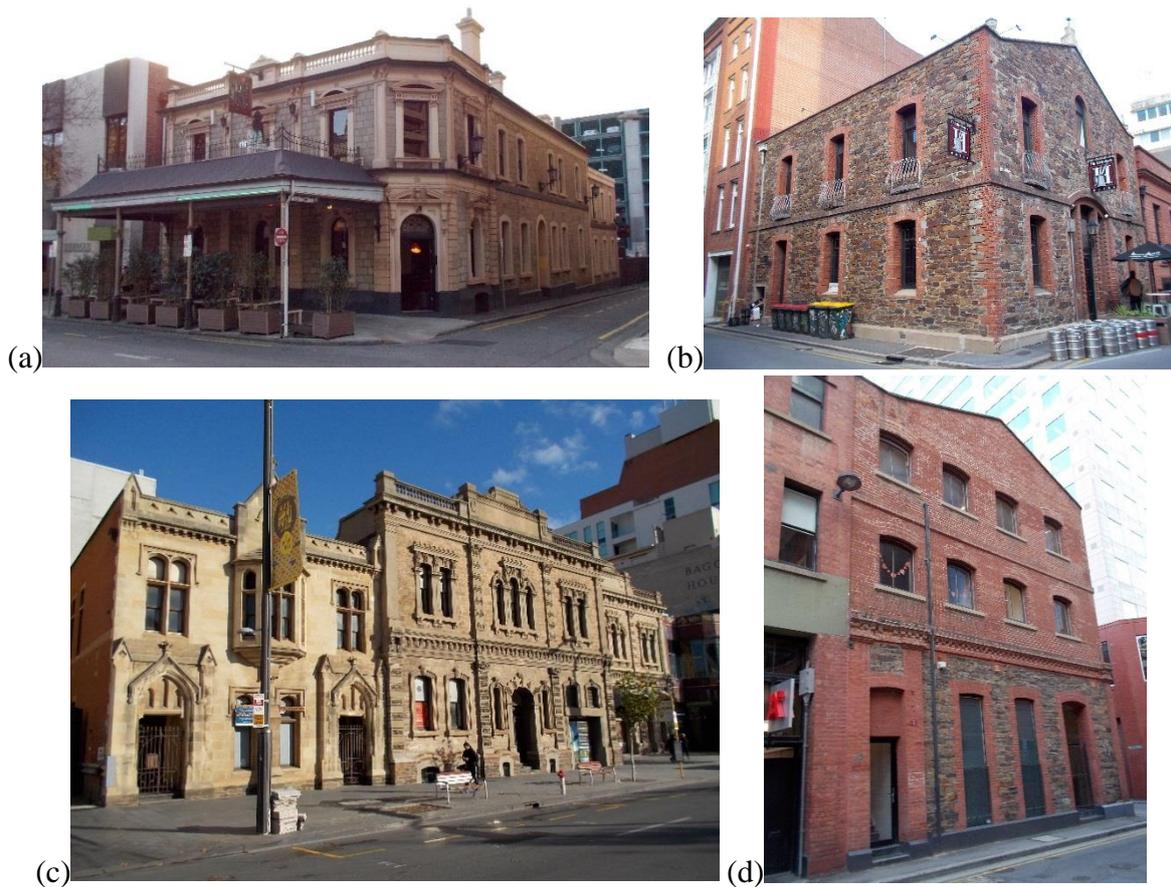
Figure 3: Typical heritage buildings encountered in the Adelaide survey.

- The majority of buildings were constructed between 1800 to 1940 in NSW and between 1840 to 1940 in Adelaide.
- The majority of buildings range from one to three storeys with typical examples shown Figure 3. Taller buildings with four or more storeys, as well as high profile monumental buildings such as churches and institutional halls also have a strong presence in terms of their significance but are less frequent in terms of total building count.

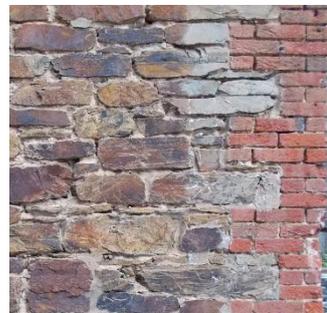
Figure 4: Various type of stonework encountered in Adelaide

(a) sandstone ashlar

(b) bluestone rubble with brick quoins

- Among stone buildings, the quality of the stonework in terms of the regularity of the stone units and interlock between them can heavily influence the seismic in-plane shear resistance of the wall (Vanin et al, 2017). A range of masonry patterns were encountered which varied anywhere between two basic extremes: i) finely-cut, perfectly rectangular blocks typically laid in thin mortar joints and generally providing large degree of overlap between successive courses (referred to as ‘ashlar’), to ii) so-called *random rubble* comprising oblique, misshapen stones typically laid in thick mortar joints in an irregular fashion (refer to Figure 4).

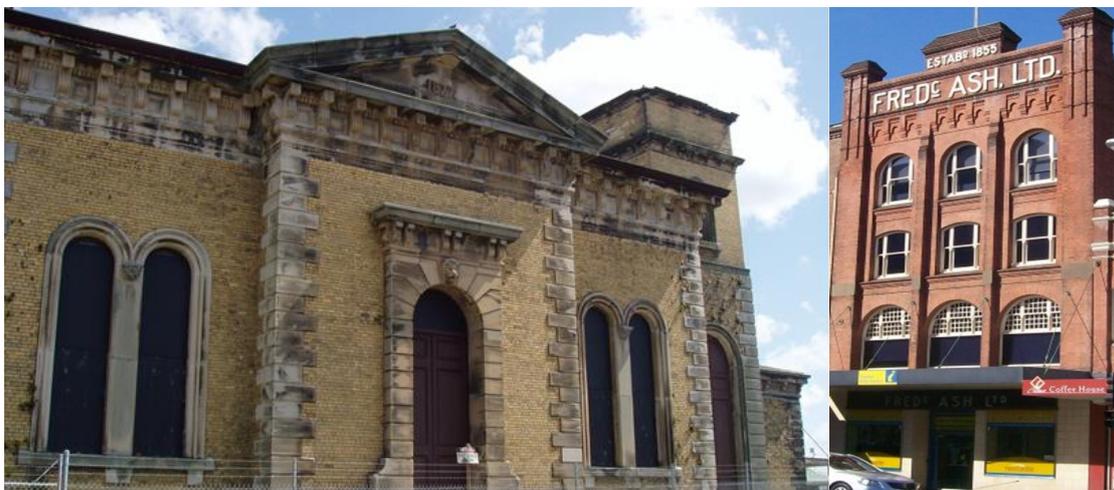
Figure 6: Examples of arched openings encountered in Newcastle.

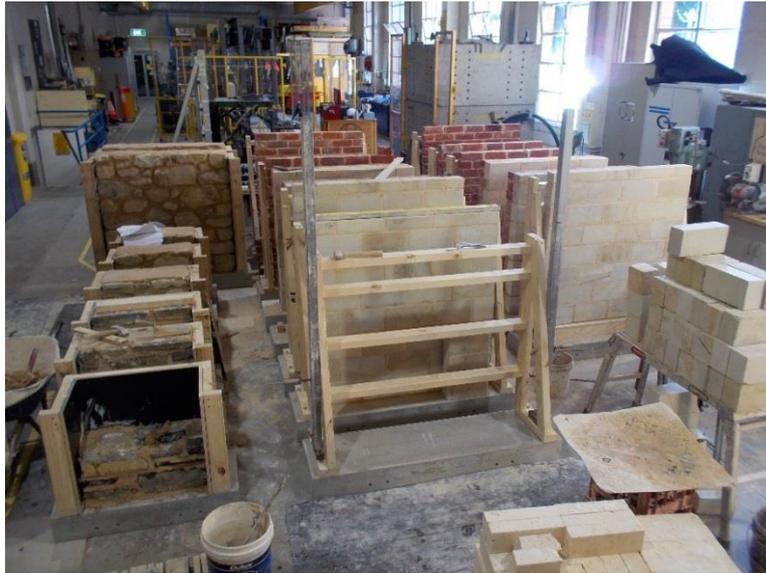
Figure 11: Construction of brick and stone walls for cyclic in-plane testing.

Construction of these panels is shown in Figure 11. The walls will be subjected to constant precompression and a fixed-fixed boundary condition to be generated by a stiff steel beam at the top of the wall as indicated in Figure 12. The intent of the applied boundary conditions is to generate shear failure in the wall as opposed to flexural modes of failure. The walls will be subjected to displacement-controlled cyclic loading at increasing levels of applied displacement until the walls reach their ultimate drift capacity.
