# Bridge performance during the 2010/2011 Canterbury Earthquakes

**Rolando P. Orense<sup>1)</sup>, Tam J. Larkin<sup>2)</sup> and Nawawi Chow<sup>3)</sup>**

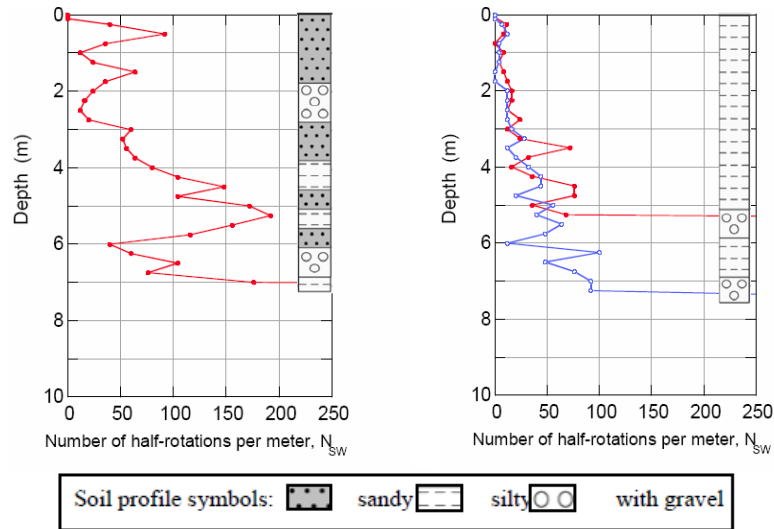
Following the September 2010 earthquake, the NZ-GEER-JGS Reconnaissance team conducted Swedish Weight Sounding (SWS) tests at numerous locations affected by liquefaction. SWS is a simple manually operated penetration test under a dead-load of 100 kg in which the number of half-rotations required for a 25 cm penetration of a rod (screw point) is recorded. One of the advantages of the SWS test is the ability to perform the test within a confined space in backyards of residential properties. Typical results of SWS tests conducted at two locations in Dallington and Avonside, expressed in terms of the number of half-rotations per metre,  $N_{sw}$ , are shown in Figure 3. The depth to the water table in these areas varied between 0.5m and 2.5m. It can be seen from the strength-depth profiles that in these areas, layers of about 5 m or thicker exist

Figure 3: Post-event penetration resistance in Dallington and Avonside measured in SWS tests (after Cubrinovski and Orense, 2010).

with a high potential to liquefy (very loose silt/sand layer with  $N_{SW}$  value < 100).
