The Padang Earthquake 2009 – Lessons and Recovery

Paul Grundy

Department of Civil Engineering, Monash University

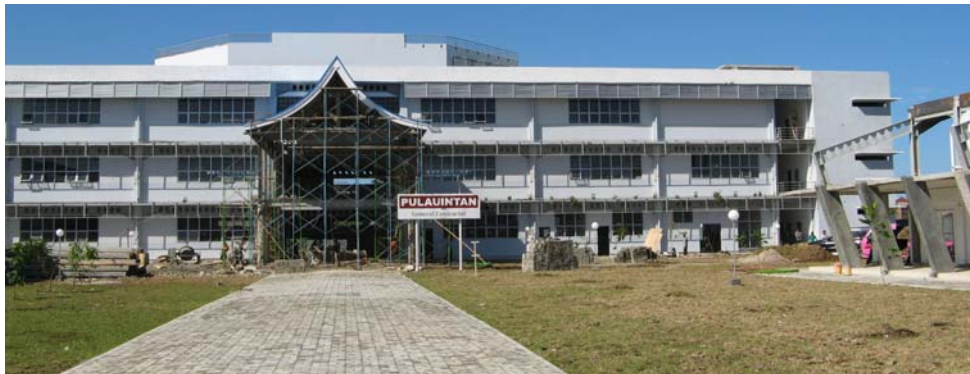
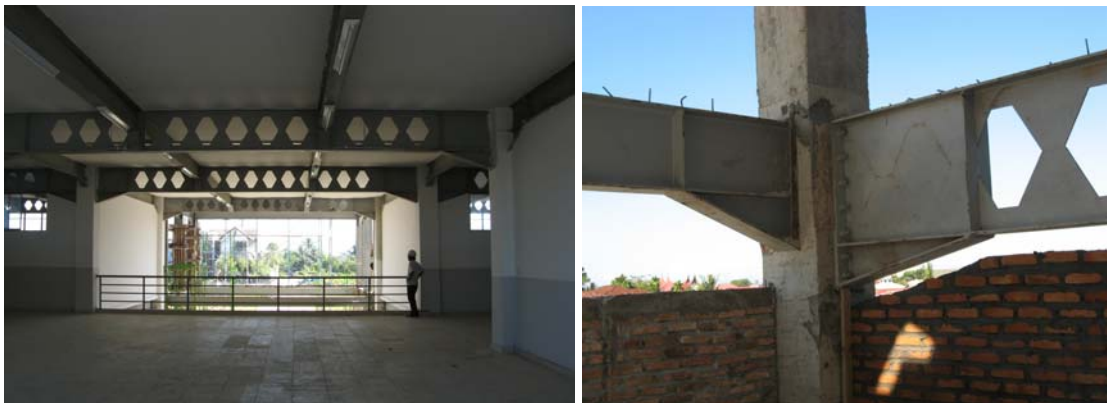
There are a few shining examples which address the need for safe refuge and emergency accommodation after a major earthquake and tsunami, such as a combined evacuation centre and school in steel framed construction nearing completion in July 2010 (Figure 8). Features of this building include

- Located approximately 1 km from the coast in an area at risk of a tsunami.
- Consisting of three storeys and a helipad,
- Steel framed, concrete encased columns,
- Founded on RC piles 18-24m to resist liquefaction
- Built by a Jakarta construction company and labour force,
- Funded by Buddhist Compassion Tzu Chi Foundation

Figure 8 – Regional school with post disaster function

This building is estimated to cost three times that of a traditional school. However, this is justified because of its crucial post disaster function.

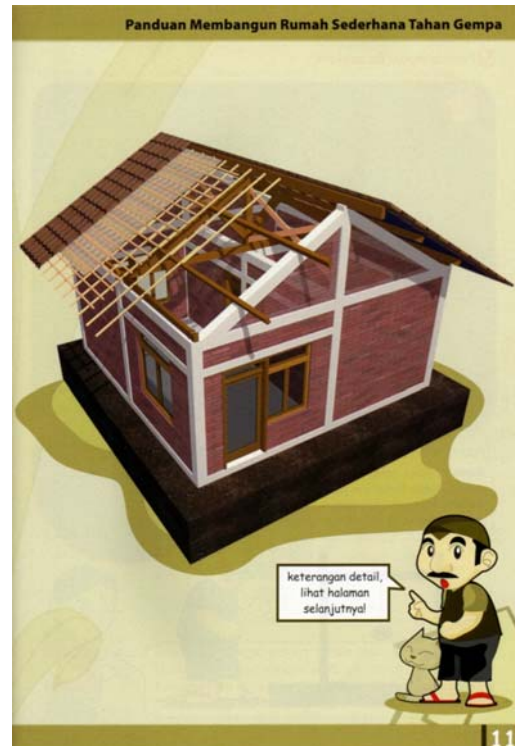
Adjacent to the Provincial Governor's residence in Padang is an exhibition hall where many NGOs display their activities and proposals. These are mostly in the area of restoring community services and building back better. None address retrofitting. Grundy (2007a & b) reported the light concrete frame infilled with conventional domestic masonry, developed in response to the Yogyakarta Earthquake in 2006 (Figure 10).

It should be immediately apparent that the house framing system illustrated in Figure 10 will require training or retraining of bricklayers and other trades if it is to be executed properly. A similar training program is required if the strap on solutions proposed by Grundy are to be effective.

Figure 10 – House built with RC frame infilled with masonry (Suryabrata et al, 2007)
