Unsolved engineering problems after 2011 gigantic earthquake in Japan

ABSTRACT: The gigantic earthquake of magnitude=9 in 2011 in Japan caused many unexpected problems in the community. The significant number of problems over a vast area interacted with one another and made the situation much worse. Nuclear issues have developed to political problems and are difficult to solve in a short time. In addition, engineering is encountering such problems as mitigation of the risk caused by the next tsunami attack, protection of people's houses from subsoil liquefaction, and the preparedness for very rare seismic events in future. The balance between life safety and continuation of economic activities is the key issue but the decision is often affected by political and emotional issues. Because of the speakers majoring field, the talk will put emphasis on geotechnical issues. Note that this report is a minor modification of one of the author's recent papers that were published, first, during the Indian Geotechnical Conference (2011) and, second, in an electronic issue of the Indian Geotechnical Journal

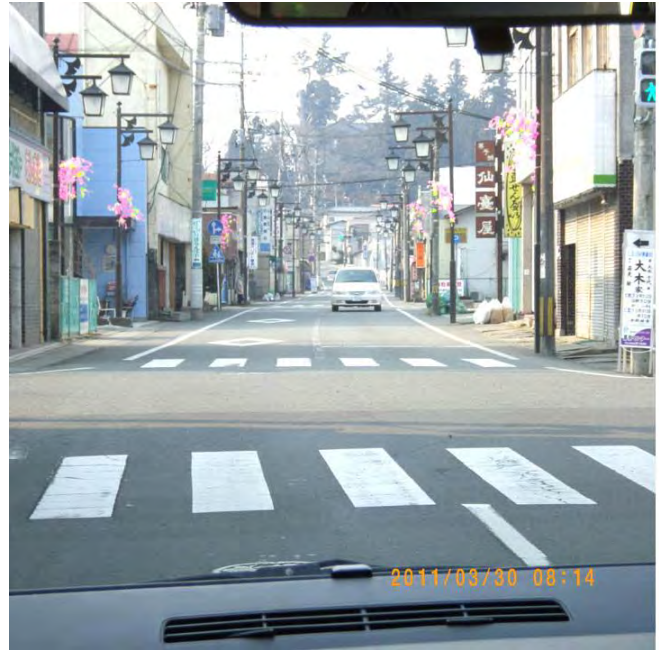
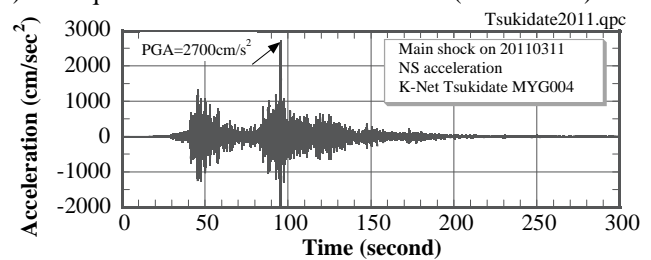
(a) Situation in Tsukidate Township 3 weeks after the quake

(b) Earthquake motion record in Tsukidate (after K-Net)

Fig. 3 Intact situation in Tsukidate Township

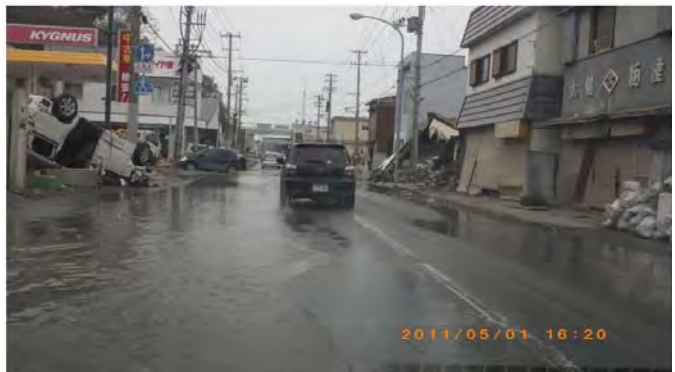
at maximum (announcement by the Meteorological Agency). Consequently, drainage of tsunami water became difficult and the low ground level together with the disappearance of sea walls made the coastal area extremely vulnerable to high waves during typhoons. Fig. 4 shows the Ishinomaki City with ground surface covered by water. Similar coseismic subsidence occurred during the 1946 Nankai earthquake of $M_w=8.1$ or more in Japan and the 1960 Chile earthquake of $M_w=9.5$ together with some other gigantic quakes in the past. In contrast to those former events after which the ground level came back to the original level within several months or a few years, the present subsidence has not been recovered very much (as per the end of October, 2012).

Fig. 4 Zero-level of water-covered ground surface in Ishinomaki City

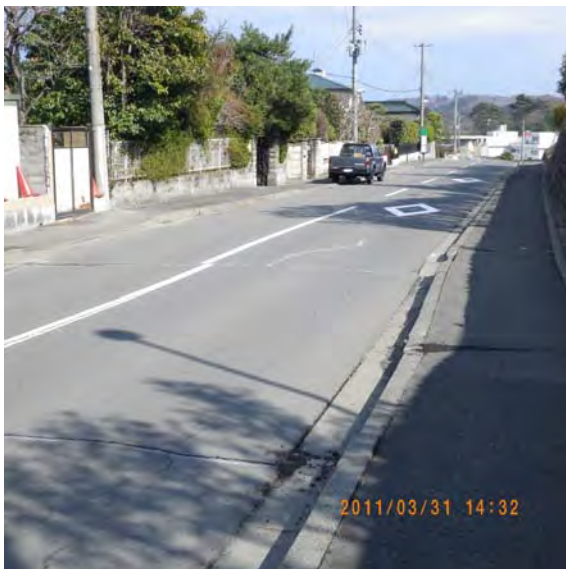
More damaging slope problems, although the size was smaller, occurred in artificial earth fills in hill areas. The residential development in Sendai City has traditionally been conducted in hilly areas where cut-and-fill construction has been the tradition. Fig. 9 reveals a damage example. This occurred in the fill part of the area, causing significant property loss to the residents. Furthermore, Fig. 10 shows the remaining sand at the surface. This sand was an ejecta from liquefaction, because this area was constructed by filling a small water stream. The fill was submerged in water and became vulnerable to liquefaction. In contrast, the cut part of the residential area was of minor damage (Fig. 11).

Fig. 11 Relatively intact shape of residential development in cut part

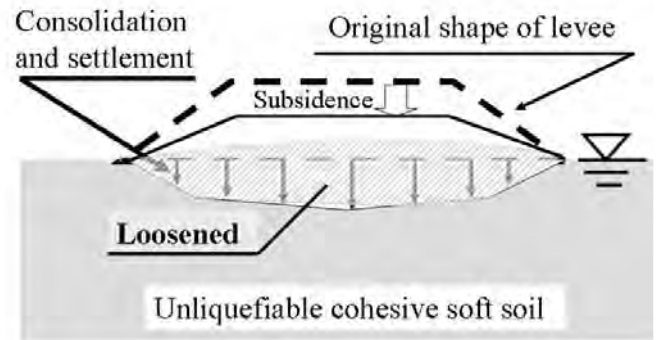
Fig. 15 Mechanism of liquefaction in originally compacted river levee after consolidation settlement in foundation

Figure 15 illustrates the current understanding of the mechanism. First, during normal times, the compacted body of a levee sinks into soft clayey deposit that is subject to consolidation and settlement. Second, the subsided part of the levee is submerged in ground water. This water-saturation has been confirmed by excavation and restoration of damaged levees after the 1993 Kushiro-Oki earthquake [3] and the present earthquake. Third, the subsided part is made looser and liquefiable by an unknown procedure. Some engineers suggest that river levees resting on very soft clay deposits are hardly compacted in practice. Since this part of the idea is not yet verified, more information is expected after the completion of ongoing detailed studies. In addition, the practitioners are now facing a problem how to identify this kind of liquefaction-prone sections out of thousands of kilometers of levees in alluvial planes.

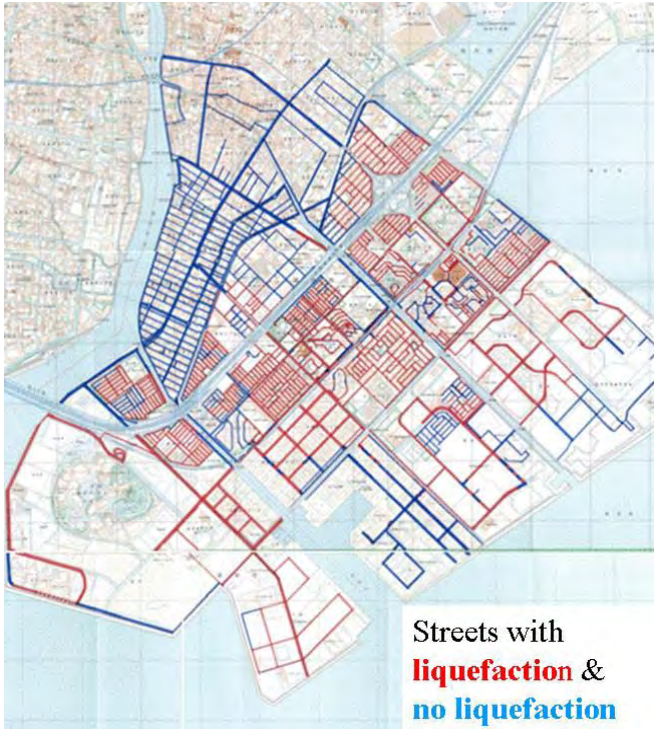
Figure 24 illustrates the distribution map of liquefaction in which streets along which liquefaction was observed are coloured by red, while those without liquefaction by blue. Obviously the south-eastern part of the city was affected by significant liquefaction, while the north-western part was free of liquefaction (Fig. 25). The latter part consists of the original alluvial ground that is as old as 100 years or more. Although the composing sand in this area is basically identical with the seabed sand that was dredged in the recent times and used for reclamation, the consequence of liquefaction was entirely different. This difference, in spite of similar SPT-N values is called the ageing effect at this moment, but its detailed mechanism is still unknown.

Fig. 24 Distribution of liquefaction in Urayasu City

The liquefaction hazard map that was prepared before the quake specified that the entire Urayasu City is prone to liquefaction. Reality was in contrast (Fig. 24), implying that the existing technology underestimates the liquefaction resistance of aged (not as young as manmade islands) sand. To shed light on this, the seismic stress ratio, L , was calculated at many places and plotted against the corrected $SPT-N_1$ value (Fig. 30). Black and open symbols in this figure correspond to the occurrence and lack of liquefaction, respectively. Different symbols correspond to different times of land construction (different ages). Further, the curve indicates the liquefaction resistance of sand assessed by JRA

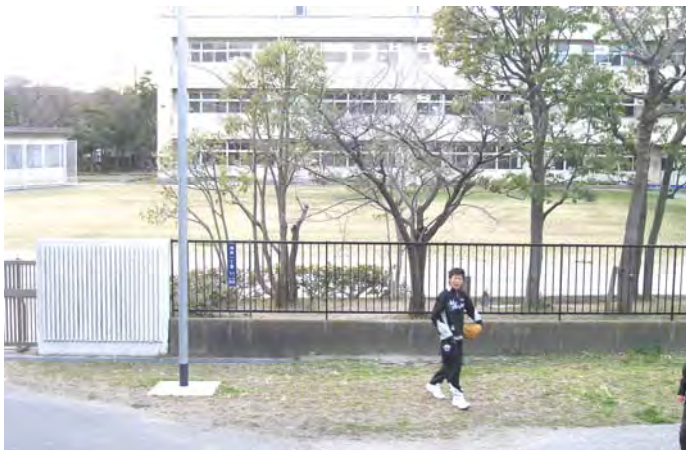
Fig. 25 Lack of liquefaction in north-western part of Urayasu City

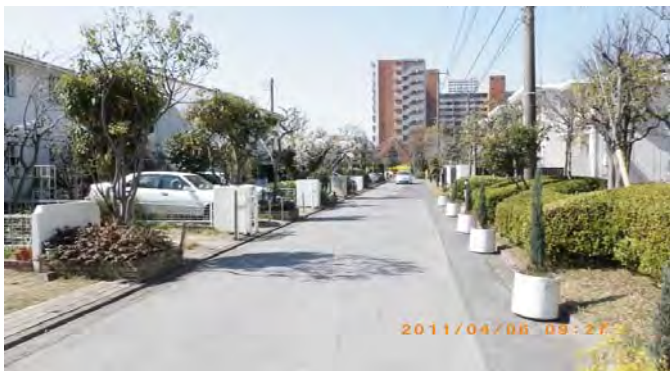
Fig. 26 Successful soil improvement by gravel drains against liquefaction

The lack of liquefaction in the young reclamation area in Fig. 24 was attained by a variety of soil improvement technologies. Although there are still some restrictions to publish those information, it is possible to demonstrate Fig. 26 where a block of residential area had been improved by sand compaction piles and gravel drains prior to building houses. Compaction was executed in the major part of this area, while gravel drains were installed near the border with adjacent residential areas in order to avoid noise and vibration. What is important is that soil improvement before house construction is easy and inexpensive, while improvement under existing houses is more than 5 times more expensive and is now causing problems in the local community. Although some people are accusing of local developers for ignoring the risk of subsoil liquefaction prior to sales, a local real estate businessman said that people had preferred to spent their money not on disaster mitigation but indoor decoration and convenience in life (dish washers etc.). It seems that a trade-off between safety and convenience is going to be a big issue of discussion. It is at least reasonable to say today that safety is not free of charge.

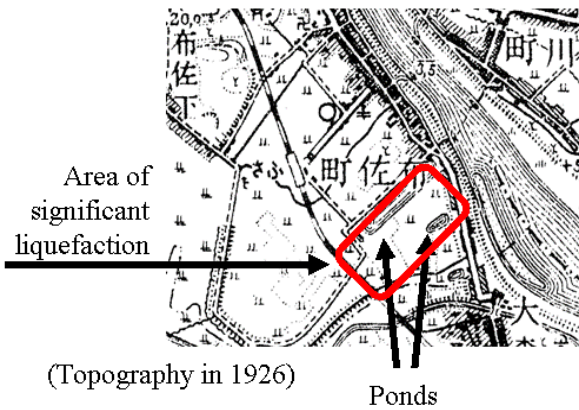
Tone River (Fig. 1) is one of the biggest rivers in Japan and there are many swamps and meandering channels along its main stream. Some of those water areas were filled with soil and formed liquefiable subsoil conditions. Fig. 27 is a liquefied site where flooding in 19th Century created a pond (Fig. 28) that was later filled with sand. The problem was that the liquefaction risk in this area was not indicated in a local hazard map probably because the lack of bore-hole investigation.

Fig. 28 Former topographical map in 1926 of the area in Fig. 26
