Implications of the 2010 Darfield (Christchurch, NZ) earthquake for Australia – are we ready?

Mike Griffith¹, Jason Ingham², Lisa Moon³

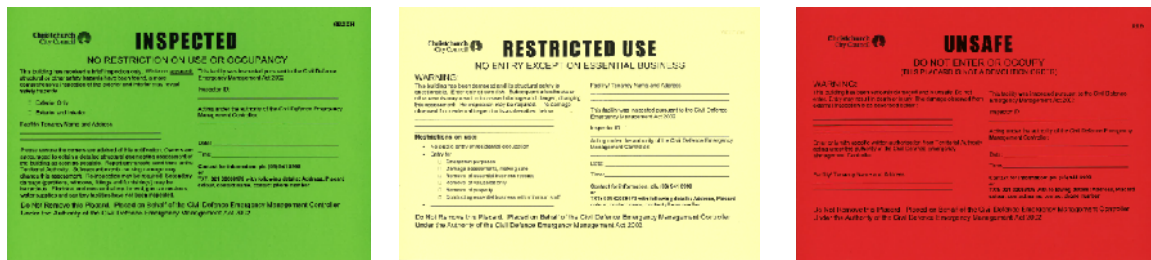
Figure 2. Building assessment notices.

In general, the observed damage to URM buildings in the 2010 Darfield Earthquake was consistent with observed damage to URM buildings in past New Zealand and Australian earthquakes (Davey and Blaikie 2010, Dowrick 1998, Page 1991) and in numerous earthquakes from other countries. As part of the emergency response to this earthquake, the authors spent 72 hours assisting Christchurch City Council with building damage assessments, tagging buildings with either a green, yellow or red placard depending, respectively, upon whether a building was safe for public use, had limited accessibility for tenants/occupants, or was not accessible (refer to Figure 2). Each assessment team

consisted nominally of a structural engineer, an emergency services technician (normally a fire services employee), and a city council employee. On the first day, an Urban Search and Rescue technician also accompanied each team. It took nearly three days to assess all the buildings in the Christchurch CBD, although the task was complicated by three magnitude 5⁺ aftershocks that occurred on the Monday night/Tuesday morning which necessitated review of many buildings to determine whether their status needed changing. Rapid building assessment was essential for the city to reopen as much of the CBD as soon as possible and allow the recovery process to commence. Many examples of earthquake damaged URM buildings were observed during this exercise, as well as many examples of seismic retrofits to URM buildings that had performed well.

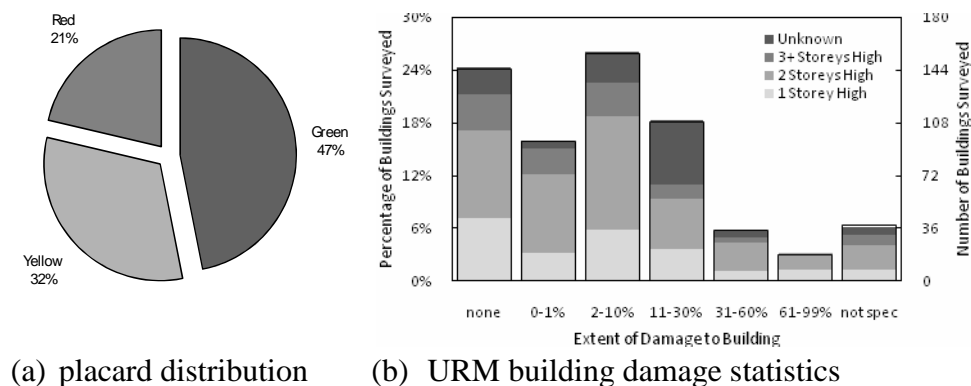
Figure 3. Damage statistics.

The results from the interrogation of damage assessment information are reported in Figure 3. Figure 3a reports the ‘useability’ assignment of the 595 URM buildings assessed. Figure 3b reports the level of damage for the same URM buildings. Despite the known vulnerability of URM buildings to earthquake loading, only 34% of the 595 assessed URM buildings were judged to have more than 10% damage.

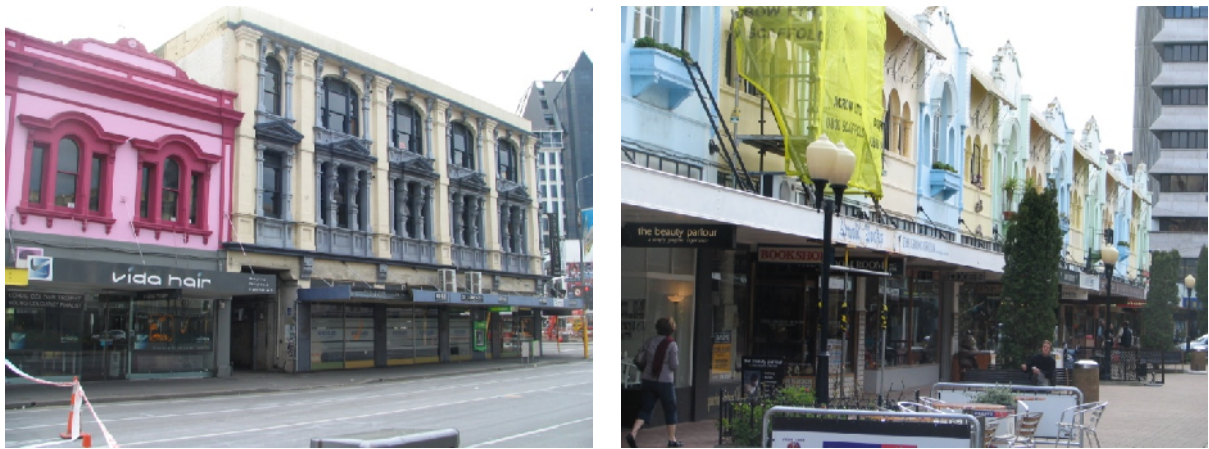
Figure 4. Typical 2- and 3-storey URM buildings in Christchurch.

The architectural features of the URM building stock in the Canterbury region are consistent with the general form of URM buildings throughout both New Zealand and Australia (Russell and Ingham 2008; 2010). These buildings can be characterised as typically 2 or 3 stories in height, with 2 storey buildings being most common, and being either stand alone or row buildings, but with row buildings being most common (refer Figure 4). The most common occupancy type for the 595 URM buildings assessed was ‘commercial’ or ‘office buildings’, hence the majority of buildings were unoccupied at the time of the earthquake, significantly contributing to the lack of earthquake fatalities. A brief summary of the typical failure mechanisms are presented here. For a more

complete discussion of the behaviour of URM buildings during the 2010 Darfield earthquake, refer to Ingham and Griffith (2010).
