# Earthquake Loadings and Steel Structures

L. Pham

CSIRO Division of Building Construction and Engineering, Australia

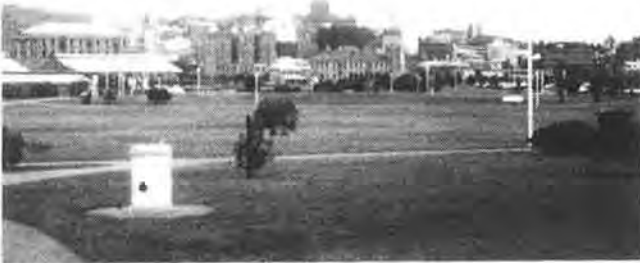
**Figure 1 - General view of East Newcastle**

1. **General view of East Newcastle** with the Cathedral in the upper central position. The recent slides highlight the east west motion of the 1989 earthquake.
2. **West wall.** The masonry foundations were placed between 1883 and 1885. They are in the order of 2m width and 2m depth. Prior to recent investigation, it was thought that they were founded upon the prevalent sandstone of the area. However, it has now been determined that the site consists of dense sands of 10 to 30m depth. The lower half of the massive solid masonry wall was erected in the 1890's.

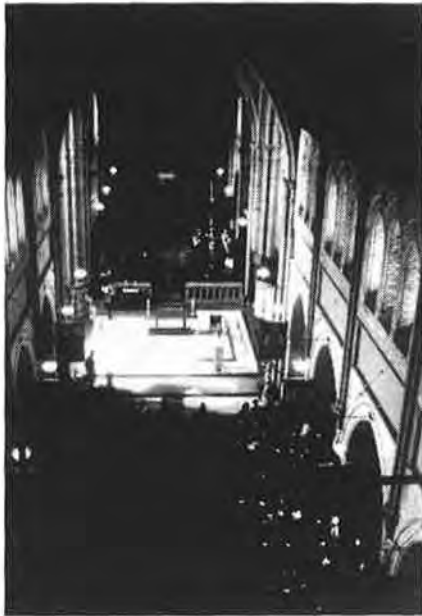
**Figure 13 - General interior**

13. **General interior.** With transept in the middle and the arches of the main northern and southern walls.
14. **Northern arch.** Cracking of the masonry over the arches occurred due to differential settlement of the structure caused by consolidation of the founding material after the erection of the tower in the 1970's. It appears that sway of the tower during the earthquake has exacerbated the existing cracking in the first bay from the transept arches in each direction.

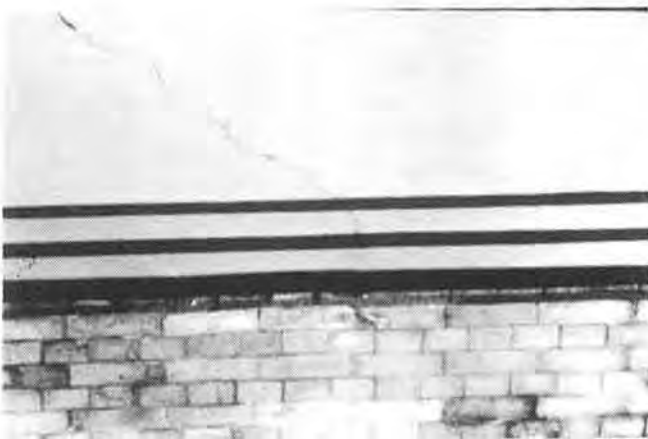
**Figure 15 - Previous repairs to archway**

15. **Previous repairs to archway.**
16. **Flying buttress.** These were built for stability of the walls in the north south direction. Their own stability in the east west direction was not high, partly because of the existence of flashings in their height. The vertical part of the buttresses displaced up to 20mm due to the earthquake, affecting the arching over. As a result, the arches have suffered extensive damage, requiring remedial bracing

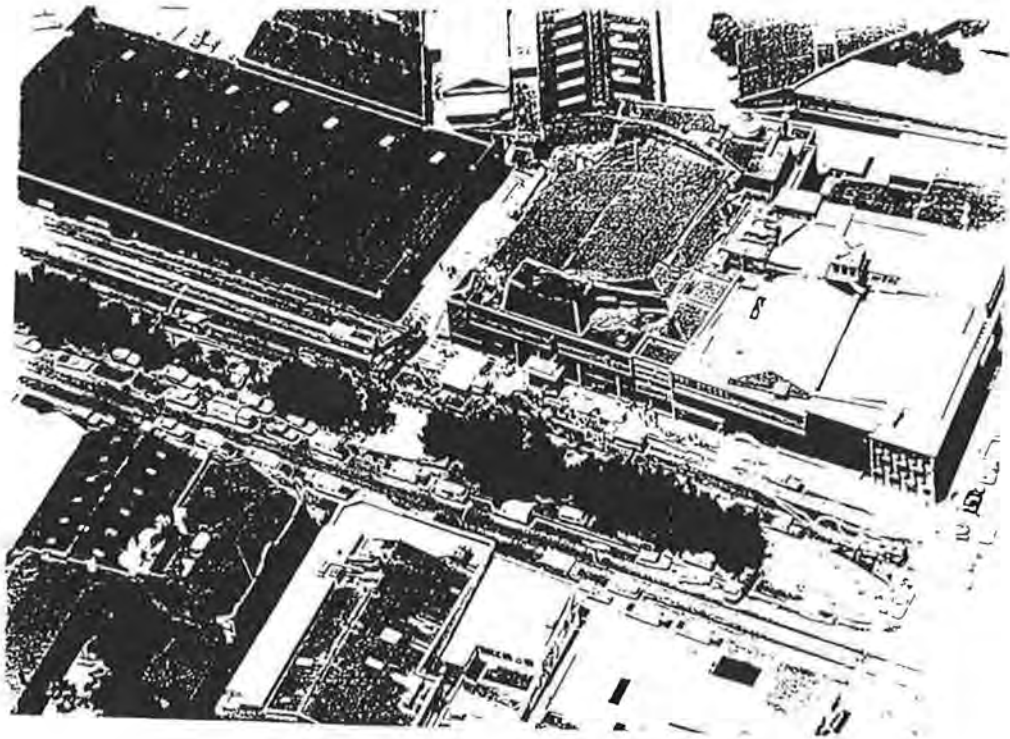
The buildings that formed the Newcastle Workers Club were built in several stages. The section comprising of the eastern half of the building (white roof area) is the original structure while the westerly section (the darker collapsed section) was designed in 1970 and constructed soon after (figure 1).

Figure 1 - Aerial view of collapsed Workers Club

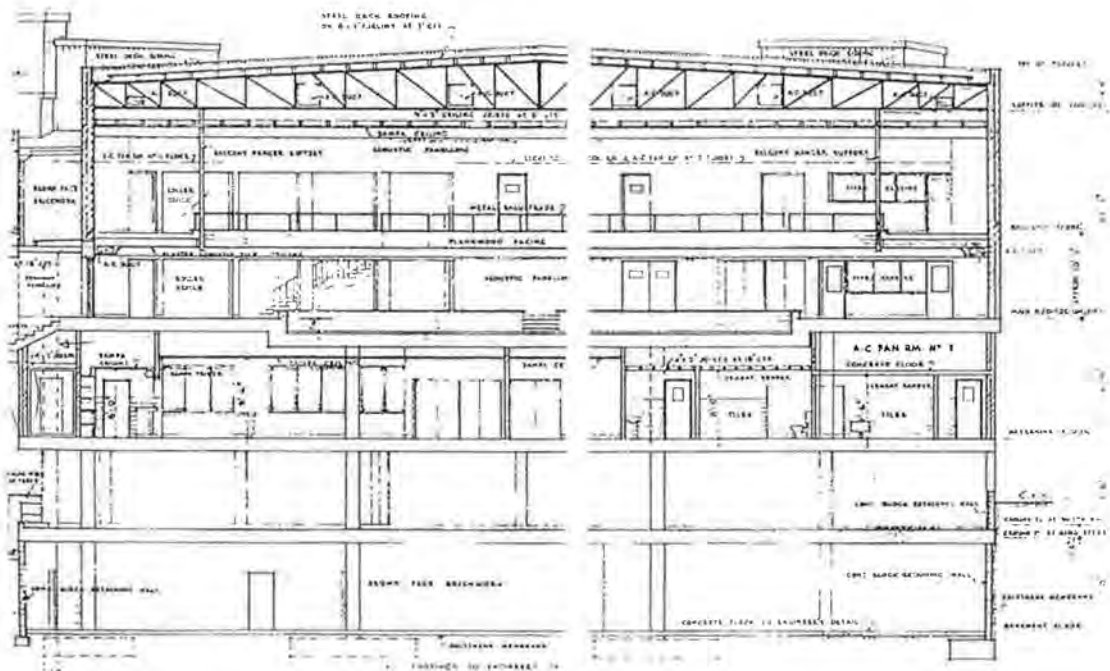
- The 1970 or westerly section of the building is of reinforced concrete construction for all the suspended floors. The floor noted on the drawings as the balcony level is a solid reinforced concrete beams. The steel beams are fixed to the structural steel columns at the perimeter of the building with the internal support being in the form of RHS section hangers from the roof trusses. The reinforced concrete beams are either supported on reinforced concrete columns or at the perimeter of the building of loadbearing brickwork (figure 2).

Figure 2 - Building cross section

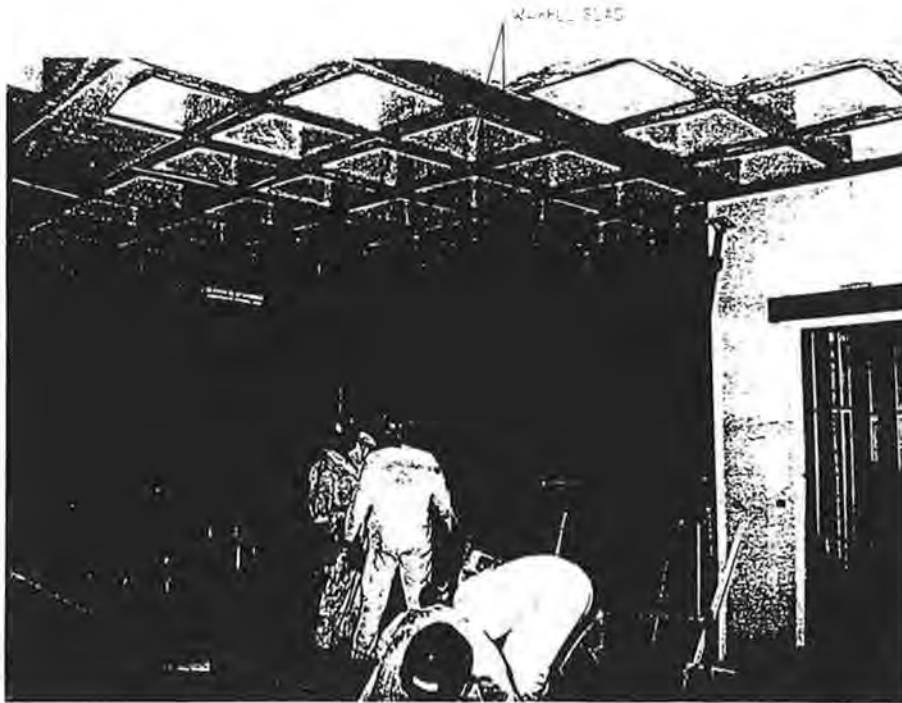
- The first three levels were waffle type slabs supported on reinforced concrete columns (figure 3).
- The roof structure consisted of metal sheeting supported on timber purlins which was in turn supported on structural steel trusses. The trusses are supported on structural steel columns. From the drawings it would suggest for lateral load, the resistance of roof level was to be provided by horizontal trusses in the plane of the roof which would transfer these loads to the walls in the direction of the load. From the balcony floor down the lateral loads would be distributed to the remaining structure in accordance with the stiffness of the various elements (figure 4).

**Figure 3 - Waffle slab construction**

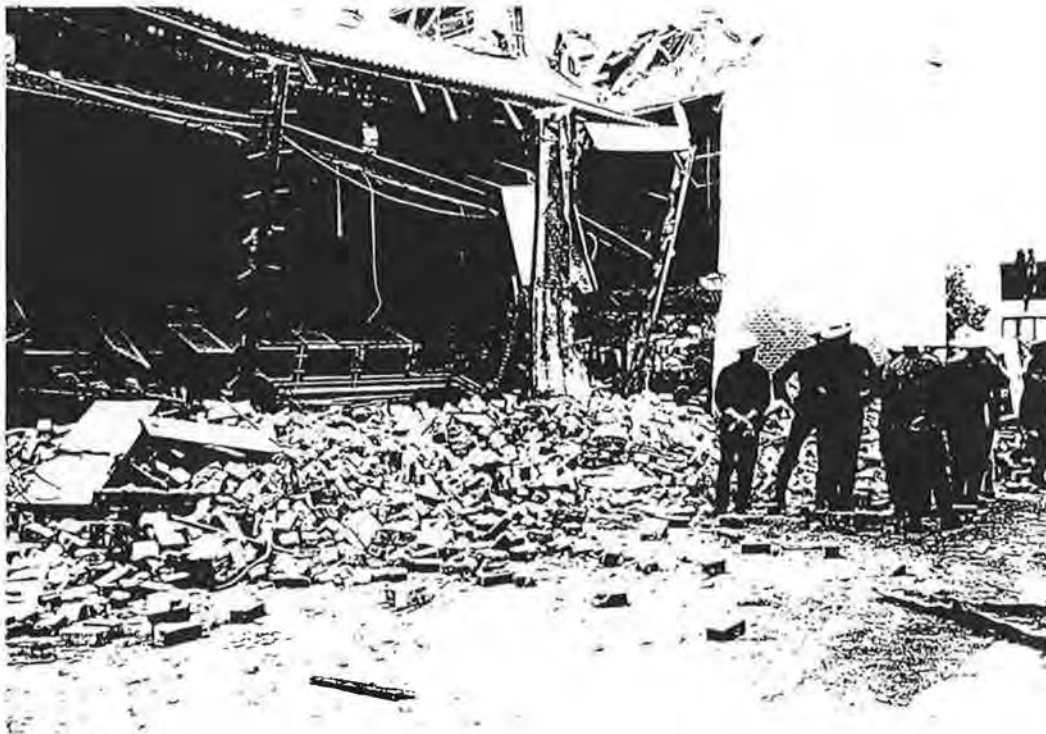
**Figure 4 - Western wall failure**

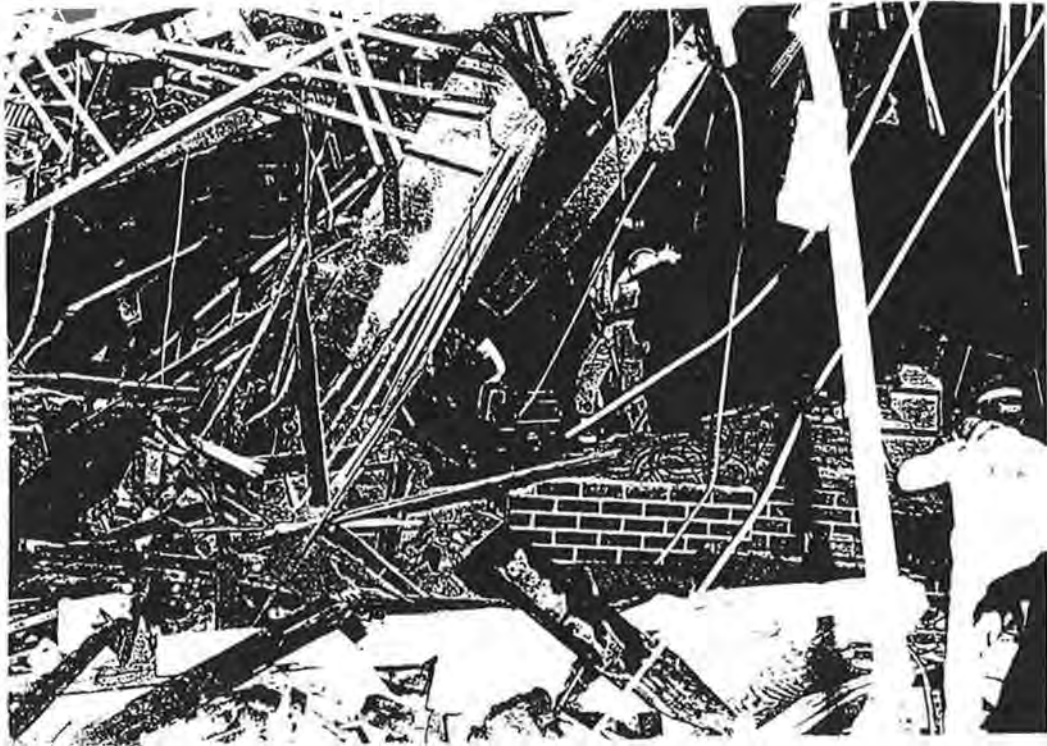
1. The punching shear failure at ground floor at the first line of columns adjacent to the west wall (figure 6).
2. Shear failure at first floor level close to the western edge of the drop panel adjacent to the western wall was the area of major collapse and the area where most fatal injuries occurred (figure 7).
3. The attachment of the steel hangers to the bottom chord of the structural steel trusses.
4. The lack of any of the typical signs of damage to the structural steel columns normally associated with the failure of such members (figure 8).
5. The collapsed brick wall for almost the full extent of the western wall.

Figure 7 - Western wall failure

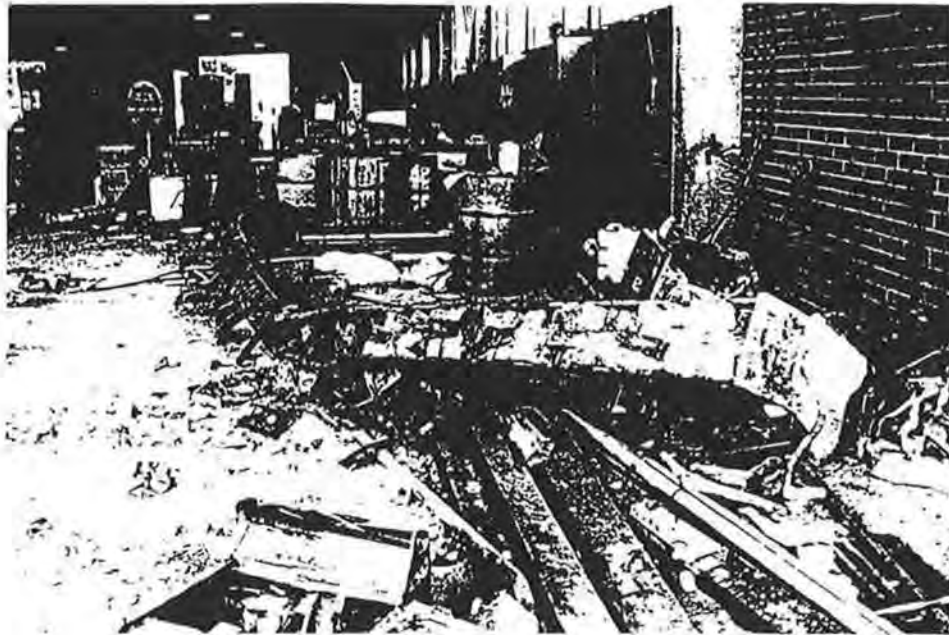
However, for the assumptions of a. and c. to be valid requires the reaction from the horizontal load to be either transferred through the brick that is cut between the column flanges or the frictional resistance of the brickwork bearing on the steel cleats (figure 9). We do not believe any reliability could be placed on the brickwork cut between the steel flanges as the very act of notching the stretcher course would in all probability have initiated a crack at the re-entrant angle. Accepting this statement then we believe the only reliable means of checking horizontal support is through the frictional resistance provided between the steel plate and the area of brickwork bearing on this

Figure 9 - Brickwork failure
