# Performance of posttensioned seismic retrofit of two stone masonry buildings during the Canterbury earthquakes

# Abstract

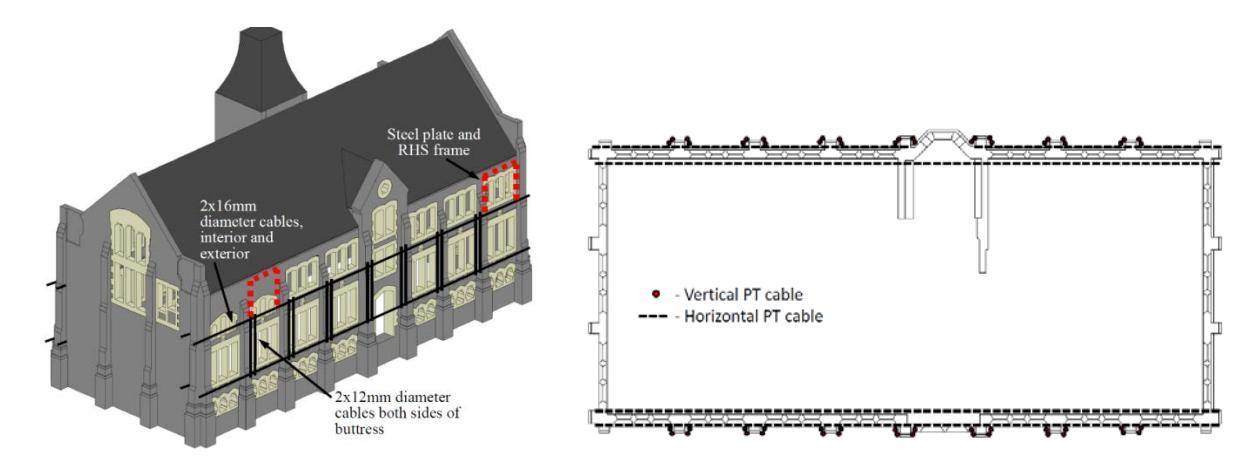
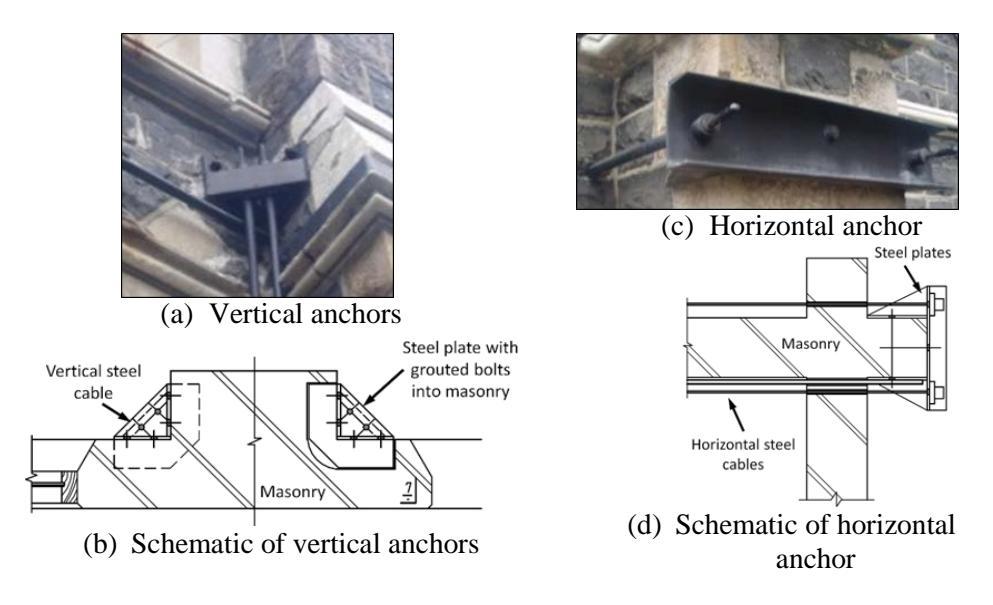
Figure 3: Chemistry building

The retrofit to the Chemistry building (as shown in Figure 3) was part of a strengthening scheme that also involved diaphragm strengthening and steel frames being applied to the attic level (see Figure 4, also, illustrated by dotted lines in Figure 3a). Vertically oriented posttension tendons were installed on the ground level along the north and south facades. These tendons were located in pairs on either side of the buttresses and were anchored into the concrete slab above the basement, stretching up to the bottom of the top level of the building (Figure 4). In total, seven pairs of vertically oriented tendons were also applied on the north and south faces. Horizontally oriented posttension tendons were also applied on the north and south faces of the building, and were paired with a companion tendon running parallel on the inside of the wall in order to enhance a frame-type action of building response. Two pairs of horizontally oriented tendons were applied to the north and south faces, one at the base of the ground level and one at the base of the first floor level.

(a) Isometric view of the building showing the location and the extent of the retrofit

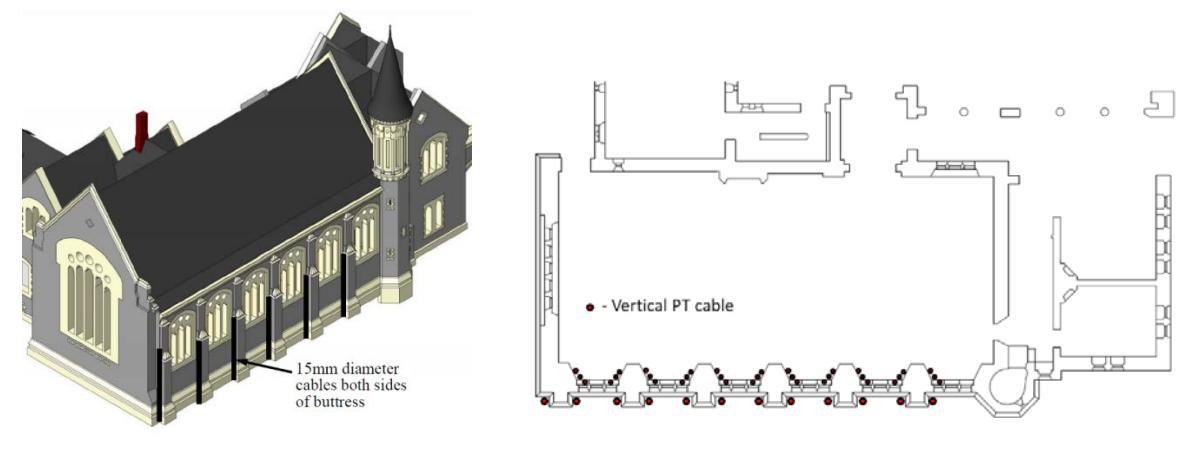
Figure 5: College Hall building

The College Hall posttensioned seismic retrofit was applied to the west side of the building (Figure 5 and 6) and was completed in conjunction with window frame strengthening and widening of the foundations for stability once the posttensioning was applied. The exterior posttension tendons extended from the new foundations to wall mid-height, while the interior posttension tendons extended from the foundation to the roof truss (see Figure 6). The exterior tendons were located in pairs on either side of the buttresses, while the internal tendons were in groups of three, again located on the internal side of each buttress as indicated in Figure 5b. The posttensioned retrofit was applied to compensate for the ineffectiveness of the roof diaphragm in the east/west direction. Therefore the walls were designed as cantilevers and during the retrofit grout was pumped into the drilled holes around the piers in order to fill any voids within the piers.

- (a) Isometric view of the building showing the location and the extent of the retrofit
- (b) Floor plan of the building showing the location and the extent of the retrofit
