Seismic Performance of Non-Engineered Residential Buildings in the 2014 Mae Lao Earthquake

T. Ornthammarath

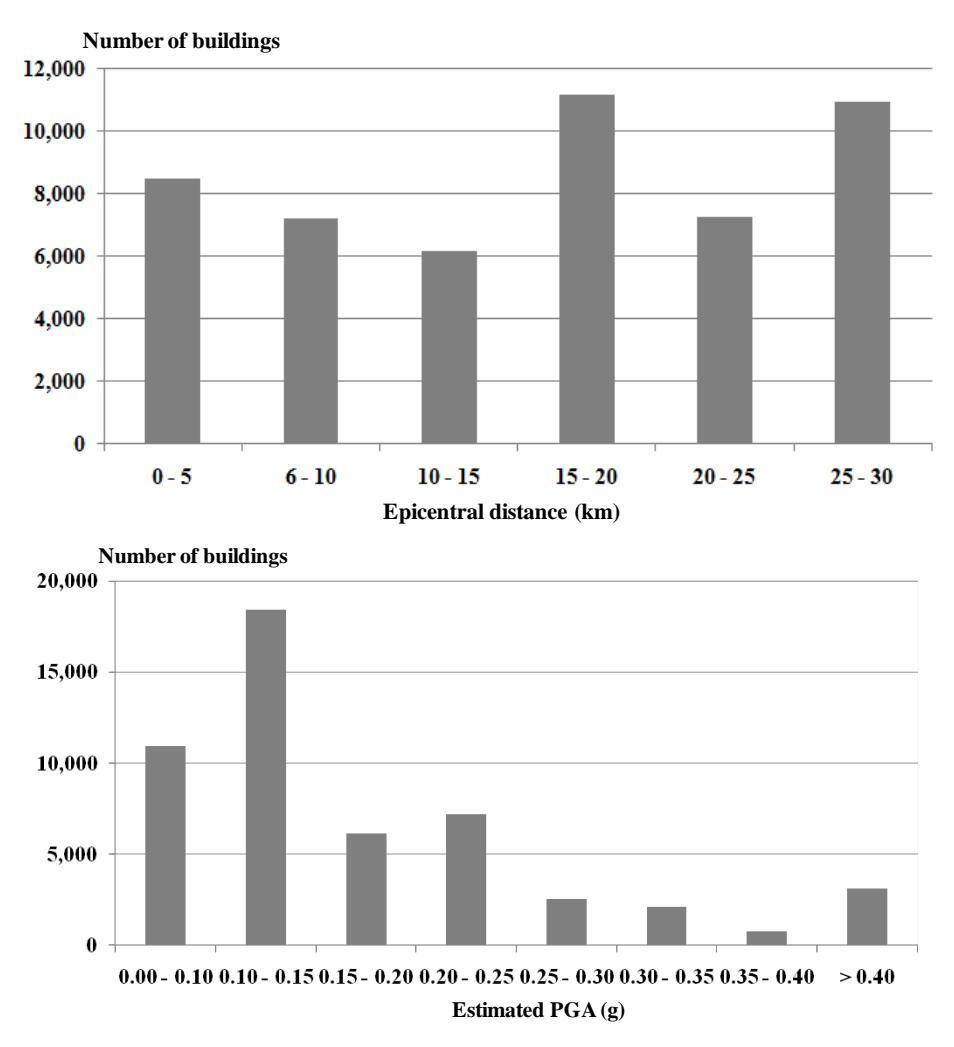
Figure 5 a). The number of buildings in earthquake affected area with respect to the epicentral distance and b) estimated peak ground acceleration (PGA) based on BA08.

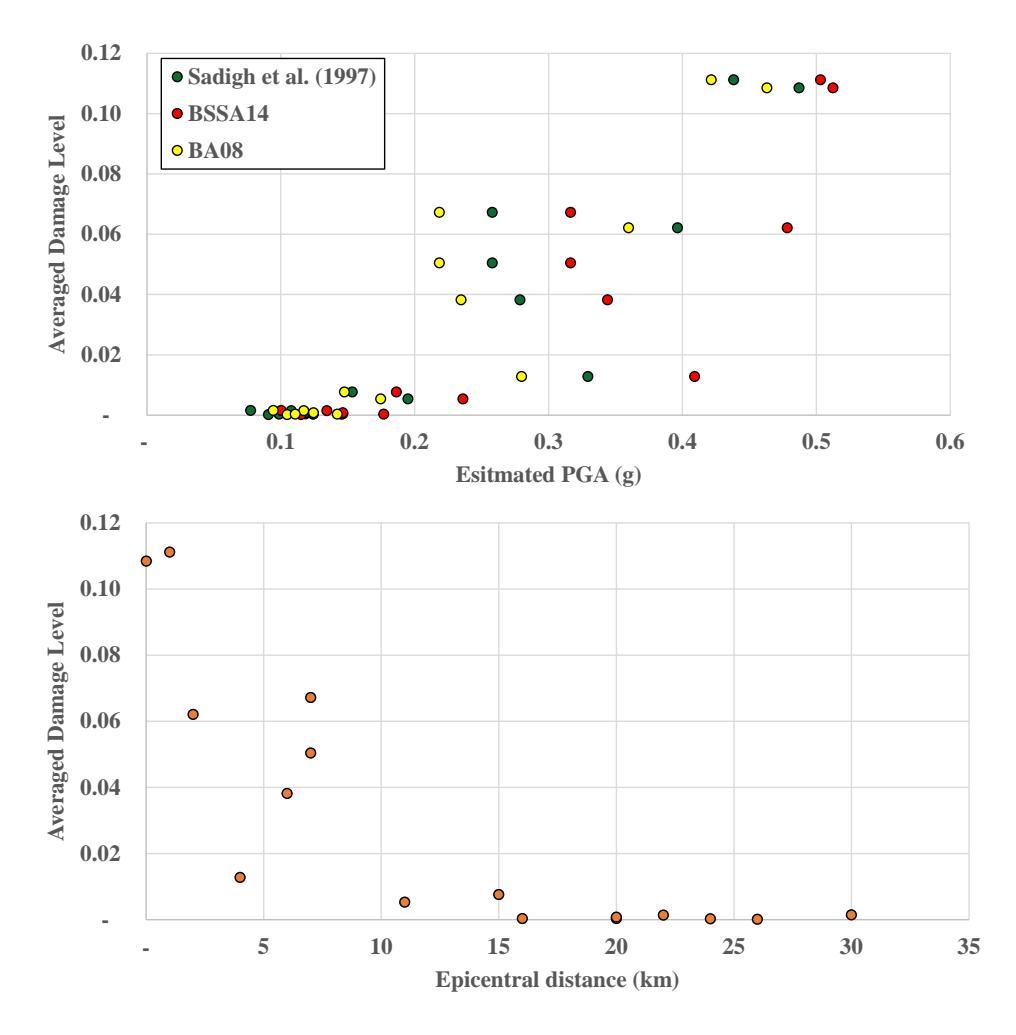
Figure 6 displays the relation between the averaged damage level with estimated PGA and epicentral distance. The averaged damaged level tends to decrease as the distance increase. PGA values seem to correlate well with observed damage this is might due to the fact that most dwellings in affected area are one to two story buildings. The maximum averaged damage level is 0.11. Within relatively small area, for 10 km long, the averaged damage level is in range of 0.01 - 0.11 conforming to field investigation that large numbers of buildings within Mae Lao are still intact with minimal structural damage. In addition, the averaged damage level seems to significantly change if PGA exceeds 0.2g, 0.3g, and 0.4g based on BA08, Sadigh et al. (1997), and BSSA14, respectively. It is worth to note that similar damage patterns in this region have been observed in the previous Mw 6.8 Tarlay earthquake on 24 March 2011, in which the recorded ground motion PGA is 0.2g, Ornthammarath (2013).

Figure 6 a). Averaged damage level in earthquake affected area with respect to estimated peak ground acceleration (PGA) based on BA08, BSSA14, and Sadigh et al. (1997) and b) the epicentral distance.
