The 2010 Chile Earthquake: a five-year reflection

J.C. de la Llera, J. Mitrani-Reiser, F. Rivera, C. Fortuño, R. Jünemann, A. Poulos, and J. Vásquez

ABSTRACT: At 3:34AM local time, on February 27th, 2010, a moment magnitude M_w 8.8 megathrust earthquake struck offshore the coast of Chile. The earthquake ruptured a 540 by 200 km mature seismic gap of the underlying subduction pacific plate interlocking mechanism. More than 75% of the 16 million Chileans spread over several large urban areas in the center-south of the country were affected by the earthquake, which caused 521 fatalities with 124 of them due to the tsunami, and an overall damage estimate of USD 30 billion. Because the earthquake struck the most densely populated area of the country, it represents a very unique opportunity to reflect on its ubiquitous impact over many different physical and social systems. The reflection contained in this article occurs five years later, once reconstruction and recovery are complete from this *longitudinal wound* of the country. Seismic codes have changed, research on the supposedly indestructible reinforced concrete shear walls has been done, new seismic protection technologies have

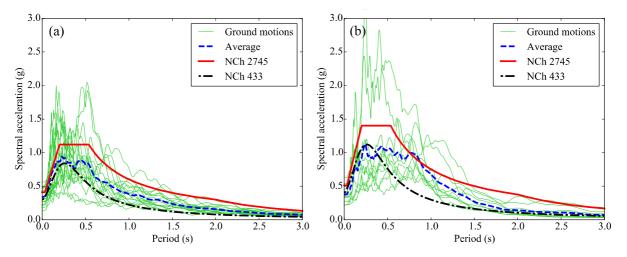
design spectra of the other local seismic code, the seismic isolation code NCh 2745, which is 0.1g at PGA larger than NCh 433, proved to be more consistent with this earthquake as shown in Figure 5.

Figure 5. Design spectra from the NCh433 and NCh2745 Chilean seismic codes, and from recorded ground motion accelerograms of the 2010 Chile earthquake near to the fault plane (from 33°S to 38.5°S), in soil type II, and: (a) zone II (central valley), and (b) zone III (coast).
