Ground deformation and proposed mitigation during 2011 gigantic earthquake in Japan

Ikuo Towhata

President, Japanese Geotechnical Society, Tokyo, Japan.

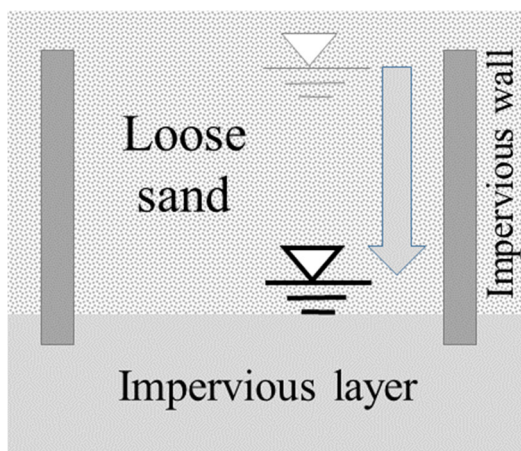
Figure 5 Principle of ground water lowering for liquefaction mitigation

Ground water lowering constructs underground impervious walls around a treated area and then installs electric pumps to remove underground water (Figure 5). When there is an impervious layer underneath, the liquefiable sandy layer can be maintained unsaturated and unlikely to liquefy. This method is inexpensive and was exercised in Amagasaki City near Osaka after the 1995 Kobe earthquake (Figure 6). Although a possible defect of water lowering is consolidation and subsidence, they did not happen significantly in the area of Figure 6. Most municipalities have chosen this option for soil improvement.

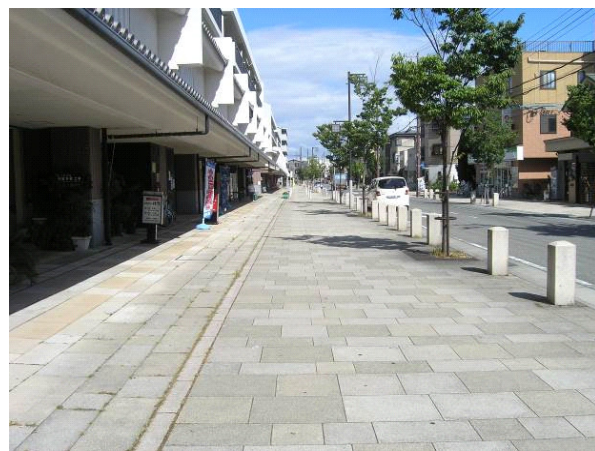
Figure 6 Tsukiji area of Amagasaki City where ground water level was lowered

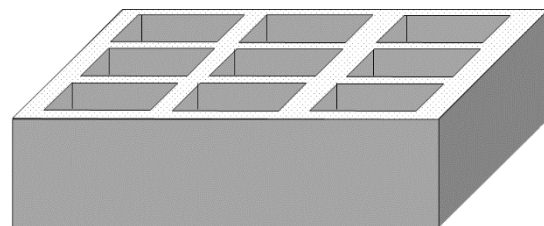
Figure 7 Schematic illustration of underground grid wall

Urayasu city has approximately 9000 houses damaged by liquefaction. The problem here is that there is more than 40-meter thickness of soft clayey soil and this city experienced significant consolidation problems in 1980s and early 90s. Because of this, water lowering was not accepted and underground grid walls was selected. Figure 7 illustrates the idea of the grid wall; one square grid under one house. It restrains cyclic shear deformation of subsoil during earthquake shaking and reduces the development of excess pore water pressure. The surface unliquefiable soil further increases this mitigative effects. This technology became popular after the 1995 Kobe earthquake in which the grid wall foundation successfully prevented liquefaction in Kobe Harbour.

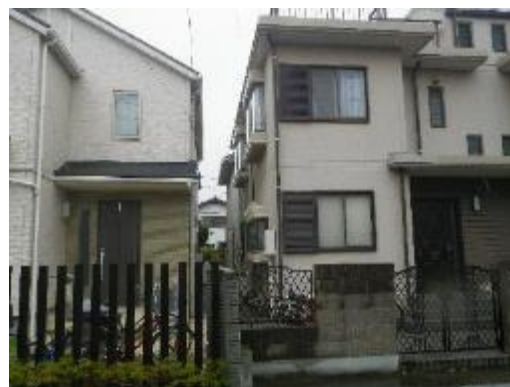
Figure 8 Small space among houses in Urayasu

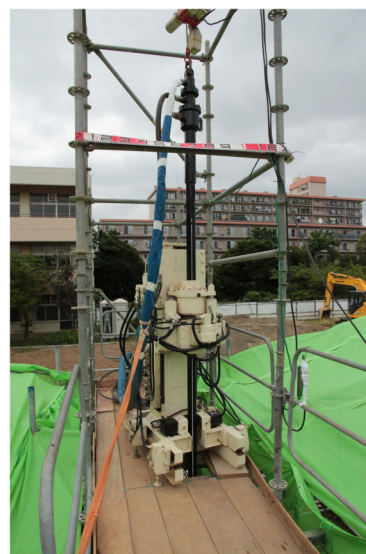
Figure 9 New small machine for construction of slurry wall

houses (Figure 8). Hence a small machine such as in Figure 9 was newly developed. As per October 2015, residents are discussing whether or not they should accept this soil improvement and shoulder required expenditures. It is important that unanimous agreement of residents, which is typically 100 families, is necessary.

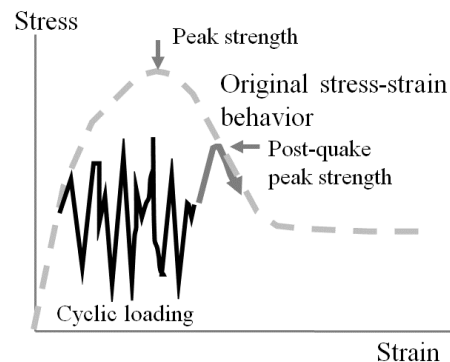
- (1) Soil falls down from mountain slopes during earthquake shaking, deposits at a valley bottom and is washed out during heavy rain,
- (2) Cracks develop in a mountain slope and rain water flows into them,
- (3) Soil and rock in a mountain body is mechanically disturbed (development of plastic deformation) during earthquakes and lose shear strength (Figure 14).

Figure 14 Loss of peak strength after seismic cyclic loading

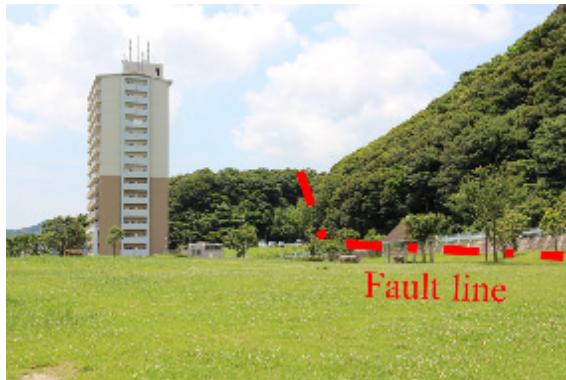
Figure 15 Open space without building upon active fault (Kita-take fault, Yokosuka, Japan)

Generally the only safety measure for fault problem is “avoiding” in which the land use upon potentially active faults is controlled or prevented (Fig. 15). In case of strike-slip faults in which horizontal displacement plays a major role, some measures have been taken; for example, a block structure in a concrete dam in New Zealand (Amos and Gillon, 2007) and a sliding foundation of Alaska Pipeline. More difficult situation occurs when vertical displacement is predominant. Figure 16 is an example of mitigation in which a station resting on a reverse fault is separated into three parts and will avoid collapse in case of fault displacement. The existing problem is that we cannot assess the fault displacement to occur and its probability in an engineering sense. Note that one of the reasons why all the nuclear power plants in Japan had to stop operation after the 2011 earthquake is the possible risk of fault action underneath. Discussion focused only on whether or not an underlying material discontinuity was fault and did not address the magnitude of displacement during future earthquakes. Our engineering is not developed enough to deal with such a rare event as occurs once every thousands of years.

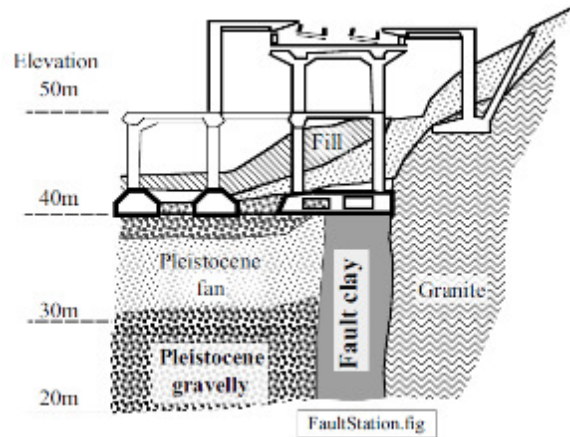
Figure 16 Separated structure of New Kobe railway station resting on reverse fault
