Performance Study of Seismic Bracing Assemblies of Suspended Ceiling Systems

G.C. Yao & W.C. Chen

Department of Architecture, National Cheng Kung University, Taiwan.

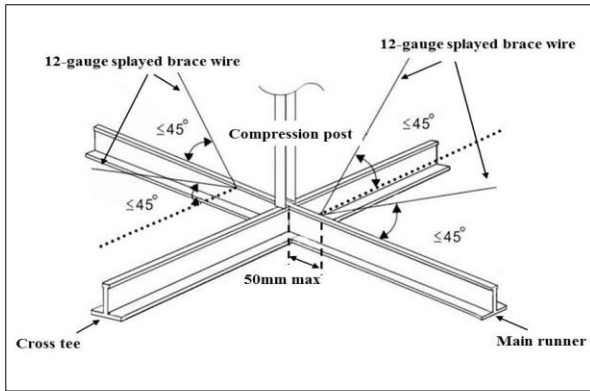
Figure 1. Details for the bracing assembly

In 2011, an appendix referring to ASTM E580-06 was issued in the Taiwanese building seismic design code. The appendix explicitly provides guidance for the seismic installation of the suspended ceiling systems. The main construction details include the use of the fixtures at two fixed adjacent ends and the installation of the edge hanger wires which have proven advantageous in limiting the movement of the ceiling systems. In addition, the lateral bracing assemblies are required for all ceiling areas greater than 100m². However, the construction of the bracing assembly has always been a difficult problem leading to uneven qualities of the suspended ceilings. Figure 1 shows a bracing assembly consisting of four wires splayed 90° from each other also at an angle not exceeding 45° from the ceiling plane and a vertical strut performing as a compression post. To satisfy the demand of the angle not exceeding 45°, sufficient space in the horizontal direction is necessary. However, the installation of the suspended ceilings has always been arranged after the construction of other overhead non-structural elements such as mechanical equipment and piping systems. For this reason, the lateral bracing members especially the splayed wires are frequently obstructed by equipment and consequently installed in bad construction. Figure 2 demonstrates a common situation of ceiling construction in Taiwan, and it is obvious that there is almost not enough space to set up the bracing assembly.

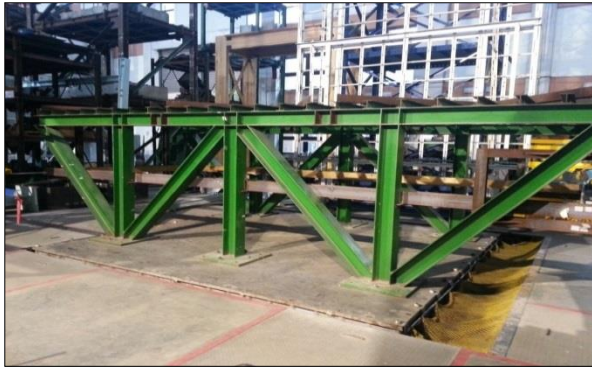
Figure 3. Elevation view of the steel frame

Experiments of suspended ceiling systems were performed using a shaking table at the National Center for Research on Earthquake Engineering (NCREE) in Taiwan. Suspended ceiling specimens with different test configurations were installed in the 8m by 3m and 2m high steel frame as shown in Figure 3. The natural frequencies of the steel frame along the long side (denoted as X direction) and short side (denoted as Y direction) are 35Hz and 10Hz respectively. Considering the possibility of resonance effect of the steel frame in Y direction, ground excitations are performed only in X direction. Furthermore, the small H steels at the top of the frame are also reinforced (Figure 4) to avoid local mode effect. The natural frequency of the steel frame in vertical direction (Z) is approximately about 30Hz.

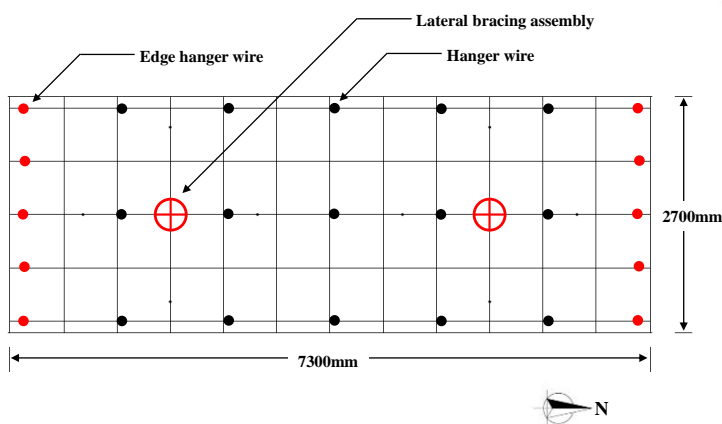
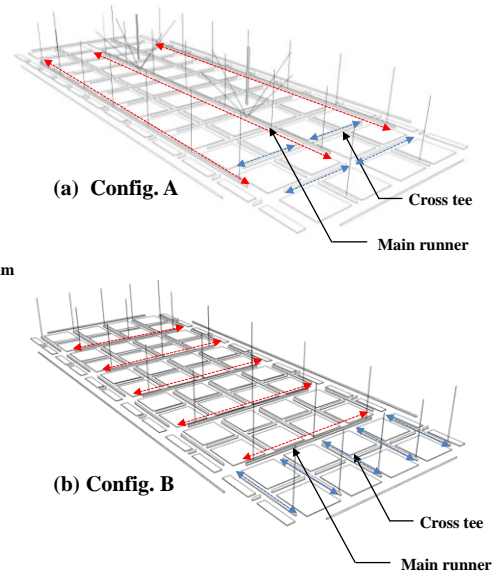
Figure 5. Overall view of the ceiling system

Figure 5 demonstrates the layout of the ceiling system which is symmetric in plan with dimension of 7.3m by 2.7m. The 24mm wall moldings were attached to the perimeter boundaries. At the west and south side, tapping screws were used to fix the ceiling grids to the wall moldings. Alternatively, at the east and north side the grid members were attached with 12mm clearance to the wall moldings that allowed the grid members to float freely. All the ceiling systems were constructed using the JTB-Seismic Design exposed tee system manufactured by a Taiwanese qualified manufacturer (Yi Star Enterprise Corp.). The main runners and the cross tees were aligned in two configurations: 1) the main runners installed in the north-south direction (Figure 5-a), and 2) the main runners installed in the east-west direction (Figure 5-b).

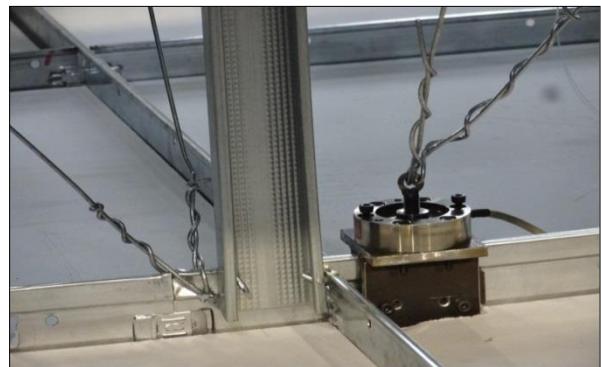
Figure 7. Installation of the load cell

smaller than 100m². The lateral bracing assemblies were placed 1840mm from the boundary and the distance between two bracing assemblies was 3660mm. Moreover, the bracing assemblies were installed only in the A type configurations since the spacing regulations mentioned above were not applicable in the B type configurations. In order to determine the effect of the bracing assembly, a load cell was installed on splayed wires as shown in Figure 7.

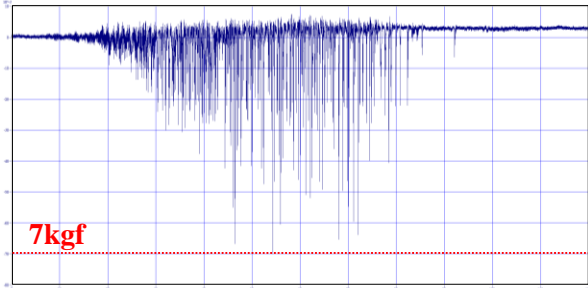
Figure 17. Tensile force of the splayed wire

This paper aims at evaluating the seismic capacity of the lateral bracing assembly, and the experiment results demonstrate that both braced and unbraced ceiling system perform well when undergoing horizontal motions. During the experiment C5, the maximum horizontal acceleration is approximately 2.0g and generates 420kgf of the horizontal inertial force as the self-weight of the ceiling system is about 210kgf. The load cell installed on the ceiling specimen help to measure the tensile force of the splayed wire and the maximum value is 7kgf (Figure 17). The result shows the bracing wire only sustains 3% of the horizontal inertial force.

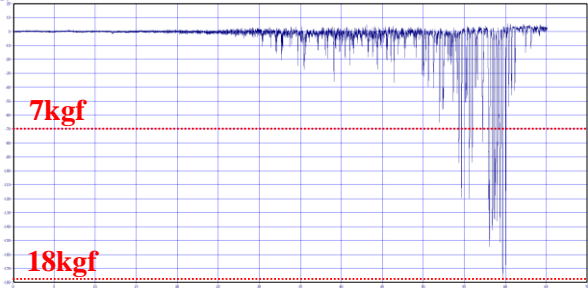
Figure 18. Tensile force of the splayed wire

In the first stage of the experiment C6 (H1300, V300), the tensile force sustained by bracing wire is lower than 7kgf as the vertical excitation is applied to the ceiling,. This is because that the bracing wire buckled easily when suffering upward excitation and therefore loses its resistance to the lateral force. This observation points to an important message; that is, the installation of the lateral bracing assembly may not improve the seismic response of the ceiling system especially if the system is subjected to vertical excitation. Damage to perimeter connections occurred in the sequent stages of experiment C6 and it makes the ceiling become a system without edge restraints. In comparison with the result of C5, the splayed wire of C6 sustained more tensile force. However, the maximum tensile force measured before the ceiling collapsed is 18kgf (Figure 18), which indicates that the bracing wire still sustains less than 10% of the horizontal inertial force. The ineffectiveness of the bracing wire is considered mainly a result from the slack wire effect. Although the wire is installed tightly before the tests, it becomes slacker as experiments progressed. Therefore, the slack wire allows some lateral movement before it effectively restrains the ceiling. However, the clearance is only 12mm between the ceiling grid and the boundary, which makes the wire difficult to perform ideally before the ceiling impact the boundary.

post, the splayed wire sustains more tensile force. However, it is still a small portion to the lateral inertial force. In addition, the vertical displacement at the center of the ceiling is measured during the test. It is found that whether the compression post is installed or not, the displacement is almost the same. This result shows the ineffectiveness of the compression post in limiting the vertical movement of the ceiling system.
