Performance of as-built and retrofitted URM parapets during the 2010/2011 Canterbury earthquakes

D. Dizhur¹, M. Giaretton², M. Brisacque³, F. da Porto² & J. Ingham¹

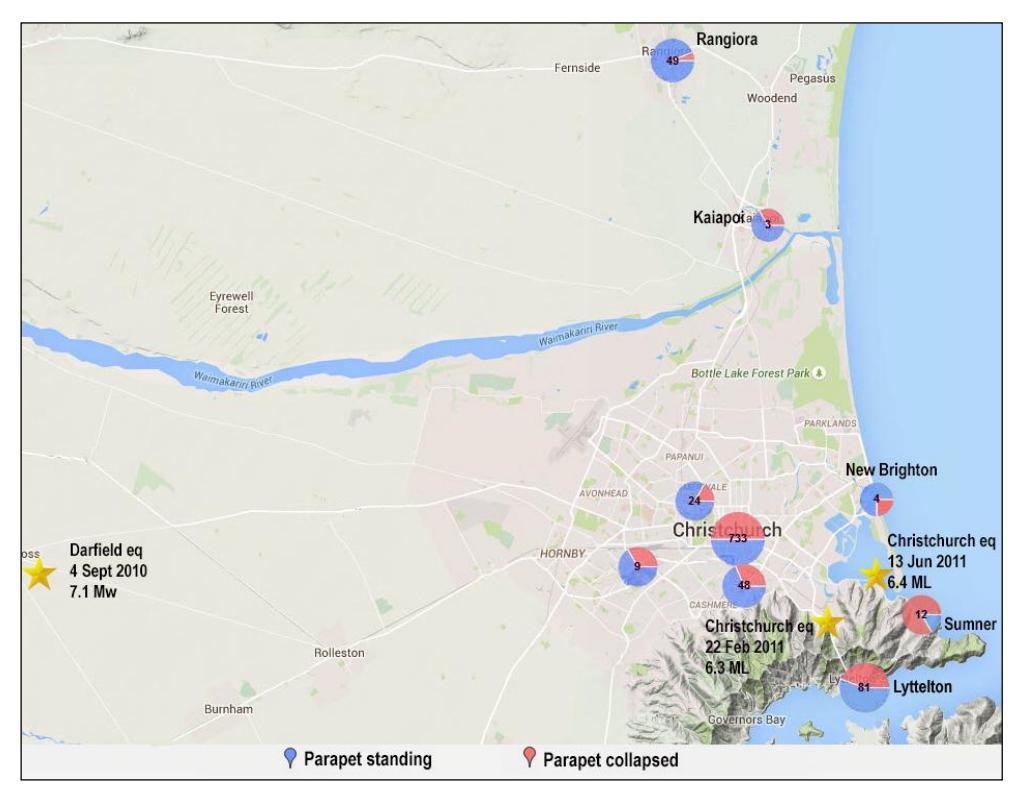
Figure 2. Distribution of surveyed parapet and damage state following the three major earthquakes that occurred on 4 September 2010, 22 February 2011, and 13 June 2011

The 2010 Darfield earthquake did not result in as much damage to parapets when compared with the subsequent aftershocks, with 75% (327) of the recorded parapet stock not exhibiting signs of damage and only 13% (58) having collapsed. The 22 February 2011 earthquake generated higher PGAs and resulted in more damage, considering also that buildings were already weakened from the previous earthquakes. The PGA was high, with 0.7g registered in the CBD and 1.0g in Lyttelton, and both vertical and horizontal ground movements were recorded. The largest number of collapsed parapets (42%, 371) were associated with a recorded PGA higher than 0.50g, 286 (32%) of which were as-built and 85 (10%) being retrofitted parapets. Although the 13 June 2011 earthquake was comparable in terms of PGA, location, and depth of the epicentre to the 22 February 2011 earthquake, the collected data are less than for previous earthquakes because a large number of parapets (80%, 395) had already collapsed. The buildings were already heavily damaged and parapets collapsed at PGA values lower than 0.50g.

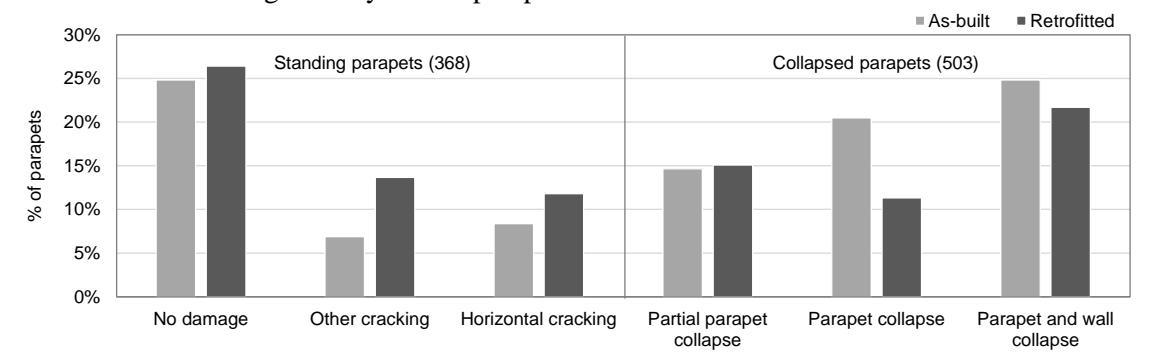
Figure 15. Observed failure categories on URM and retrofitted parapets after the 22 February 2011 Christchurch earthquake

Considering the damage caused to the parapets by only the 22 February 2011 earthquake, failure was observed to be more prevalent on as-built (URM) parapets while retrofitted parapets presented an increase of horizontal or other cracking failures, see **Figure 15**. After the event 40% (269) of the asbuilt parapets were standing while 60% (403) had collapsed. Retrofitted parapets presented a slightly better performance with 52% (109) of parapets standing and 48% (100) of parapets collapsed. A large percentage of retrofitted parapets collapsed but it has to be considered that in many cases it was not easy to identify from the street the presence of any retrofit intervention, unless the parapet had partially or fully collapsed. **Figure 15** shows the improvement in performance of retrofitted parapets when compared with as-built parapets, with more cases standing and fewer cases collapsed. Moreover, a large number of parapets (23%, 212) collapsed due to full or partial collapse of the façade, hence the adopted retrofit intervention designed only for the parapet was not able to avoid the failure.

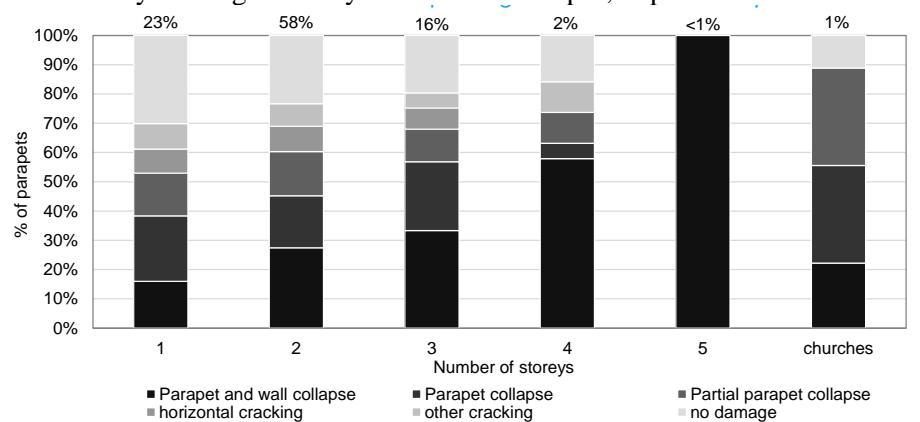
Figure 16. Observed parapet failure categories and proportion in relation to the number of storeys of the building

Considering the state of the parapets after the three seismic events (after June 2011) an increase in the level of damage to parapets proportional to the height of the building (number of storeys) was observed as expected, see **Figure 16**. In the case of two storey buildings, the most populated category, 27% (153) of the parapets collapsed in conjunction out-of-plane failure of the wall, 18% (99) exhibited overturning failure of the parapet and 15% (84) partially collapsed. Of the parapets that remained standing, 9% (48) exhibited the initiation of overturning failure indicated by horizontal cracking, 8% (43) had other types of cracks and 23% (130) presented no damage.

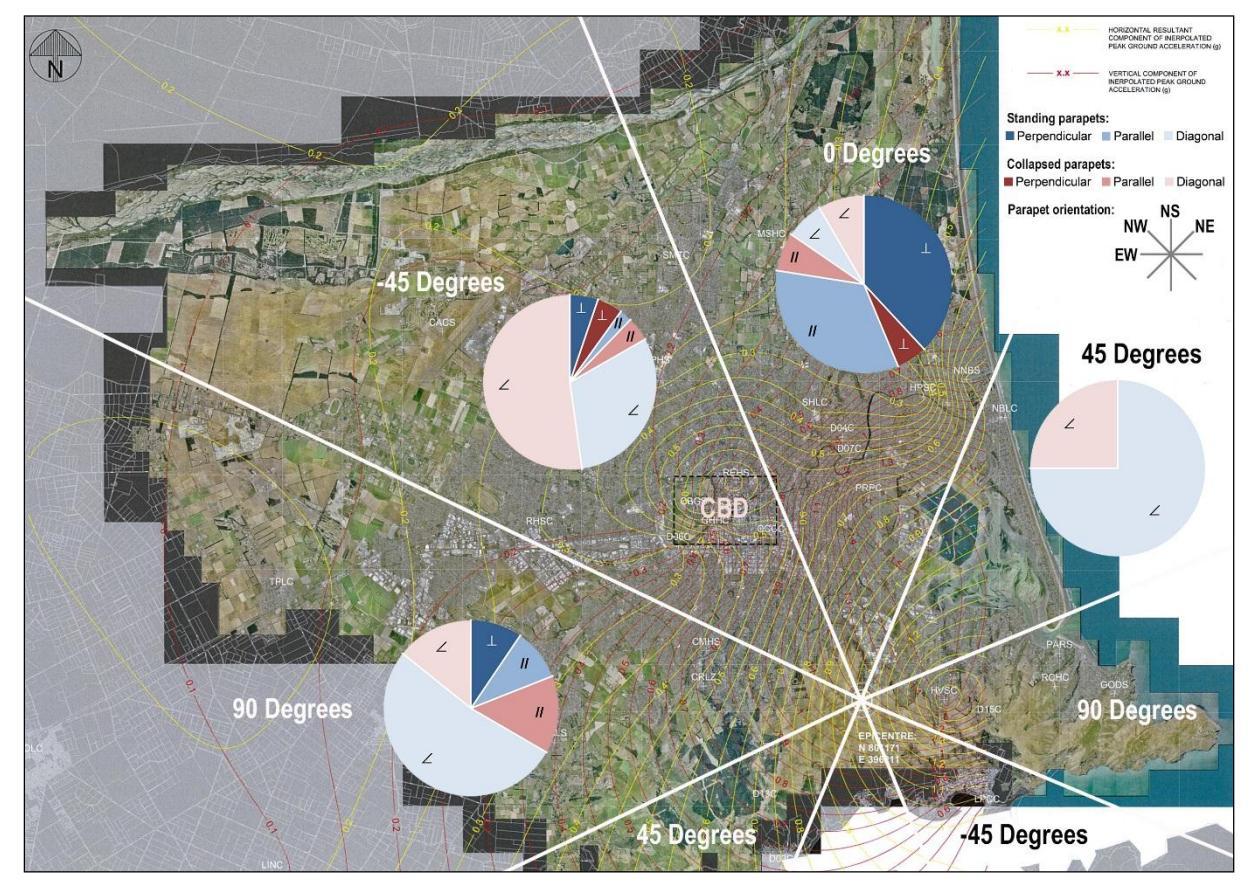
Figure 21. Map showing the epicentre and PGA contours (Source: Christchurch City Council), and for each considered angle group a pie chart showing standing and collapsed parapets for each orientation

described, the orientation of the parapet was identified by the direction of its length and was clustered into four groups: north-south (NS), east-west (EW), north-west (NW), and north-east (NE). The angle between the epicentre and each building was calculated using GPS coordinates. The resulting angles were then clustered into four groups: (i) "0 degrees" that includes the angles from 337.5° to 22.5° and the opposite 154.5° to 202.5°, (ii) "45 degrees" between 22.5° to 67.5° and 202.5° to 247.5°, (iii) "90 degrees" from 67.5° to 112.5° and 247.5° to 250.5°, and (iv) "-45 degrees" considering the angles from 112.5° to 154.5° and 250.5° to 337.5°, see Figure 21. In each group, parapets were clustered as perpendicular, parallel or diagonal with respect to that angle. For example, in the case of group "-45 degrees" that includes most of the CBD (6-12 km from the epicentre) and Lyttelton (5-6 km from the epicentre), all the parapets oriented NE are perpendicular (\perp), parapets NW are parallel (//), and parapets NS and WE are considered diagonal (\angle). Figure 21 summarises the results using pie charts divided into sectors representing each angle group. The pie charts present standing (blue portions) and collapsed (red portions) parapets considering their orientation being perpendicular, parallel or diagonal. In the CBD it was observed that the urban pattern was mainly oriented NS and EW and as a consequence a large number of parapets were diagonal to the direction of the earthquake and most of them collapsed. The area called "0 degrees" includes Rangiora and Kaiapoi located respectively at 32 km and 22 km from the epicentre, and the western suburbs where most of the parapets were perpendicular and parallel and the recorded PGA was less than 0.50g, resulting in a large number of parapets standing. Table 4 presents the results and the number of parapets considered for each group.
