Earthquake Performance of Structures in Bohol: A Post-event Assessment of the M7.2 October 2013 Bohol Philippines Earthquake

M.E. Naguit & P.R. Cummins

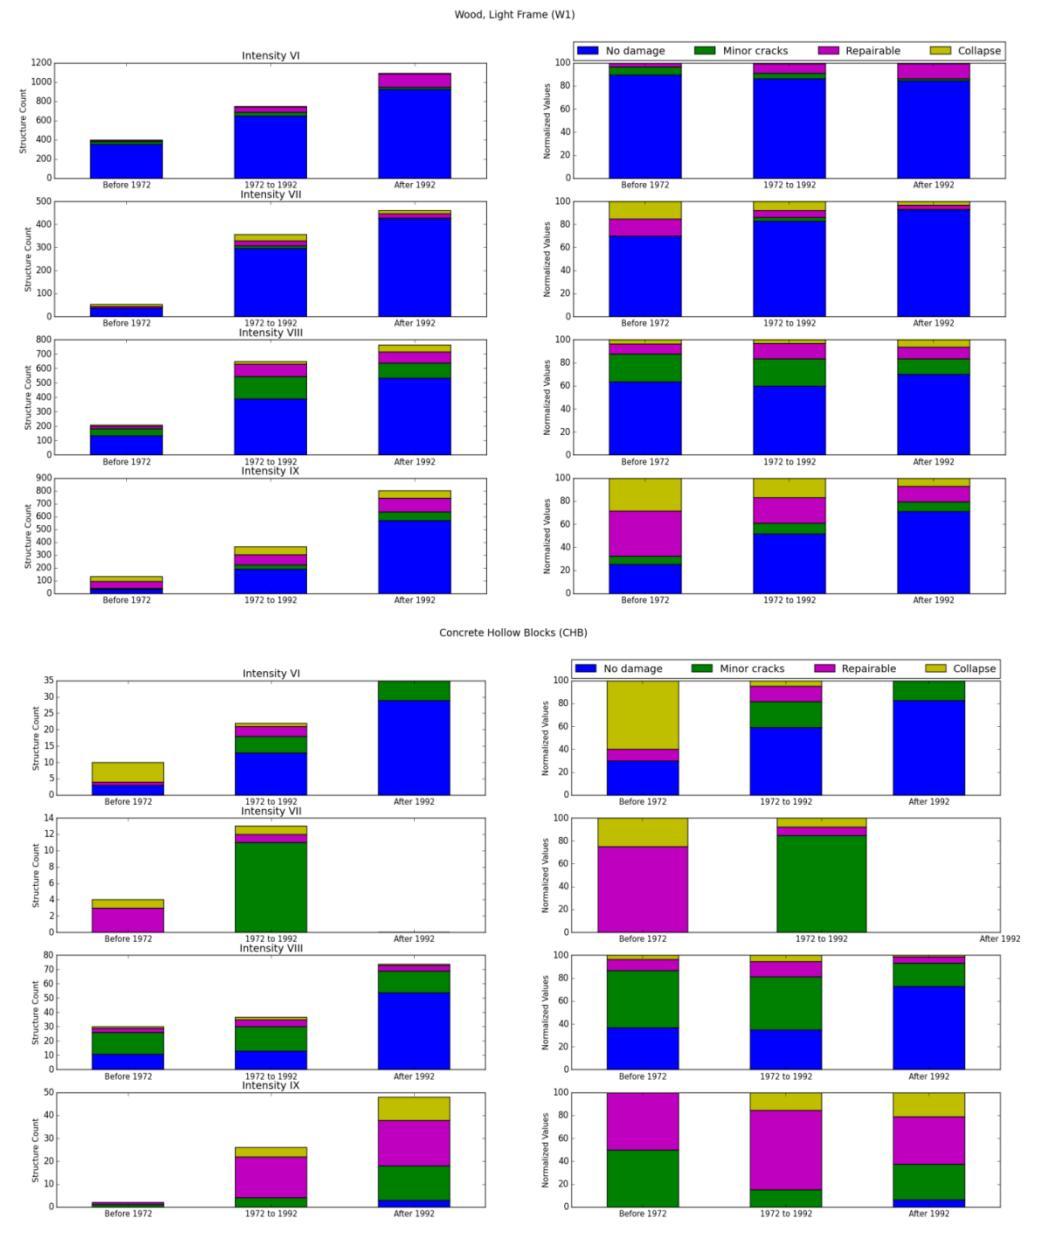
Figure 7. Comparison between W1 & CHB at various intensity levels and era of construction

Each building type is well represented in the surveyed municipalities. CHB has a much smaller sample size compared with other building categories. In Figure 7, the comparison between W1 and CHB is shown taking into account the earthquake intensity levels and construction era. Highlighted in W1 is the large structure count placed under the No Damage state and fewer collapsed structures especially when exposed to severe conditions like higher intensity and the construction period falls before 1972. For CHB, all damage states are noticeable even at lower intensity levels. Results may have not established a clear trend, especially at intensity IX where more new buildings collapsed but this can be attributed to the number of structures representing each age category.

For all building types, the database showcases a general trend wherein all damage states become prevalent in the exposed population as structures incur more damage with increasing earthquake intensity. Also, buildings constructed after 1992 appear to perform much better than older buildings. Not surprisingly, preliminary findings suggest that wooden structures are able to endure earthquake forces quite well when compared to other building types. On the other hand, at least 50% of structures classified under MWS and CM were able to resist the seismic loads, although a considerable percentage needs repair and suffered minor cracks.
