Seismic Performance of Masonry Buildings in the Christchurch Earthquakes 2010-2011: A Progress Report

Lisa M. Moon¹, Dmytro Dizhur², Jason M. Ingham³ & Michael C. Griffith⁴

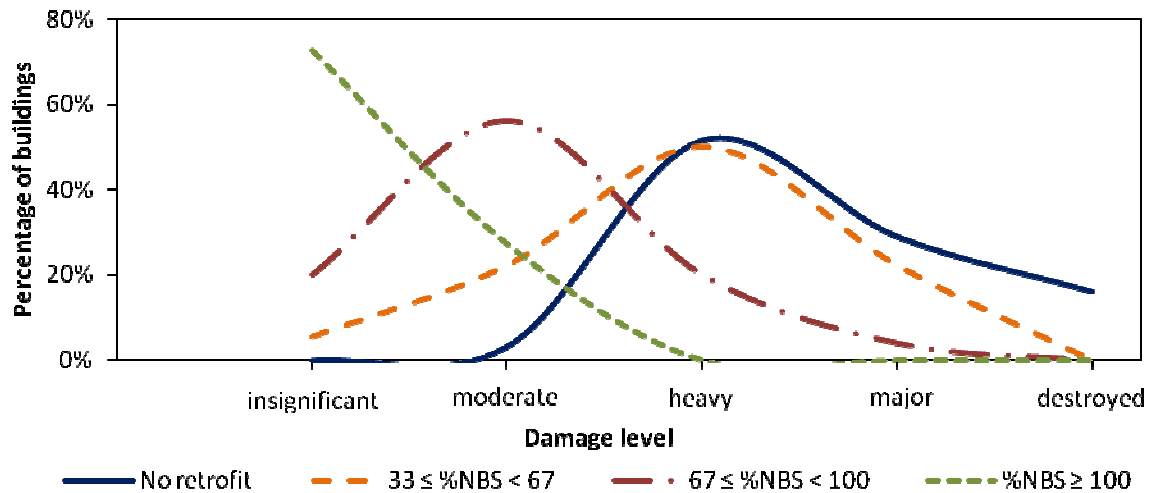
Figure 6 - Effects of retrofit level on damage level

Of the 368 URM buildings left in the Christchurch CBD in February 2011, 62% were confirmed to have received some form of seismic retrofitting. Figure 6 shows the damage levels of buildings for different levels of retrofit and shows that only buildings strengthened to 67% of new buildings strength (NBS) or greater showed significantly lower levels of damage than unretrofitted buildings.
