Unsolved engineering problems after 2011 gigantic earthquake in Japan

ABSTRACT: The gigantic earthquake of magnitude=9 in 2011 in Japan caused many unexpected problems in the community. The significant number of problems over a vast area interacted with one another and made the situation much worse. Nuclear issues have developed to political problems and are difficult to solve in a short time. In addition, engineering is encountering such problems as mitigation of the risk caused by the next tsunami attack, protection of people's houses from subsoil liquefaction, and the preparedness for very rare seismic events in future. The balance between life safety and continuation of economic activities is the key issue but the decision is often affected by political and emotional issues. Because of the speakers majoring field, the talk will put emphasis on geotechnical issues. Note that this report is a minor modification of one of the author's recent papers that were published, first, during the Indian Geotechnical Conference (2011) and, second, in an electronic issue of the Indian Geotechnical Journal

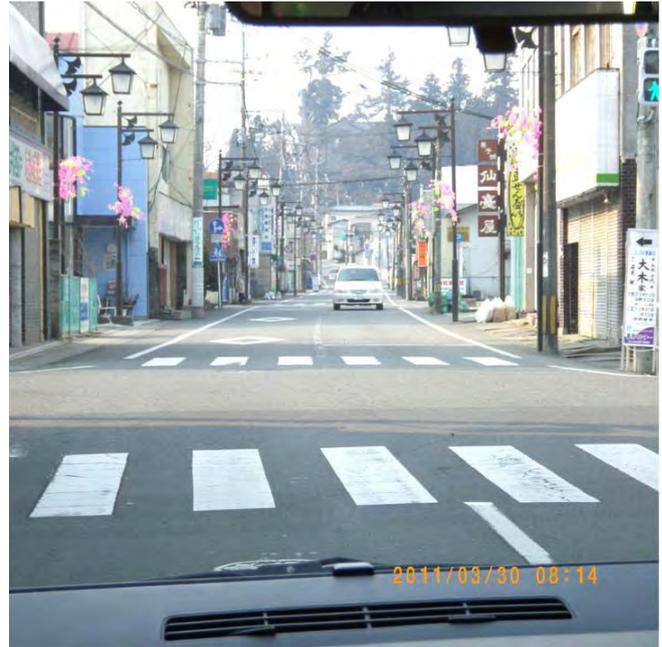
(a) Situation in Tsukidate Township 3 weeks after the quake

Fig. 3 Intact situation in Tsukidate Township

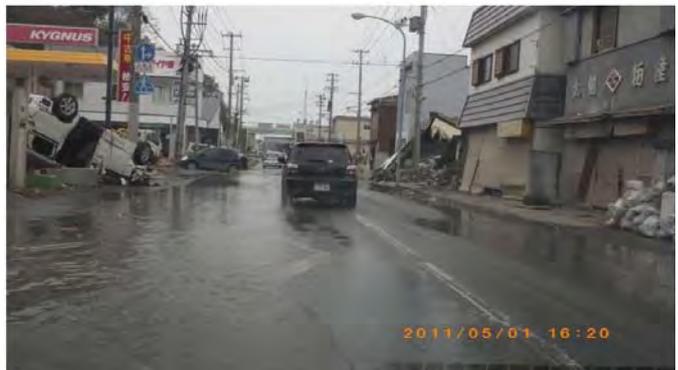
at maximum (announcement by the Meteorological Agency). Consequently, drainage of tsunami water became difficult and the low ground level together with the disappearance of sea walls made the coastal area extremely vulnerable to high waves during typhoons. Fig. 4 shows the Ishinomaki City with ground surface covered by water. Similar coseismic subsidence occurred during the 1946 Nankai earthquake of $M_w=8.1$ or more in Japan and the 1960 Chile earthquake of $M_w=9.5$ together with some other gigantic quakes in the past. In contrast to those former events after which the ground level came back to the original level within several months or a few years, the present subsidence has not been recovered very much (as per the end of October, 2012).

Fig. 4 Zero-level of water-covered ground surface in Ishinomaki City

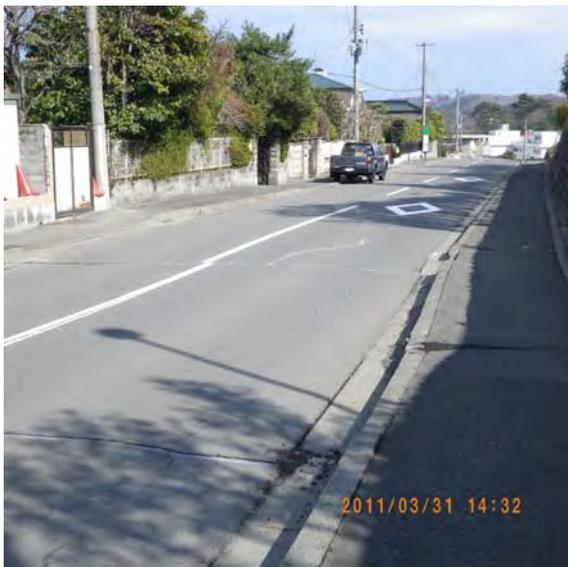
More damaging slope problems, although the size was smaller, occurred in artificial earth fills in hill areas. The residential development in Sendai City has traditionally been conducted in hilly areas where cut-and-fill construction has been the tradition. Fig. 9 reveals a damage example. This occurred in the fill part of the area, causing significant property loss to the residents. Furthermore, Fig. 10 shows the remaining sand at the surface. This sand was an ejecta from liquefaction, because this area was constructed by filling a small water stream. The fill was submerged in water and became vulnerable to liquefaction. In contrast, the cut part of the residential area was of minor damage (Fig. 11).

Fig. 11 Relatively intact shape of residential development in cut part

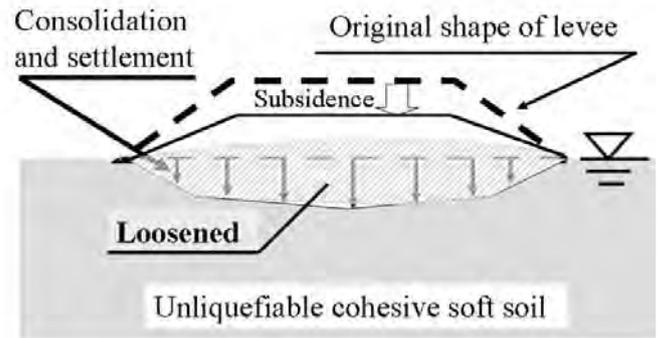
Fig. 15 Mechanism of liquefaction in originally compacted river levee after consolidation settlement in foundation

Figure 15 illustrates the current understanding of the mechanism. First, during normal times, the compacted body of a levee sinks into soft clayey deposit that is subject to consolidation and settlement. Second, the subsided part of the levee is submerged in ground water. This water-saturation has been confirmed by excavation and restoration of damaged levees after the 1993 Kushiro-Oki earthquake [3] and the present earthquake. Third, the subsided part is made looser and liquefiable by an unknown procedure. Some engineers suggest that river levees resting on very soft clay deposits are hardly compacted in practice. Since this part of the idea is not yet verified, more information is expected after the completion of ongoing detailed studies. In addition, the practitioners are now facing a problem how to identify this kind of liquefaction-prone sections out of thousands of kilometers of levees in alluvial planes.

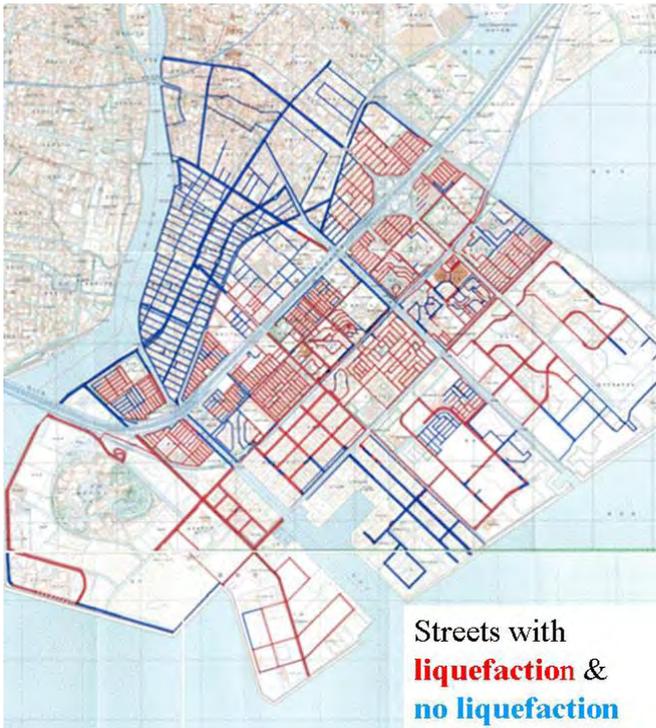
Figure 24 illustrates the distribution map of liquefaction in which streets along which liquefaction was observed are coloured by red, while those without liquefaction by blue. Obviously the south-eastern part of the city was affected by significant liquefaction, while the north-western part was free of liquefaction (Fig. 25). The latter part consists of the original alluvial ground that is as old as 100 years or more. Although the composing sand in this area is basically identical with the seabed sand that was dredged in the recent times and used for reclamation, the consequence of liquefaction was entirely different. This difference, in spite of similar SPT-N values is called the ageing effect at this moment, but its detailed mechanism is still unknown.

Fig. 24 Distribution of liquefaction in Urayasu City

The liquefaction hazard map that was prepared before the quake specified that the entire Urayasu City is prone to liquefaction. Reality was in contrast (Fig. 24), implying that the existing technology underestimates the liquefaction resistance of aged (not as young as manmade islands) sand. To shed light on this, the seismic stress ratio, L , was calculated at many places and plotted against the corrected $SPT-N_1$ value (Fig. 30). Black and open symbols in this figure correspond to the occurrence and lack of liquefaction, respectively. Different symbols correspond to different times of land construction (different ages). Further, the curve indicates the liquefaction resistance of sand assessed by JRA

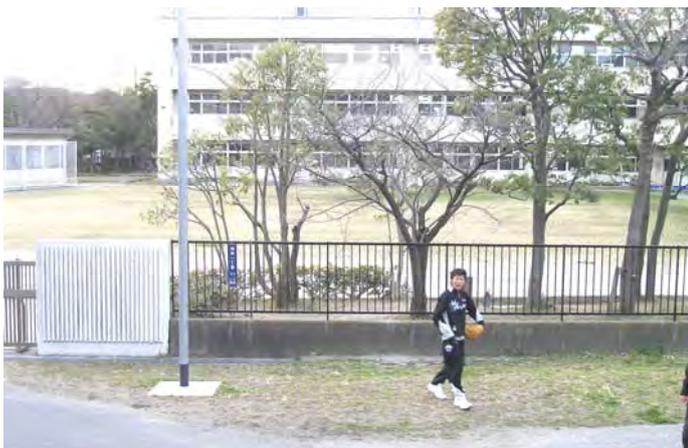
Fig. 25 Lack of liquefaction in north-western part of Urayasu City

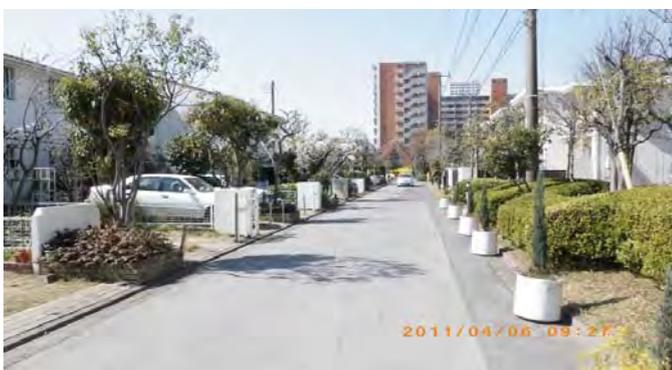
Fig. 26 Successful soil improvement by gravel drains against liquefaction

The lack of liquefaction in the young reclamation area in Fig. 24 was attained by a variety of soil improvement technologies. Although there are still some restrictions to publish those information, it is possible to demonstrate Fig. 26 where a block of residential area had been improved by sand compaction piles and gravel drains prior to building houses. Compaction was executed in the major part of this area, while gravel drains were installed near the border with adjacent residential areas in order to avoid noise and vibration. What is important is that soil improvement before house construction is easy and inexpensive, while improvement under existing houses is more than 5 times more expensive and is now causing problems in the local community. Although some people are accusing of local developers for ignoring the risk of subsoil liquefaction prior to sales, a local real estate businessman said that people had preferred to spent their money not on disaster mitigation but indoor decoration and convenience in life (dish washers etc.). It seems that a trade-off between safety and convenience is going to be a big issue of discussion. It is at least reasonable to say today that safety is not free of charge.

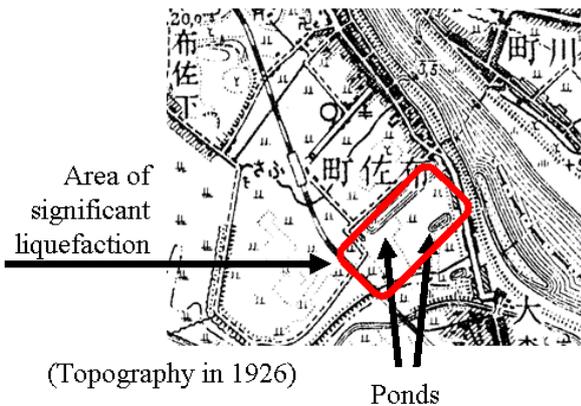
Tone River (Fig. 1) is one of the biggest rivers in Japan and there are many swamps and meandering channels along its main stream. Some of those water areas were filled with soil and formed liquefiable subsoil conditions. Fig. 27 is a liquefied site where flooding in 19th Century created a pond (Fig. 28) that was later filled with sand. The problem was that the liquefaction risk in this area was not indicated in a local hazard map probably because the lack of bore-hole investigation.

Fig. 28 Former topographical map in 1926 of the area in Fig. 26
