# **Lessons Learned for Steel Seismic Design from the 2010/2011 Canterbury Earthquake Series**

**G. Charles Clifton<sup>1</sup>**

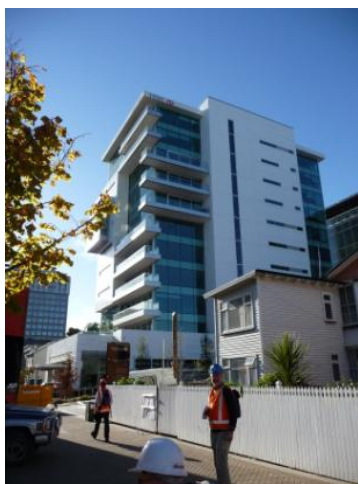
(a) Overall view of tower from North West Corner  
[M Bruneau]

Because the pattern of inelastic demand in this building was as predicted and the peak inelastic demand during the earthquake in the north-south direction (the direction parallel to the external concrete wall shown in Figure 2 (a)) could be determined by scuff marks on the stairs, the ratio of actual building stiffness to predicted building stiffness could be established with reasonable accuracy. The predicted inelastic interstorey drift in accordance with (NZS1170.5 2004) under the design level event was 1.3%; the measured drift was  $\approx 1\%$  under 22 February earthquake, which was  $\approx 1.8$ DLE as averaged from the 4 closest strong ground motion recording stations. This gives a ratio of actual building stiffness to model stiffness of  $\approx 2.3$ .

PGV levels in the February 22<sup>nd</sup> 2011 earthquake exceeded 1g within the CBD, which exceeded the PGH levels in that region. This very high level had only minor influence on steel framed buildings; in HSBC Tower, for example, it dislodged glass doors from their hinge supports (see Figure 4 (a)) and enhanced non-structural internal wall lining cracking in cantilevered window boxes out the building's north face (see Figure 2 (a))

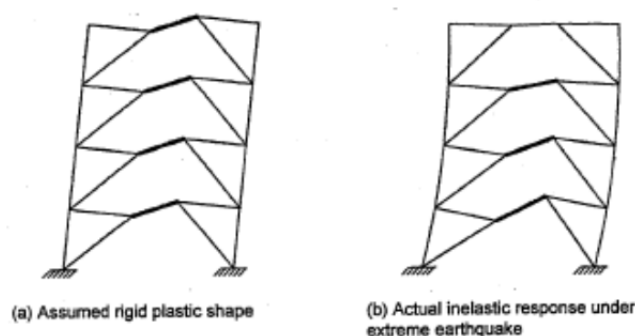
Figure 5 EBF plastic collapse mechanisms

In the 22 February 2011 earthquake, with no exceptions, inelastic action was confined to the active links in those two buildings. In HSBC Tower, the demand was similar up all levels, meaning the inelastic shape approximated that in Figure 5 (a). In Pacific Tower, inelastic demand concentrated into the lower 8 storeys of the building, due significantly to the non-structural contribution of the numerous full height fire and acoustic rated walls in the upper 14 storeys, which comprise hotel rooms and apartments. In all the other steel framed buildings surveyed in the Christchurch CBD, inelastic demand was limited to the primary seismic-resisting system elements, even in one 7 storey perimeter moment-resisting steel framed (PMRSF) building that was severely impacted by differential ground instability, with differential settlement of over 100mm between the central gravity system and the external PMRSFs. Given the range of buildings impacted comprised MRFs, EBFs and CBFs, ranging from 3 to 22 storeys in height and with the capacity design derived design actions governed by overstrength in some cases and upper limit actions in others, this outcome supports the adequacy of the current capacity design procedure.

Figure 5 shows the expected inelastic shapes generated by a severe earthquake; (a) the ideal shape and (b) the actual shape under extreme response. As described in section 4.5, both examples were generated in the 22 February 2011 earthquake. In theory, if the column bases are fixed, this requires column base hinging. However, in practice, none was observed in any of the steel framed buildings investigated in Christchurch and none has been reported in any multi-storey steel framed building sited on stable ground.
