Performance of posttensioned seismic retrofit of two stone masonry buildings during the Canterbury earthquakes

Dmytro Dizhur¹, Sara Bailey², John Trowsdale³, Michael Griffith⁴

and Jason M. Ingham⁵

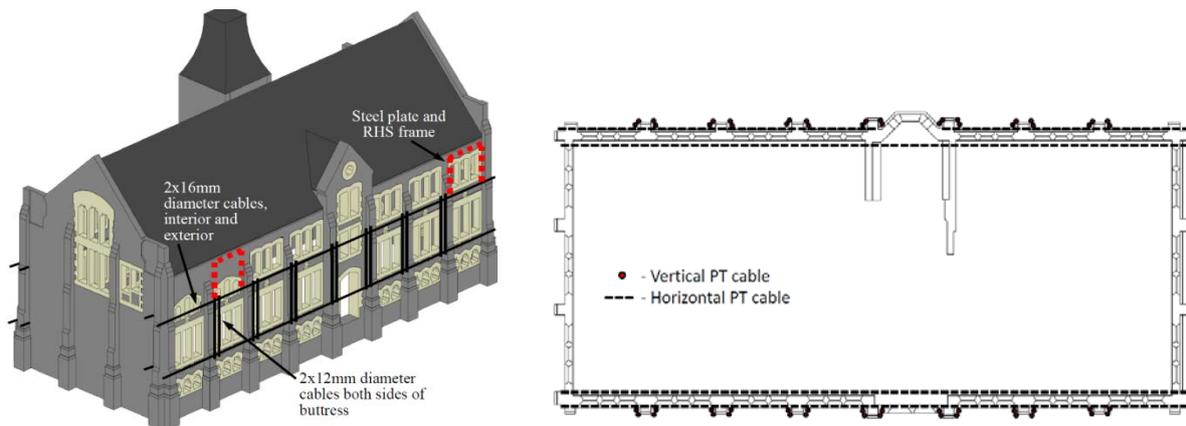
Figure 3: Chemistry building

The retrofit to the Chemistry building (as shown in Figure 3) was part of a strengthening scheme that also involved diaphragm strengthening and steel frames being applied to the attic level (see Figure 4, also, illustrated by dotted lines in Figure 3a). Vertically oriented posttension tendons were installed on the ground level along the north and south facades. These tendons were located in pairs on either side of the buttresses and were anchored into the concrete slab above the basement, stretching up to the bottom of the top level of the building (Figure 4). In total, seven pairs of vertically oriented tendons were installed on both the north and south faces. Horizontally oriented posttension tendons were also applied on the north and south faces of the building, and were paired with a companion tendon running parallel on the inside of the wall in order to enhance a frame-type action of building response. Two pairs of horizontally oriented tendons were applied to the north and south faces, one at the base of the ground level and one at the base of the first floor level.

(a) Isometric view of the building showing the location and the extent of the retrofit
 (b) Floor plan of the building showing the location and the extent of the retrofit

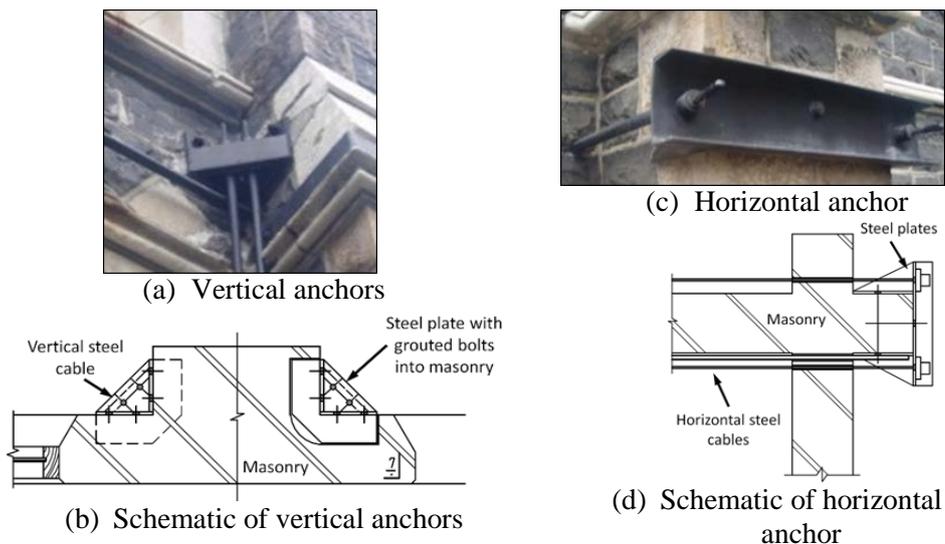
Figure 4: Posttensioned seismic retrofit of the Chemistry building

(a) Vertical anchors
 (b) Schematic of vertical anchors
 (c) Horizontal anchor
 (d) Schematic of horizontal anchor

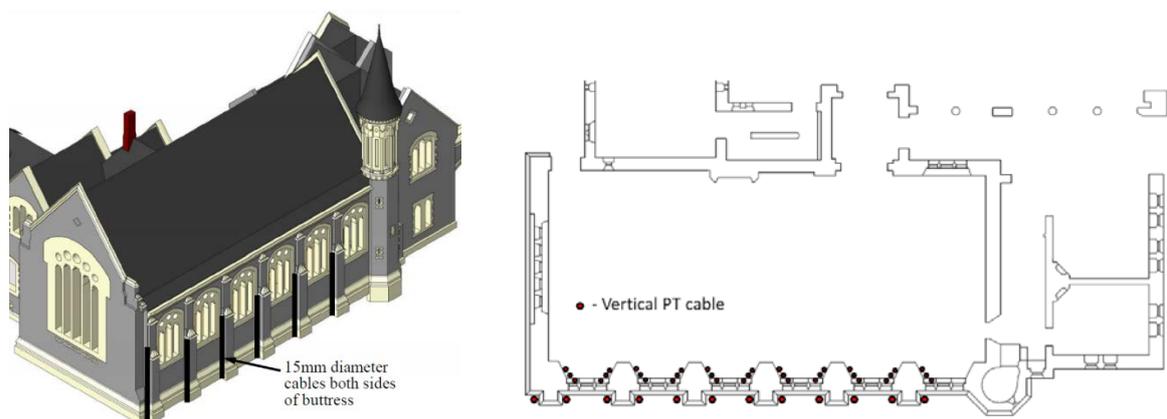
Figure 5: College Hall building

The College Hall posttensioned seismic retrofit was applied to the west side of the building (Figure 5 and 6) and was completed in conjunction with window frame strengthening and widening of the foundations for stability once the posttensioning was applied. The exterior posttension tendons extended from the new foundations to wall mid-height, while the interior posttension tendons extended from the foundation to the roof truss (see Figure 6). The exterior tendons were located in pairs on either side of the buttresses, while the internal tendons were in groups of three, again located on the internal side of each buttress as indicated in Figure 5b. The posttensioned retrofit was applied to compensate for the ineffectiveness of the roof diaphragm in the east/west direction. Therefore the walls were designed as cantilevers and during the retrofit grout was pumped into the drilled holes around the piers in order to fill any voids within the piers.

(a) Isometric view of the building showing the location and the extent of the retrofit

(b) Floor plan of the building showing the location and the extent of the retrofit
