Reconnaissance Investigation on the damages of the 2015 Gorkha Earthquake, Nepal

Bipin Shrestha

Center for Infrastructural Protection and Monitoring

October 2015

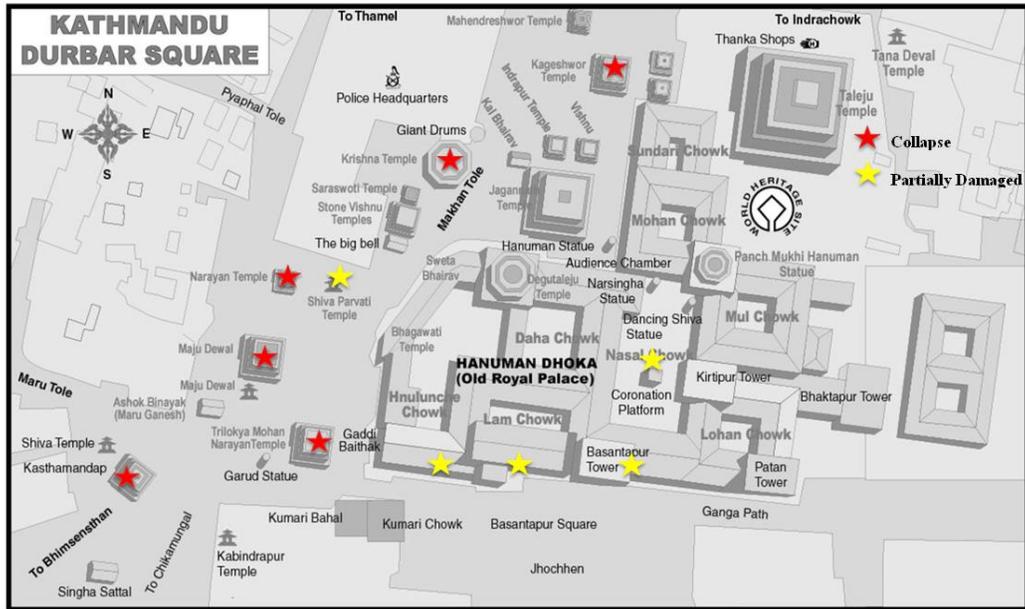
The earthquake caused extensive damages to the temples of the Kathmandu Valley; however, the effects were seen to vary significantly from temple to temple. In this section, an overall description of the principal damages that were observed in temples of three Durbar square complexes and other important structures are summarized. Amongst the three Durbar squares, the most severe damages were seen at Kathmandu Durbar Square (KDS). The map of collapsed and partially damaged temples and palace of Kathmandu Durbar square is presented in Fig. 7. An erratic situation of damages level was observed in the temples of Kathmandu Durbar square, where Kastamandap, Trilokya Mohan temple and Maju Degal temples fully collapsed while Taleju temple with similar structural configuration had no significant damages. The variation of damages of these temples may have been due to the variation in construction method built at various times from 12 to 17th century AD. However, the difference in present structural status of these historical temples might have a significant role on the damage behaviour. Fig. 8 and 9 present the map of the damaged temples of Bhaktapur and Patan Durbar square.

Fig. 7 Damages to the heritage structures in Kathmandu Durbar square. (Base map: digitalhimalaya.com)

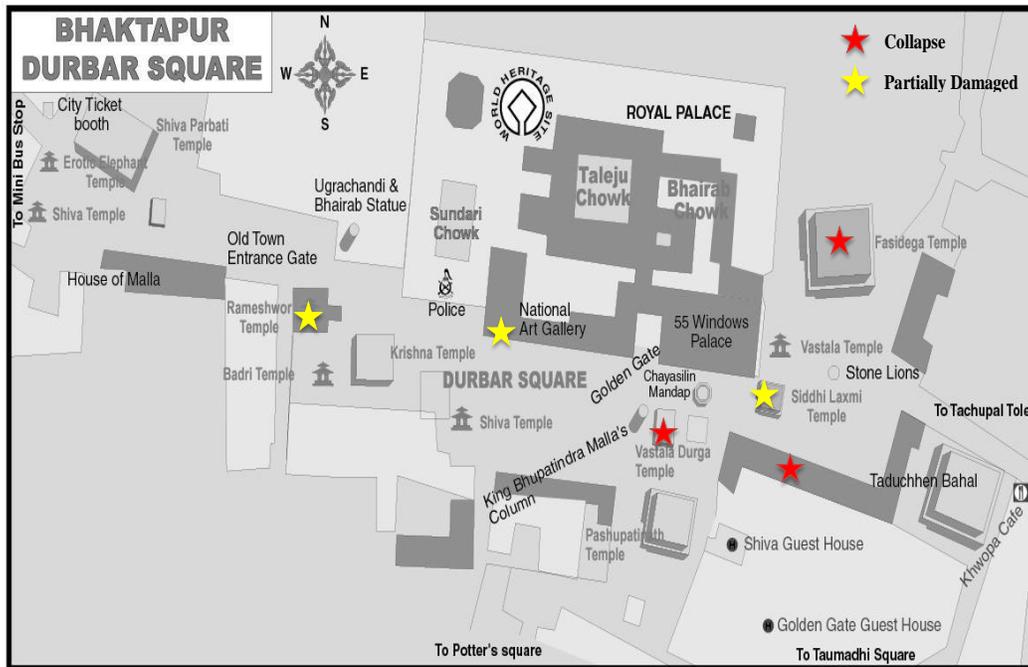
Fig. 8 Damages to the heritage structures in Bhaktapur Durbar square. (Base map: digitalhimalaya.com)

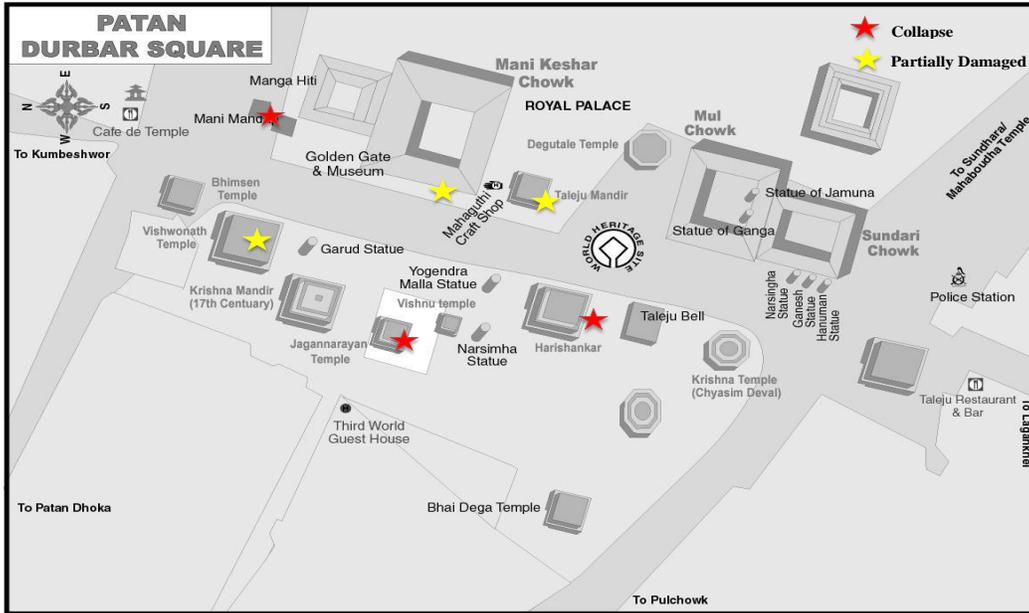
deformation on the ground floor level of the temple. In Patan Durbar square 3 temples (Jagnarayan temple, Harishanker Temple and Mani mandap pati) as shown in Fig. 9 were fully damaged. Fig. 15 displays the picture of Phasi Degal temple of Bhaktapur Durbar Square (BDS) devoted to God Mahadev. The Masonry walls at the three sides of the temple failed during the earthquake after the development of diagonal shear cracks. The remaining portion of the masonry wall as shown in the Fig. 15 (b) was later demolished to prevent any mishaps.

Fig. 9 Damages to the heritage structures in Patan Durbar square (map source: digitalhimalya.com)
