Lessons Learned from the Nepal Earthquake 2015

T. Pokharel and H.M. Goldsworthy

Department of Infrastructure Engineering, University of Melbourne, Parkville, 3010, Australia.

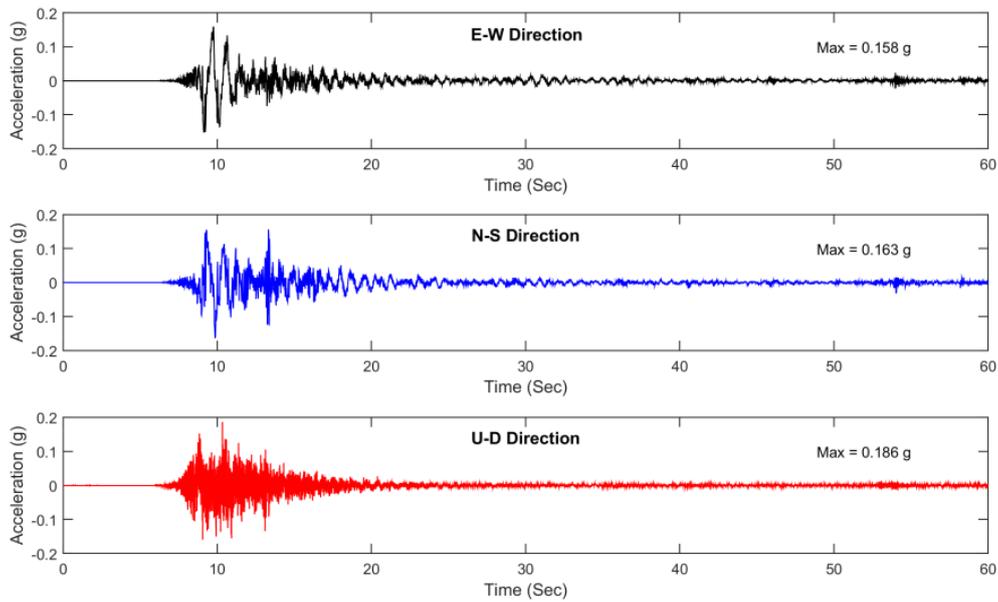
There is very limited information about the ground motion for this earthquake. Figure 6 shows the ground acceleration of the M7.8 earthquake on April 25 recorded by USGS at Kathmandu on a soft soil

site. The maximum acceleration recorded was less than 0.2g in each direction.

Figure 6: Accelerogram for main event on soft soil (Source: USGS)

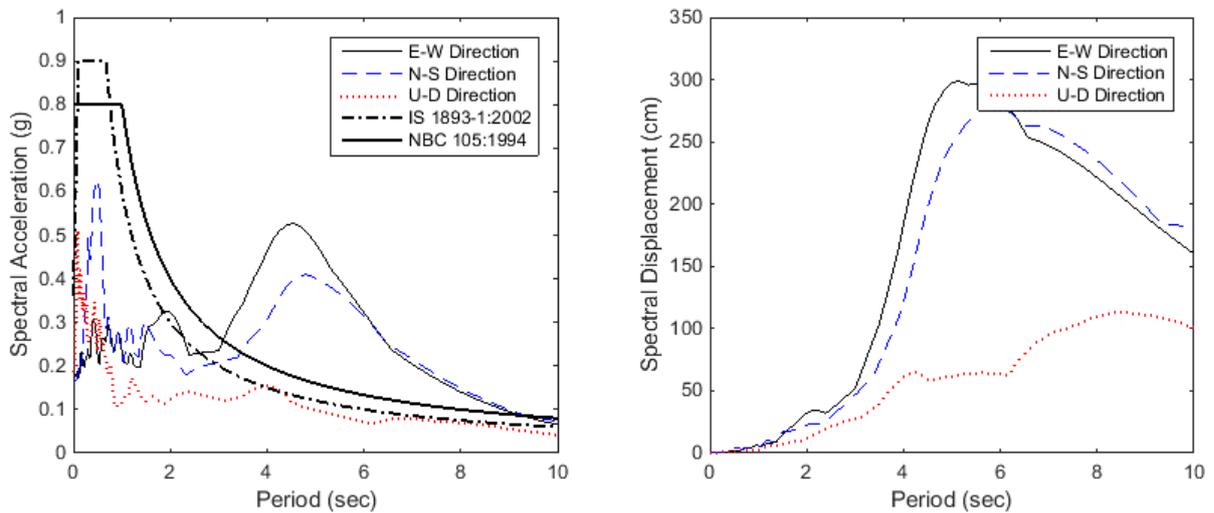
Figure 7 shows the spectral acceleration and displacement of the earthquake. The dominant period of the ground motion was observed at 4.52 seconds in the E-W direction, 0.52 sec and 4.80 sec in the N-S direction. The spike in the spectral acceleration in the N-S direction at a period of 0.52 sec is not in the E-W direction, suggesting that there were some directivity effects in Kathmandu due to the nature and location of the rupture. The peak spectral displacement was found to be nearly 300cm and 280 cm in the E-W and N-S directions respectively at 5% damping.

Figure 7: Spectral acceleration and displacement for main event on soft soil

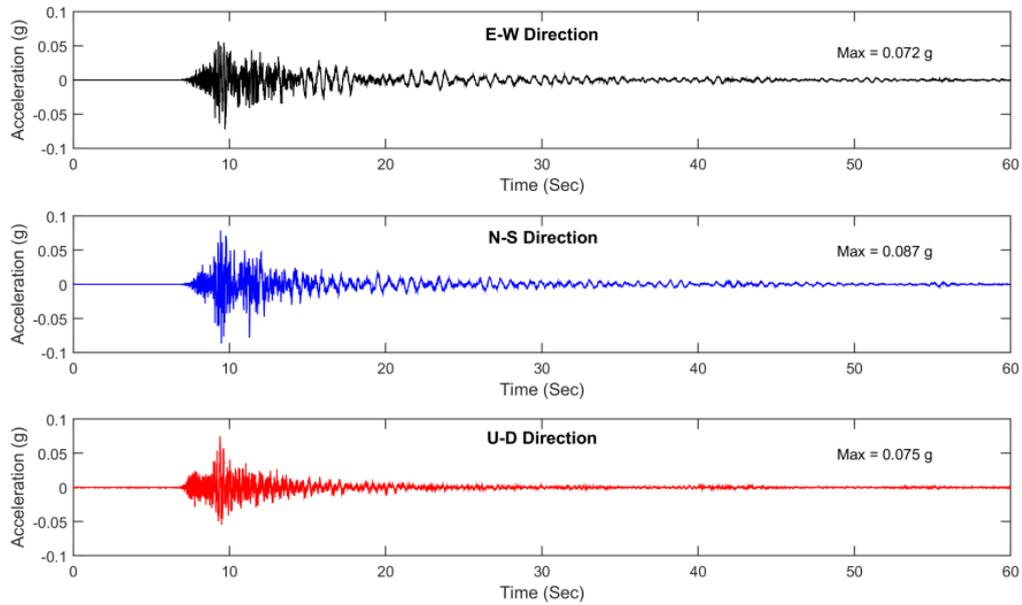
Figure 8 and Figure 9 show the acceleration ground motion caused by the M7.3 aftershock on the 12th of May on soft soil and hard rock sites in Kathmandu respectively. The ground acceleration and displacement in that earthquake was observed to be much smaller relative to those recorded in Kathmandu during the main event on the 25th of April.

Figure 8: Accelerogram of 12 May aftershock on soft soil (Source: USGS)

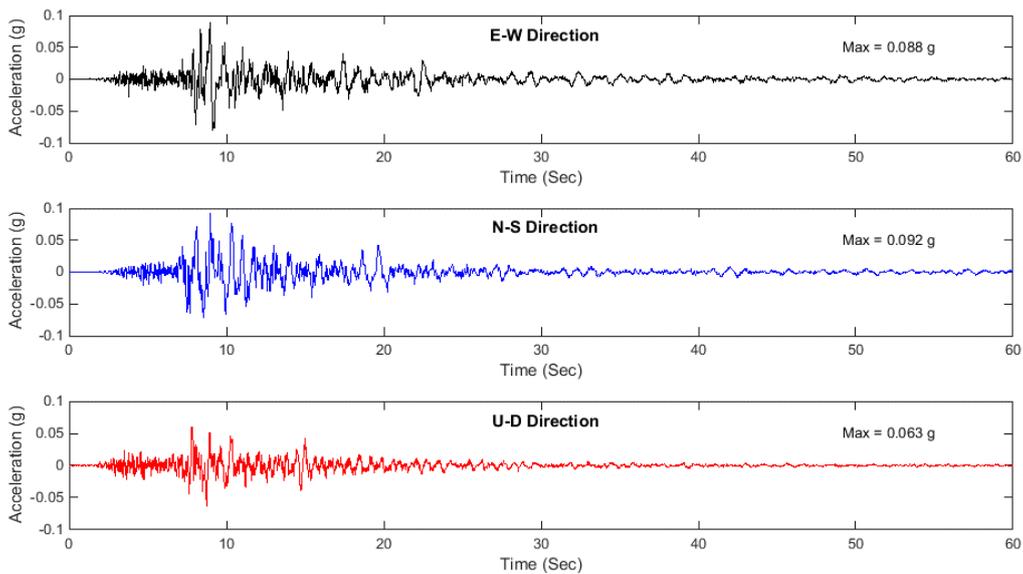
Figure 9: Accelerogram of 12 May aftershock on hard rock (Source: NSET)

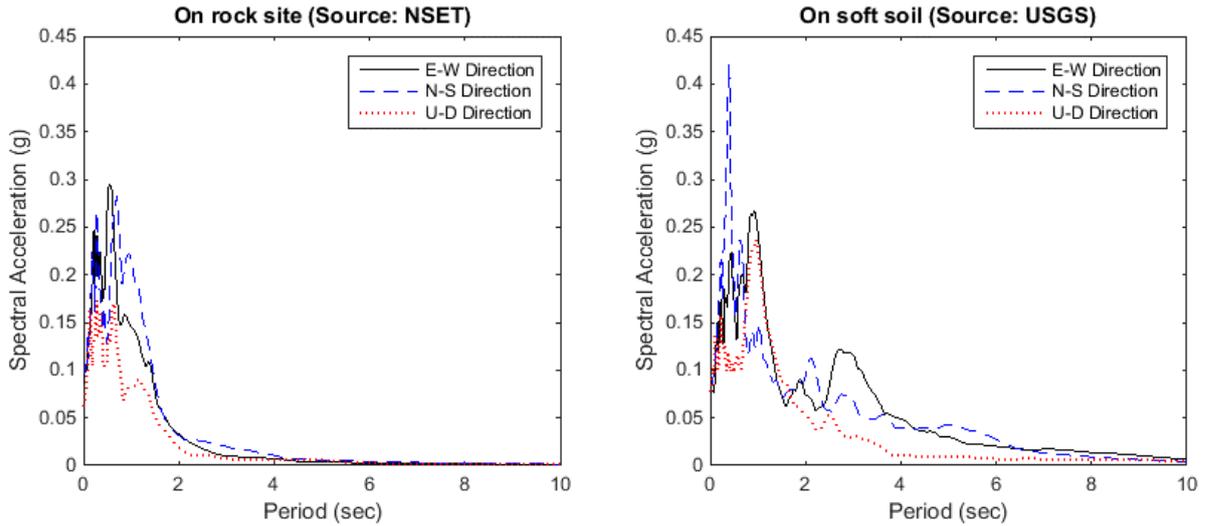
The acceleration spectra for the hard rock and soft soil sites are compared in Figure 10 for the same M7.3 earthquake. There is a huge difference in spectral acceleration profiles. There is a second peak around 3 sec on soft soil which is because of the site period of the underlying soft layer. As expected, the second peak is missing in the spectral acceleration profile on the rock site.

Figure 10: Comparison of spectral acceleration between soil and rock site of 12 May aftershock

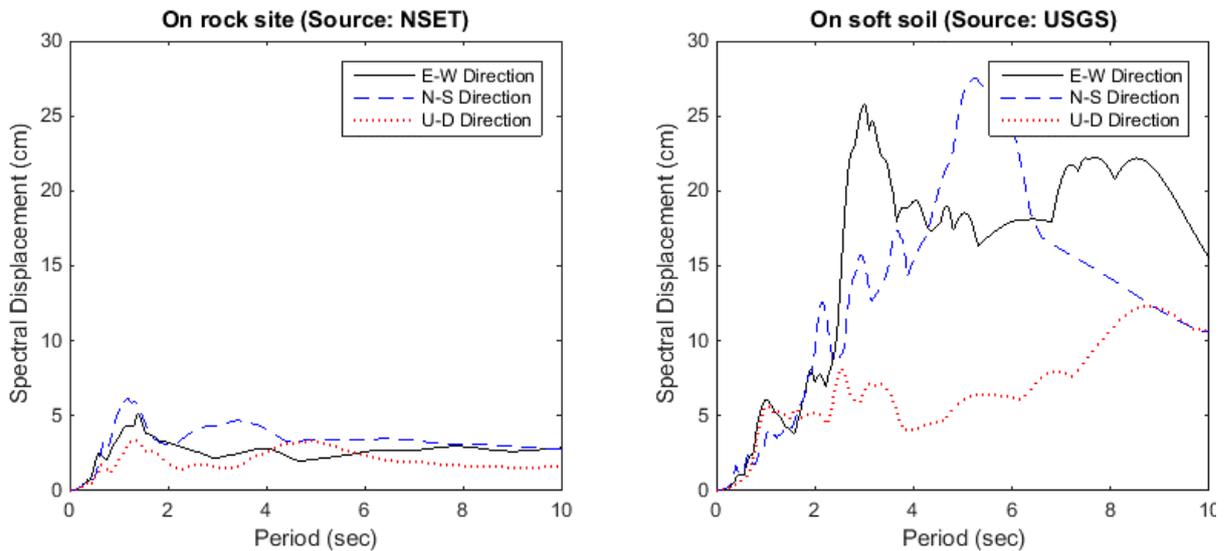
Figure 11 compares the spectral displacement on soil and rock sites. Clearly, the spectral displacement on the soft soil is very large compared to that on the rock site.

Figure 11: Comparison of spectral displacement between soft and hard soil site of 12 May aftershock

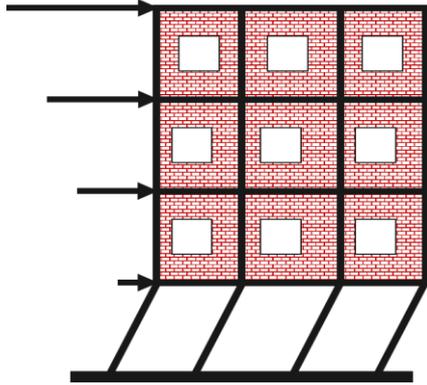
One of the major problems current buildings have is the soft storey effect particularly at (but not limited to) the first storey. This is either because the owner wanted open spaces to sell/rent to the merchants who prefer open space to sell their goods, or for parking purposes. By doing so, the stiffness and the shear strength of that floor decreases significantly and the damage concentrates at that level as shown in Figure 13. Figure 14 and Figure 15 show the soft storey effect in the ground floor. There were shops at both buildings and the stiffness of these stories were significantly low as compared to the stories with brick masonry infill (Pokharel 2015). Figure 16 shows the result of having a weak storey at the third level. The third level was constructed of unreinforced masonry whereas the storeys above and below incorporated RC elements. The weak third storey collapsed completely.

Figure 13: Soft storey effect where the stiffness of some stories are significantly less than the others. The displacement concentrates at the soft storey imposing large ductility requirements on elements at that storey.

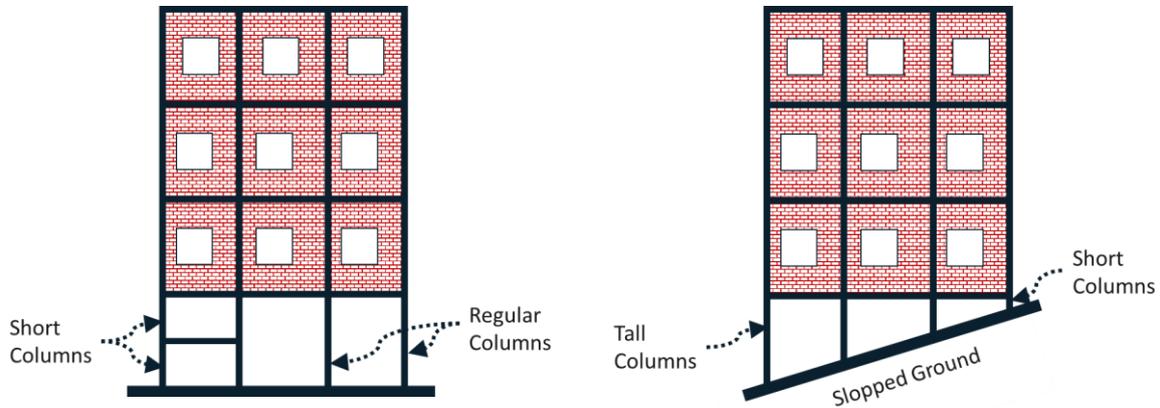
The effect of short columns is often overlooked in the design and construction of the buildings. The short column effect can either result from partial height infill walls, the addition of an extra connection beam to support a staircase, or from sloping ground as shown in Figure 18. When there is a short column in a structure it attracts more lateral shear forces and needs to be designed accordingly. One of the observed effects of short columns due to staircase is shown in Figure 19.

Figure 18: Conditions for formation of short columns in the RCC buildings.
